| Title | Diagnostic / Troubleshooting Procedures For EGR System Components; Diagnostic Trouble Codes (DTC) P0401-00, P0402-00, P04DD-00, P1121-00, P1121-98 Or SPN 2659 FMI 16, SPN 2659 FMI 18, SPN 412 FMI 0, SPN 412 FMI 15 - <b>US10, US10+OBD13, US14+OBD*, US17+OBD* With A Variable Geometry Turbocharger (VGT)</b> |

| Engine family | 11L Engine , 13L Engine , MP7 , MP8 |

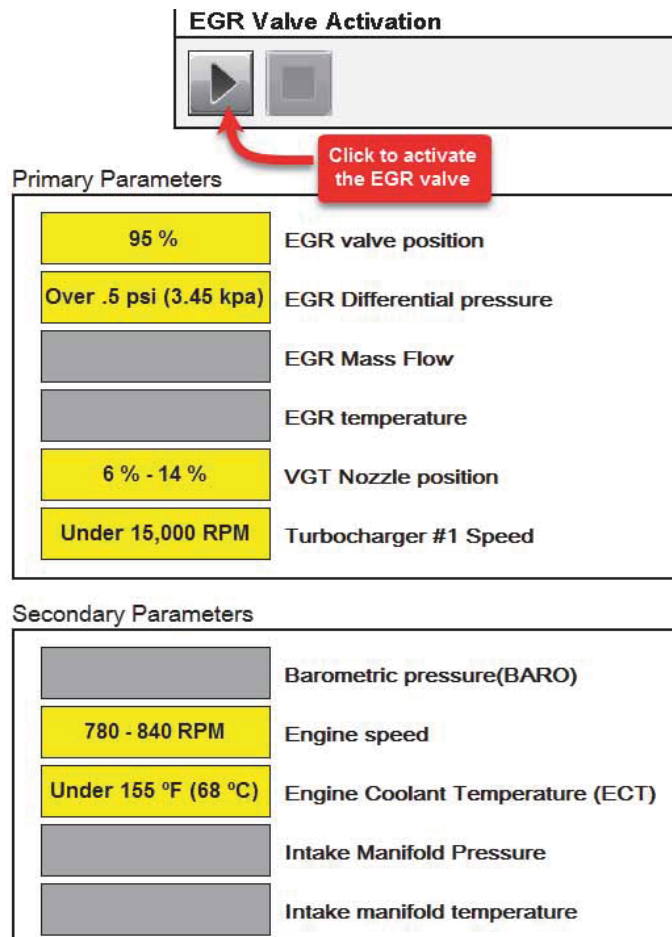
**Screenshot** : Should be taken with Conditions (in **YELLOW**) achieved and showing EGR valve at 95% just before the valve closes again OR the engine dies.

- Turbocharger speed should drop below 15,000 RPM within 10 seconds of valve activation.
- If turbo speed does not change, the EGR valve should be checked to confirm it is not stuck closed.
- If turbo speed drops but remains above 20,000 RPM, the EGR cooler is likely plugged.
  - A turbo speed reaction to EGR valve activation is a normal indicator of an operational EGR valve.
  - The Venturi tube should also be checked to ensure it is free of blockage (Much less likely).
- If turbo speed reacts as expected, the EGR differential pressure sensor or EGR Temperature Sensor are the likely issue for High or Low Flow codes.
  - Check for clogs or excessive condensation in the EGR sensor, sensor supply tubes, or Venturi tube.
  - Check for a non-plausible differential pressure value during valve activation.

A negative value or low value, for instance .2 PSI (1.4 kPa) or less, at full valve activation is an indication of an EGR dP sensor and/or venturi tube issue.
  - Check for a non-plausible EGR temperature value during valve activation.

A temperature reading below coolant temperature or higher than exhaust temperature is an indication of an EGR temperature sensor issue.
