**PRODUCT CAMPAIGN BULLETIN**

**APPLICABILITY:** 2019MY Forester and Crosstrek Vehicles      **NUMBER:** WUC-88R  
**SUBJECT:** Power Steering Gear Box Inspect/Replacement      **DATE:** 02/12/19  
**REVISED:** 04/08/19  
**NHTSA ID:** 19V-065

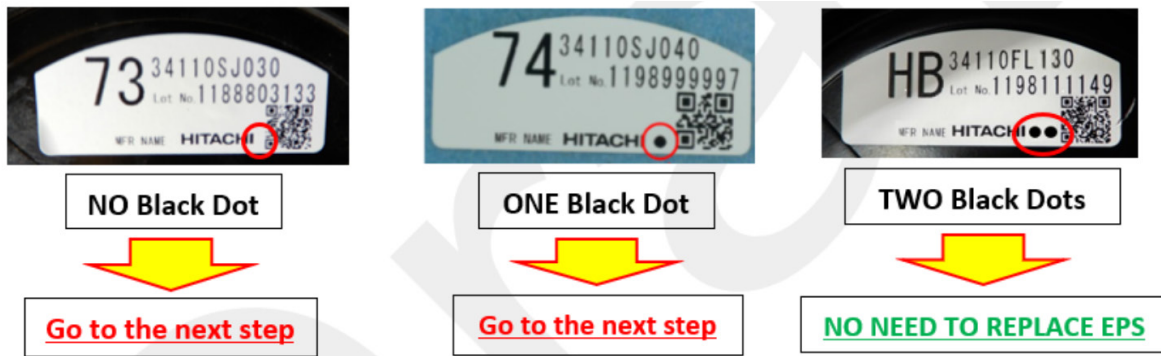
3) Inspect the label for black dots to the left of the QR code as shown.

If inspection reveals a label with TWO (2) dots, REGARDLESS OF LOT NUMBER, the Service Procedure is complete. **CAREFULLY** copy the Lot Number onto the Repair Order as it will be needed for Claim Submission. Proceed to Claim Reimbursement and Entry Procedures to process the claim for Inspection Only.

If inspection reveals a label with either NO or only ONE dot, **CAREFULLY** copy the Lot Number onto the Repair Order then compare it to the ranges provided below. **NOTE:** Parts within these lot number ranges may be found on either Crosstrek or Forester as both of the vendor's production lines produce parts for both carlines.

If the Lot Number falls within either of these ranges, the EPS assembly MUST be replaced.

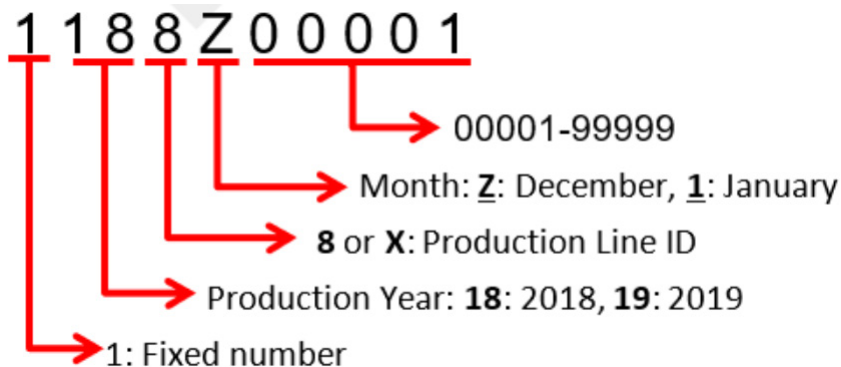
1188Z21674 – 1198199999  
 118XZ10278 - 119X199999

Use the image below for interpreting the Lot Number of the EPS gear box assembly.

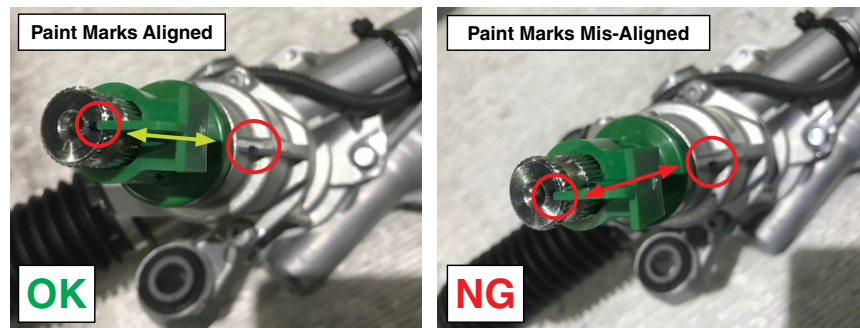
- Before installing a new gear box assembly, **ALWAYS** confirm the new part is the correct part number for the vehicle being repaired. The Forester and Crosstrek ESP gear boxes are very similar in appearance and will bolt into each model but, they are **NOT** interchangeable.
- There is a **VERY SMALL** possibility the EPS gear box assembly was not properly centered before the plastic retainer was installed during manufacturing. If this occurs:
  - it may be difficult to match up the marks when re-connecting the EPS gear box assembly to the steering shaft
  - the number of turns between full steering lock left and right will be different
  - one tie-rod boot will be collapsed (or extended) more than the other.

- If a **NG** condition is identified, see **APPENDIX A** on page 9 of this bulletin for the EPS Gear Box Centering Procedure.
  - Although the plastic retainer cap is white in the photos, it will likely be either green or blue depending on application.
5. When the Lot Number inspection procedure determines the EPS gear box assembly requires replacement, follow the procedure in the applicable Service Manual along with the Helpful Hints provided below. Pay close attention to the items listed as one-time-use. They are all supplied in the Hardware Kit and **MUST** be replaced during reassembly.

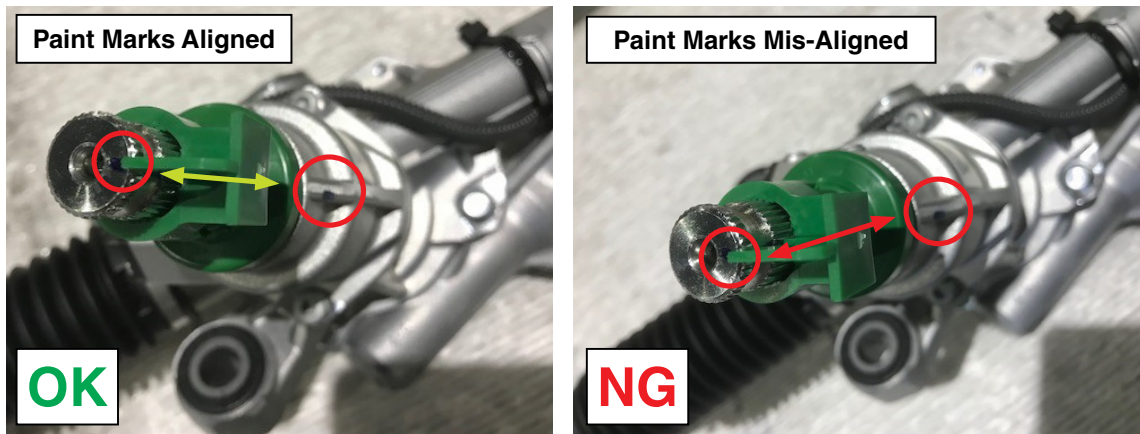
There is small possibility the steering gear box center position may be incorrect on the new replacement EPS gear box. This condition could cause the following two issues:

- Difficult to match the paint markings when connecting the gear box and the steering shaft.
  - The steering angle (number of turns) to full steer left and right may be different.
1. Before installing the new EPS gear box, confirm the input shaft paint mark and the housing paint mark are aligned as shown in the OK photo below.
  2. Confirm the tie rods and boots are the same length, left and right.
