SERVICE INFORMATION BULLETIN

APPLICABILITY: All Models Equipped with EyeSight **NUMBER:** 12-261-19
SUBJECT: EyeSight Camera Cover Removal and Installation **DATE:** 04/17/19
 Cautions

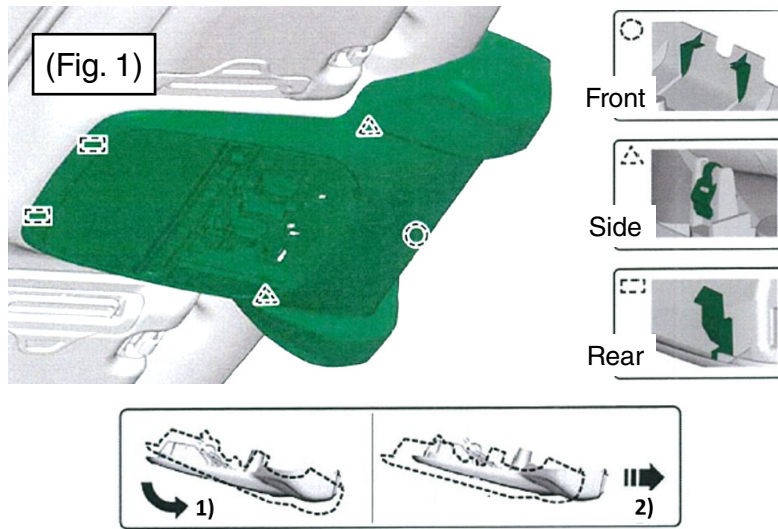
After removing the two bolts adjacent to each map light, **CAREFULLY** pull down on the back edge of the camera cover **ONLY AS FAR AS NECESSARY** to access and release the two clips at the rear with a plastic trim tool. Pulling the cover down any more than needed will likely damage the two front hooks necessitating cover replacement. See **(Fig. 1)** below. Use a twisting motion with a plastic trim tool to release the single clip on either side while being extremely careful to not damage the edges of the cover. Once all four clips are released, slide the cover forward to release the two front hooks from the camera assembly.

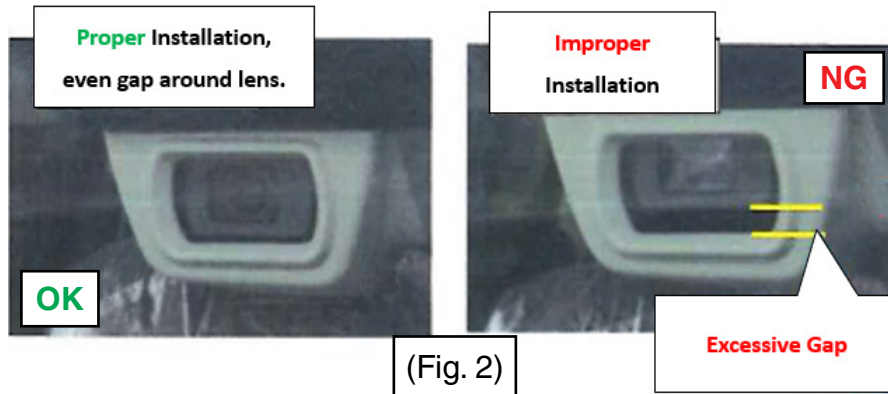
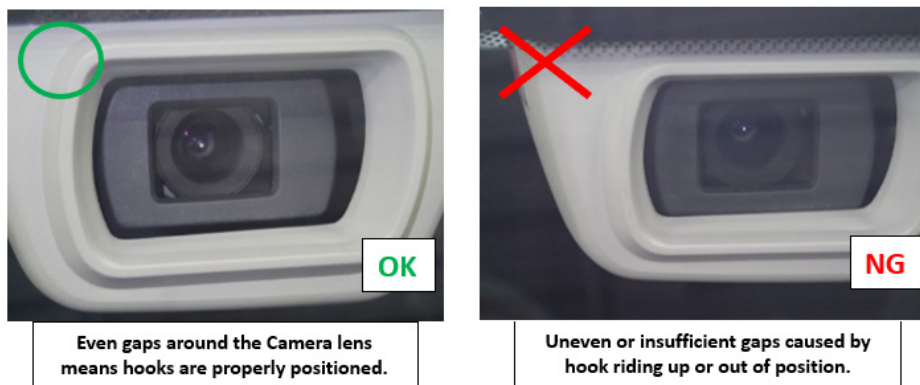
Once the cover is reinstalled, confirm a proper repair by looking closely through the windshield at the front of both EyeSight camera lenses. When the cover is installed properly, there should be an even gap (approximately 1mm) all the way around each lens as shown in the OK photo in (Fig. 2) and (Fig. 3) below. If there is an uneven gap, chances are the shorter portion of the front hook(s) has ridden up onto the camera housing instead of being butted up against it. OK and NG photos of this condition are also included in (Fig. 2) and (Fig. 3) below.

IMPORTANT: If the cover is not installed properly, there will be an uneven gap around the lens. This can cause a rattle sound when driving on rough roads and / or possible EyeSight operational concerns.

VERY IMPORTANT: Whenever the camera cover has been removed, always confirm proper EyeSight system operation as a final quality check before releasing the vehicle.
