SERVICE BULLETIN

APPLICABILITY: 2019MY Forester

NUMBER: 12-260-19

SUBJECT: Metallic Rattle / Chirping Sound from "A" Pillar Area

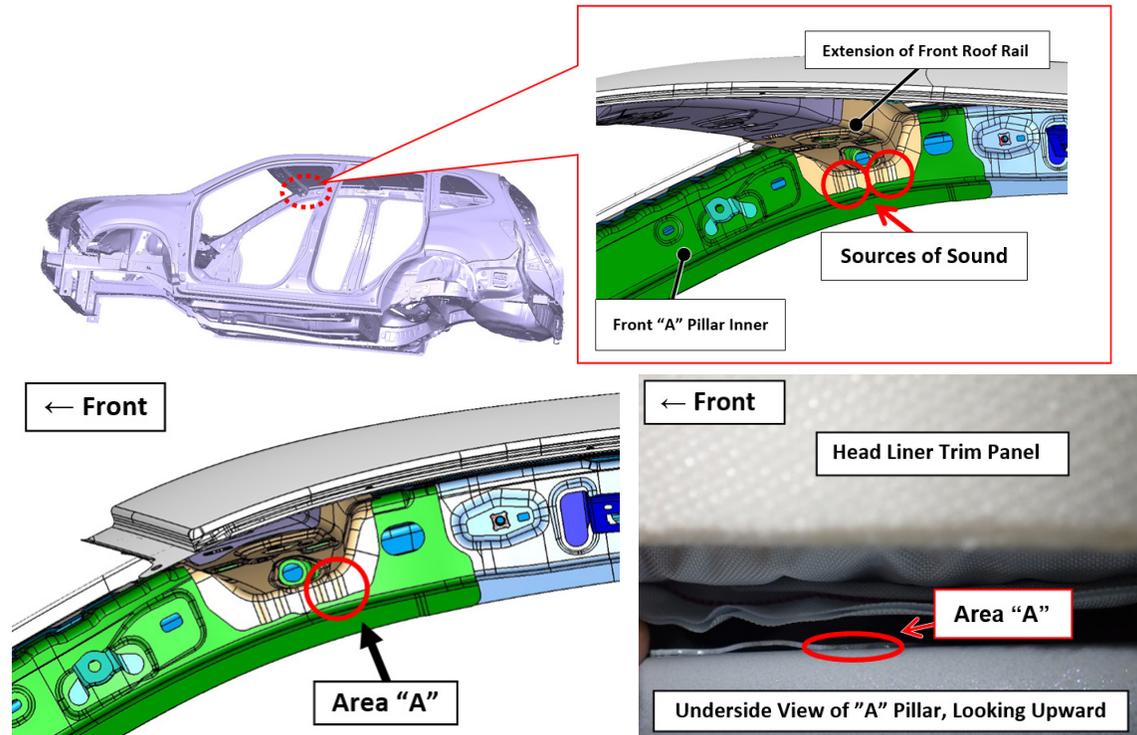
This bulletin provides a procedure to address a small number of customer concerns regarding a metallic rattle or chirping -type sound heard coming from the top of the front "A" pillar area. The sound may originate from either side of the vehicle.

2. Using the images above, locate **Area "A"** where the front roof rail joins the "A" pillar and side roof rail.
3. Drive the vehicle and while either using a set of chassis ears / NVH tester, or a helper, press on the areas around with your fingers to see if the sound changes at all or if it can be eliminated.
4. If the sound can be changed, identify specific areas **B** and **C** and the spot welds as shown in the illustration below. If the sound cannot be changed, it is likely originating from another source.
