SI B54 04 19  
Special Roofs

## CRACKING NOISE FROM ROOF OVER ROUGH ROAD SURFACES

| I15 (i8 Roadster) | | | |

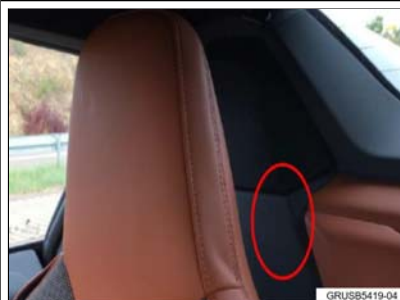
1. Completely open the convertible top to gain access to the main convertible top hinges (circled) on both sides of the vehicle.

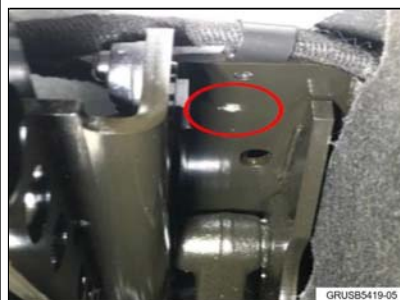
Interference between the convertible top hinge and adjustment stop screw.

2. Inspect both hinges for signs of interference between the adjustment stop screws and convertible top hinges.

Interference can be noted by a small area of missing coating on the hinge (circled).

3. Using R2 cleaner PN 83 19 0 417 324, clean the surfaces of both hinges in the area of missing coating and allow the hinges to dry.

| | <p>4. Apply a strip of sliding tape PN 83 19 9 407 798 over the area of the missing coating. Apply strips to both hinges,</p> <ul style="list-style-type: none"> <li>• Press firmly on entire tape surface</li> </ul> <p> Note: Strips should be cut in 15 mm lengths.</p> |
