SI B63 01 19
Lights

April 2019
Technical Service

DELIVERY STOP: REWORK TAIL LIGHTS

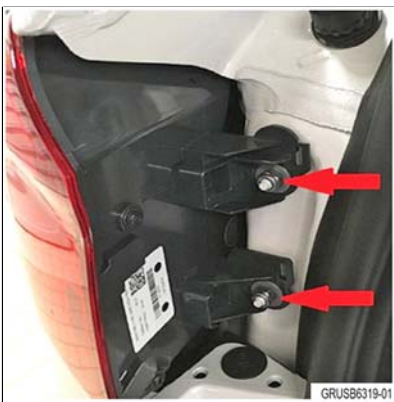
2. Visually inspect the mounting area of the tail light as shown to the left.

Different models may appear slightly different, but all models will be inspected in the same general location of the mounting tabs.

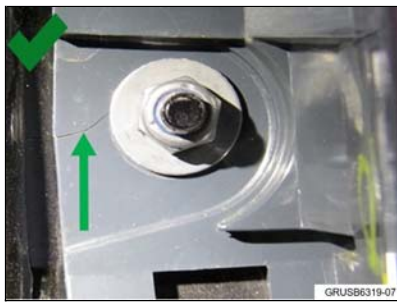
4. Reference the photos shown to the left, which demonstrate **acceptable** cracking and which require no further correction.

Single cracks are acceptable.

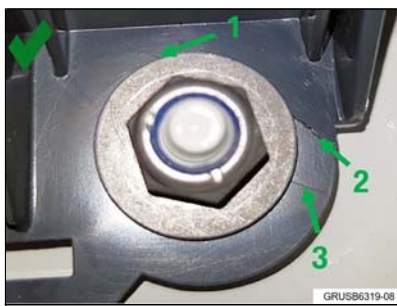
Description of picture:

- 1 – small crack, not circulating, no net of cracks, **OK**
- 2 – small crack, not circulating, no net of cracks, **OK**
- 3 – weld line, **OK**

Attention: the position of the weld line can vary from

model to model

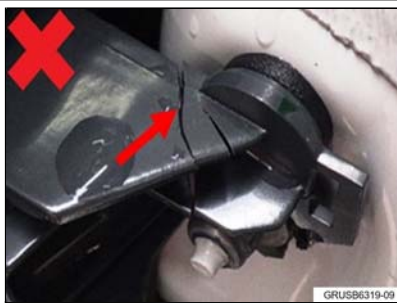
5. Reference the photos to the left showing examples of cracks that are **NOT** acceptable and which require tail light replacement.

Holder broken

<p>acceptable cracking as shown in the step 3 examples?</p> <p>YES: No further correction is required, the vehicle can be reassembled.</p> <p>NO: Continue to step 7.</p>
	<p>7. Remove one or both rear lights, depending on whether one or both lights are found to be damaged following the ISTA repair instructions for the applicable model.</p> <p>

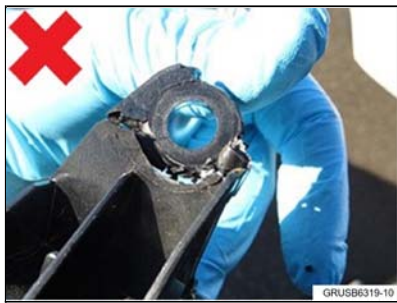
Eye broken off
