SI B17 01 18
Cooling Systems

HEATER HOSE IS CONTACTING THE STEERING SHAFT

MODEL

With the B58 engine

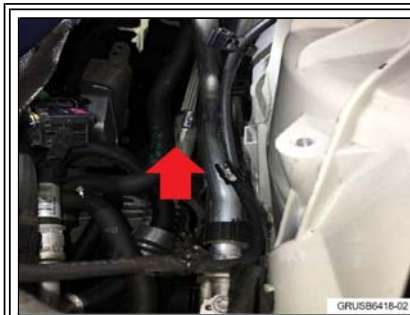
The steering shaft can contact the heater hose, possibly wearing through the hose.

- Install a hose retaining bracket to position the hose away from the steering shaft.
- Replace the heater hose if already damaged.
