SI B41 01 19  
Body

## SERVICE ACTION: CHECK AND APPLY CAVITY PROTECTION ON DRIVER'S FRONT DOOR

G07 (X7)			
Produced 12/2018-1/2019

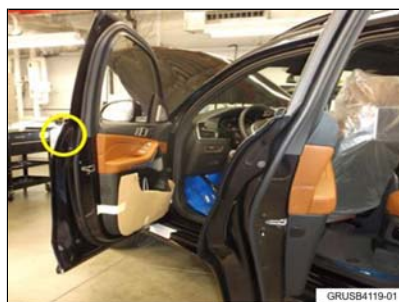
1. Open the front left door to gain access to the rear upper corner of the driver's door as shown below:

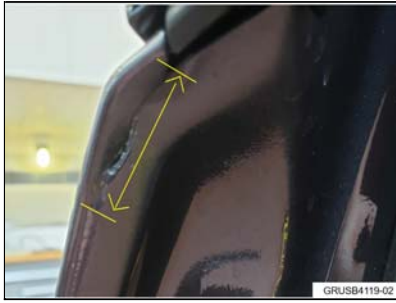
2. The arrows below indicate the area that will require application of cavity preservation.

Apply cavity preservation spray along the door panel seam. Ensure the complete length of the seam is covered, as indicated by the yellow arrow.
