GROANING NOISE FROM SUNROOF

G12 (7 Series)			
----------------	--	--	--

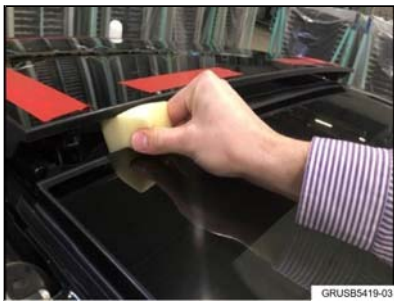
A groaning noise is present from the area between the front and rear sunroof glass panels, only with the sunroof completely closed. Venting the front sunroof glass causes the noise to stop.

The front sunroof glass is rubbing against the rubber seal of the rear sunroof glass.

1. Put the front sunroof glass into the venting position.
2. Inspect the front seal on the rear sunroof glass panel for any signs of damage or debris. If needed, the seal can be cleaned with water only. Do not use any type of cleaner or conditioner that is not outlined in this bulletin.
3. Ensure that the sunroof glass panel is correctly adjusted, following repair instructions **REP 54 13 001 "Adjusting front glass slide/tilt sunroof panel"**. Correctly adjust the sunroof panel if necessary.
4. With the sunroof in the vented position, apply Krytox Lubricant PN 83 19 9 408 523 to the rubber sunroof seal mounted on the rear sunroof glass panel as shown in the photo below using a suitable applicator, such as a sponge.
