Technical Service Bulletin

60 Rattle noise near central roof area

60 19 29 2054270/2 May 17, 2019. Supersedes Technical Service Bulletin Group 60 number 19-26 dated March 19, 2019 for reasons listed below.

Model(s)	Year	VIN Range	Vehicle-Specific Equipment
A6	2019	All	Not Applicable

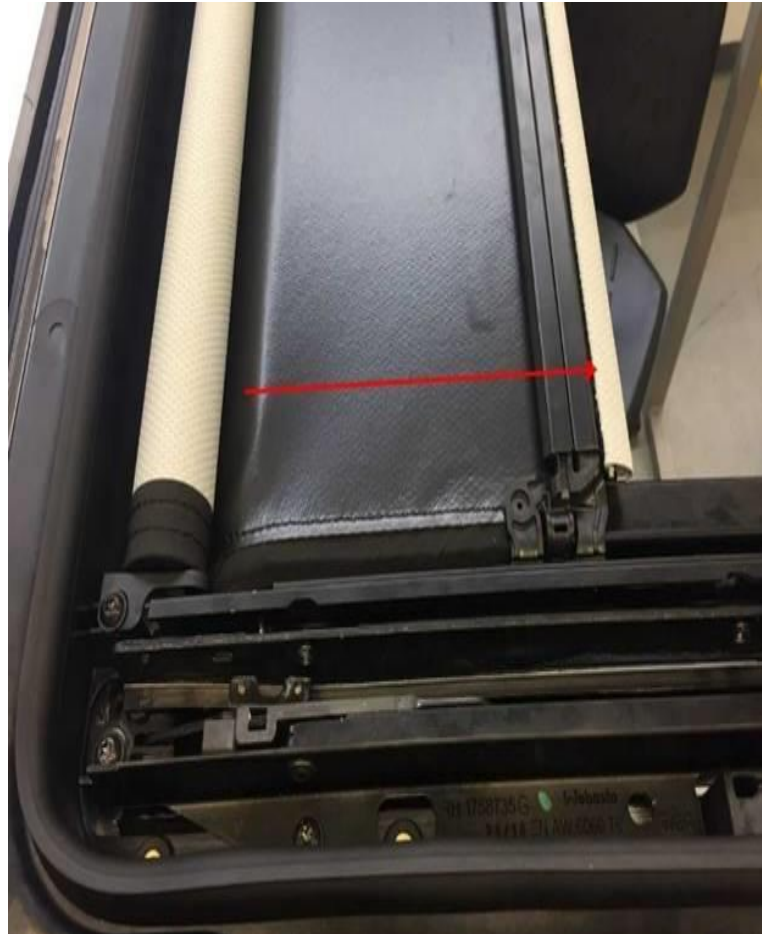
Figure 1. Closing the roller shade.

2. Close the roller shade by about 20cm (Figure 1).

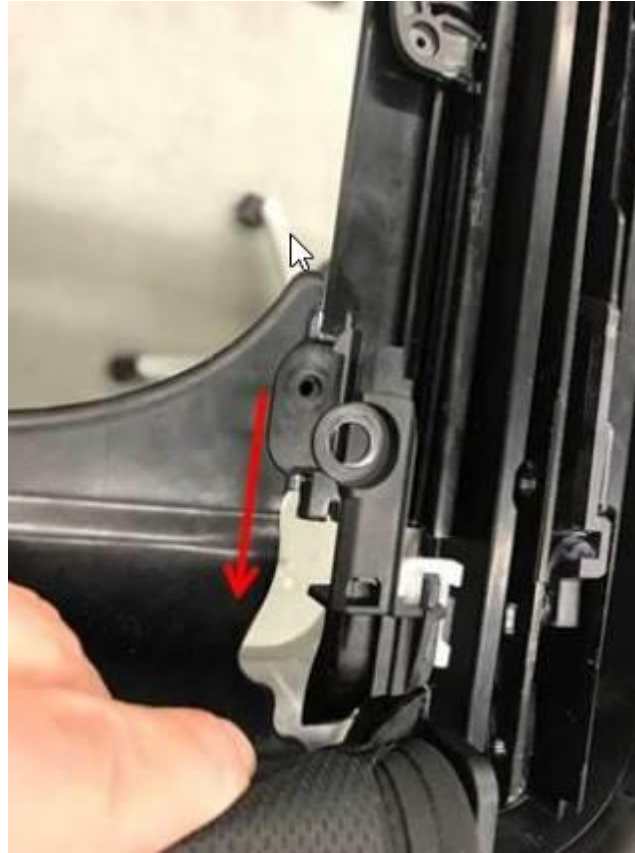
Figure 4. Slide roller shade backward.

4. Remove the roller shade by sliding it backward and clean the mounting points as shown in Figure 4 and 5. Use the cleaning solution D 009 401 04.

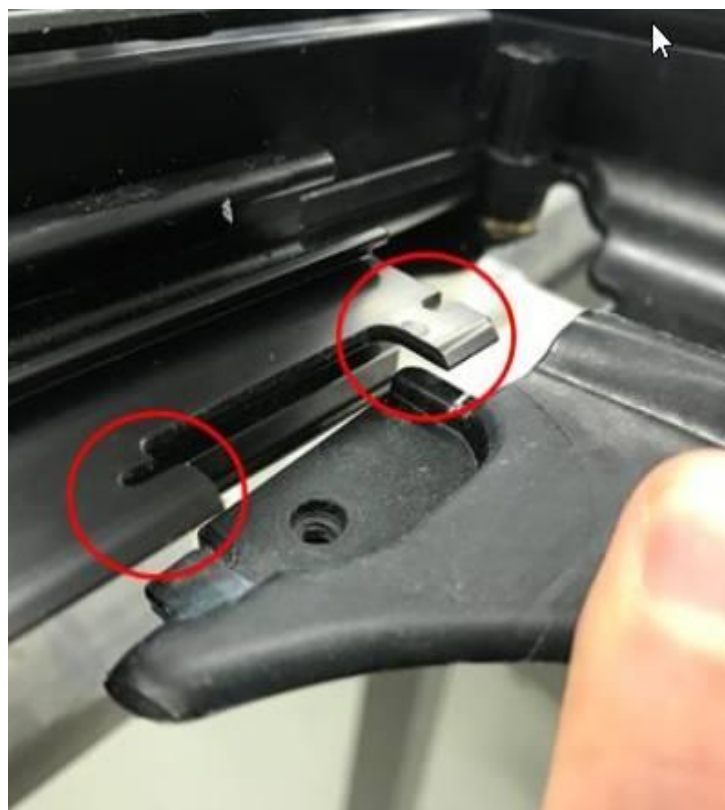
Figure 5. Removing the roller shade.

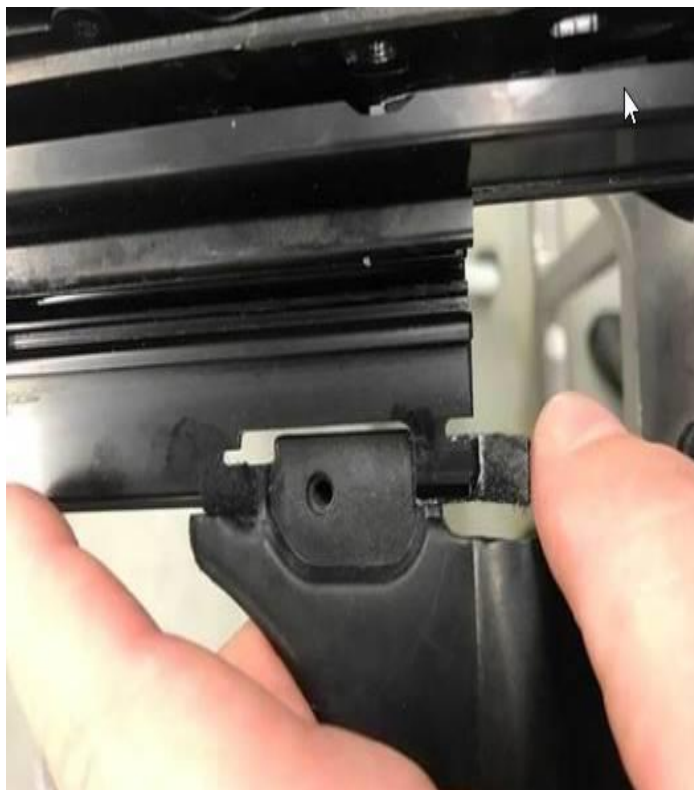
Figure 6. Applying felt tape.

5. Push down on the roller shade pan and starting from the bottom of the guide rail, apply the 1mm thick felt tape and fold them forward and over to the top of the guide rail (Figure 6 and 7).

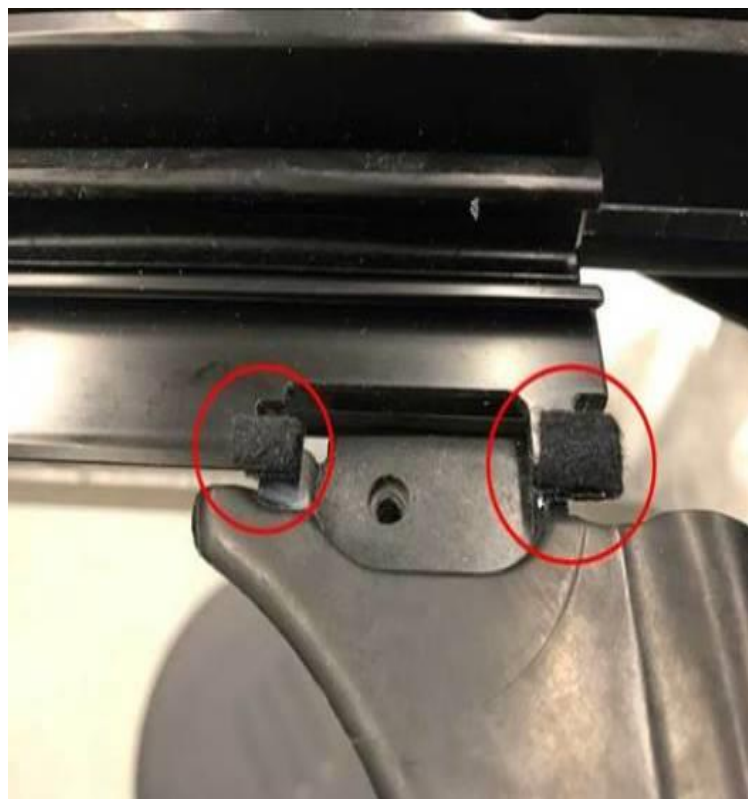
Figure 7. Apply felt tape on points shown.

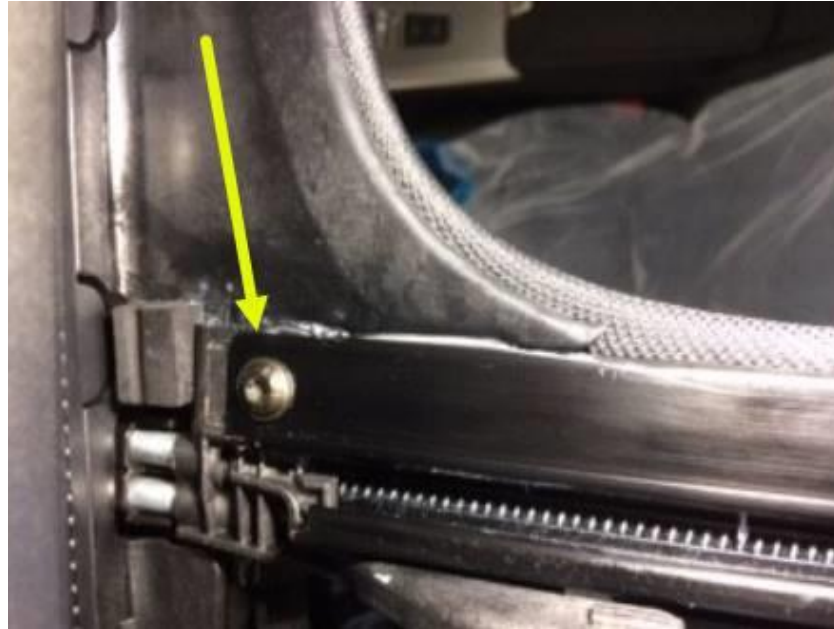
Figure 8. Loosen bolt and apply lube paste between these panels and under the bolt head. Reinstall the bolt and torque to 5Nm.

7. On the front of the sunroof guide rail, loosen that bolt by 3mm. Lift the guide rail, closing the gap between the rail and the plastic head section. Apply lube paste G 060 567 A2 between the two panels and also under the head of the bolt on the guide rail. Be careful not to get the lube paste on the threads of the bolt. Reinstall the bolt and tighten to 5Nm. (Figure 8).
