Technical Service Bulletin

91 SOS warning displayed in instrument cluster, DTCs B105313 and B153313 stored in the data bus diagnostic interface

91 19 58 2054812/2 May 13, 2019. Supersedes Technical Service Bulletin Group 91 number 19-54 dated April 25, 2019 for reasons listed below.

Model(s)	Year	VIN Range	Vehicle-Specific Equipment
A4, A5	2018 - 2019	All	With connected gateway and eCall

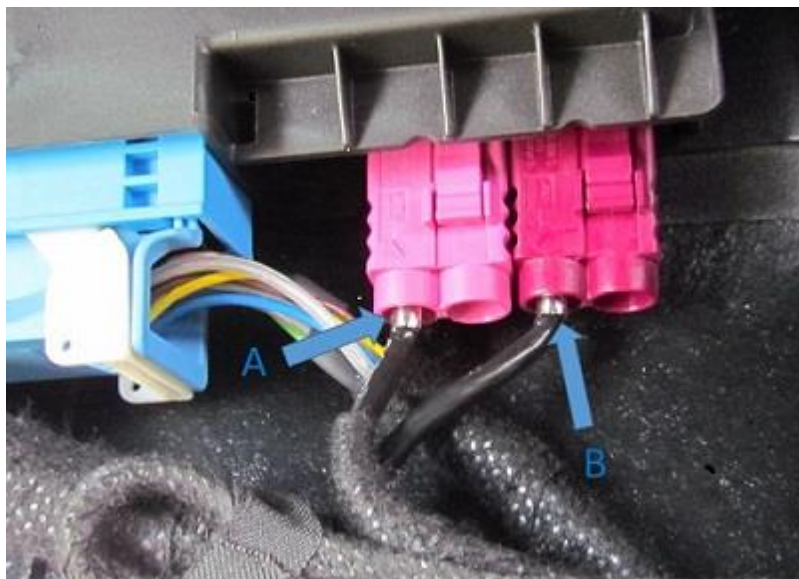
Poor contact at one of the coaxial wiring's FAKRA connections between data bus on board diagnostic interface, J533 (address word 0019) and one of the external antennas for emergency call services.

DTC Reference Table			
DTC	Measured Value Diagnostic Address 0019	Cable Position (Figure 2)	Vehicle PR-Codes
B105313 GSM antenna Open circuit	Antenna for telephone status 0x24E2	A	IW3 IW5 + 4GR IW5 + 4GY
B153313 GSM antenna 2 Open circuit	Status of antenna 2 for phone 0x1836	B	IW3 IW5

Figure 2. GSM antenna location reference at the data bus on board diagnostic interface, J533 (address word 0019).

1. If DTC B105313 or B153313 are found in the data bus on board diagnostic interface, J533 (address word 0019), then replace the coaxial wire from the applicable emergency call module antenna to the data bus on board diagnostic interface, J533 (address word 0019).
2. Utilize the VAS 6720 to build a single coaxial wire from the emergency call module to the data bus on board diagnostic interface, J533 (address word 0019).
 - **Do not** split the new wire at the TIM connection between T2dkx and T2dk.
 - Route the new wire along with the existing harness.
 - Ensure that there are no sharp bends.
 - Ensure there is no tension on the new contacts.
 - The cable should be 8.7ft (2.65m) in length.
