Bulletin No.: PIT5659B
Published date: 04/1/2019

PIT5659B Driver Side Power Seat Inoperative or Moves Unwanted

Brand:	Model:	Model Years:	VIN:		Engine:	Transmissions:
			from	to		
Chevrolet	Blazer	2019	All	All	All	All

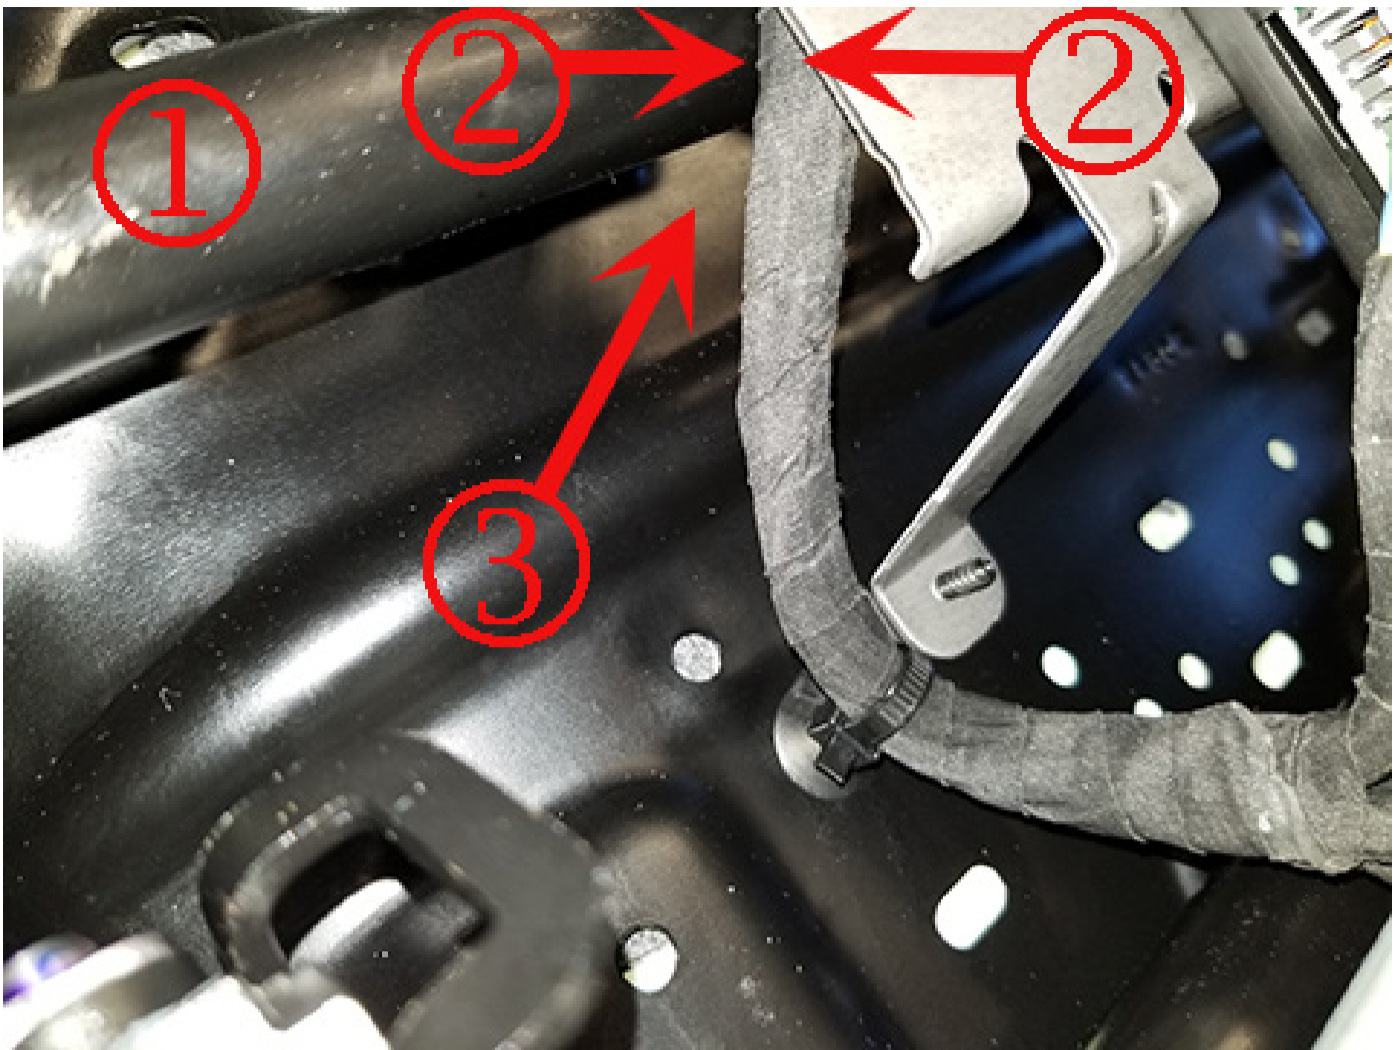
1. Seat Frame Tube

2. Harness routed below seat frame tube allowing contact with MSM bracket

3. Proper routing of harness above seat frame tube.

Inspect the seat harness for being routed below the seat frame tube instead of above it.

The harness can be seen by looking in from the front of the seat with the seat in a raised position.

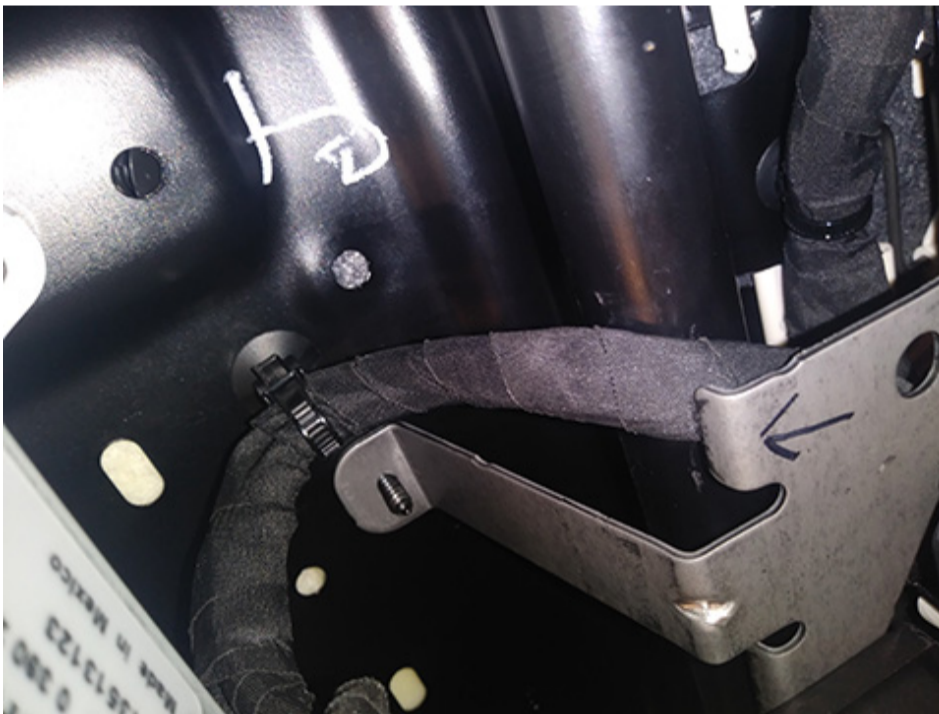
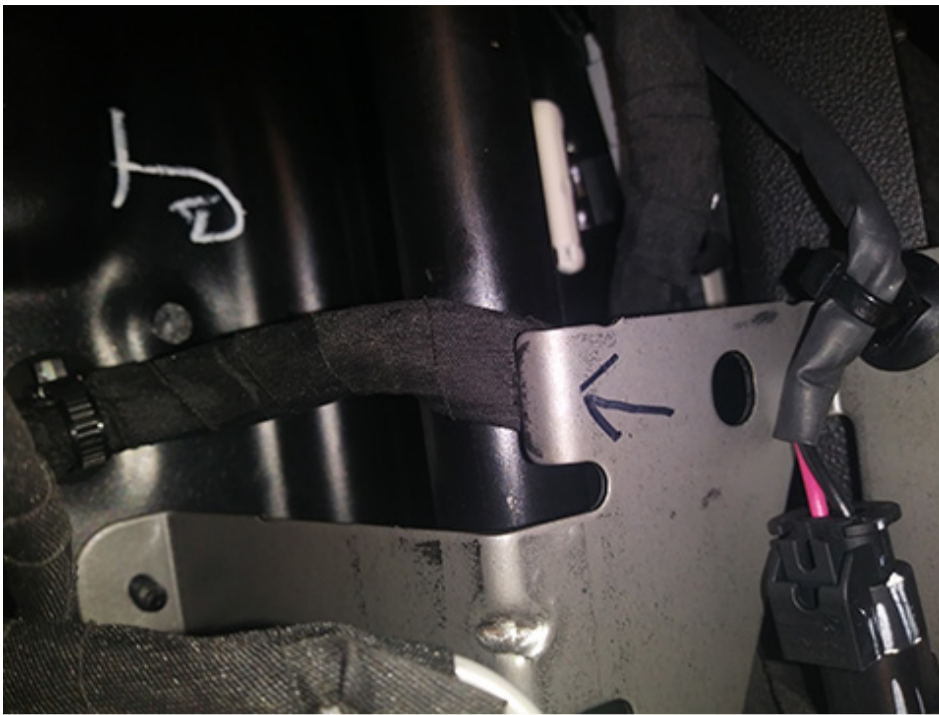
If the harness is found to be routed below the seat frame tube inspect it for being pinched between the memory seat module bracket and the seat frame tube as shown below.

Unbolt the seat and flip it up to gain access.

Repair or replace the seat harness as needed.

Re-route the harness above the seat frame tube so that it will not become pinched or damaged.

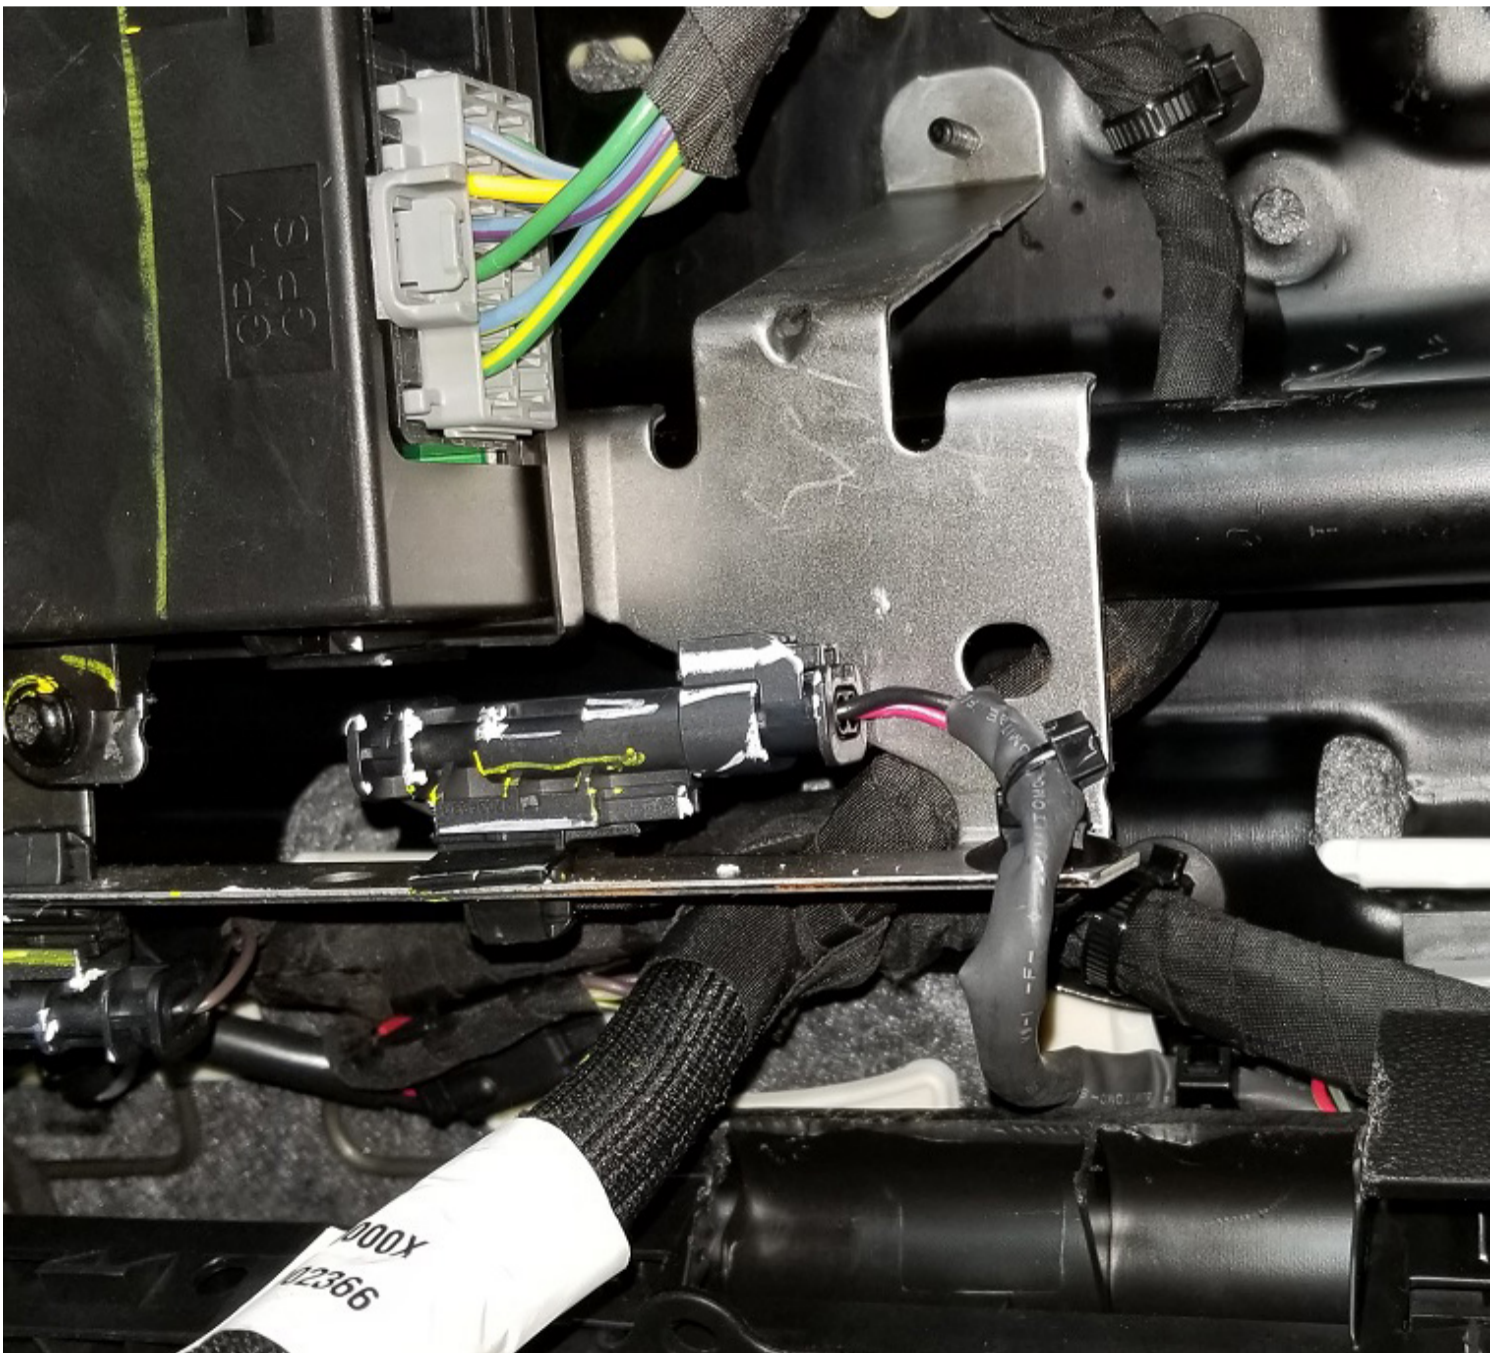
See photo below showing harness properly routed above the seat frame tube.
