Service Bulletin

Bulletin No.: 2018-0030

World Trans 2xx – 2017MY thru 2019MY

To inspect and repair by adding a weld in the bottom step entry door assembly, as necessary.

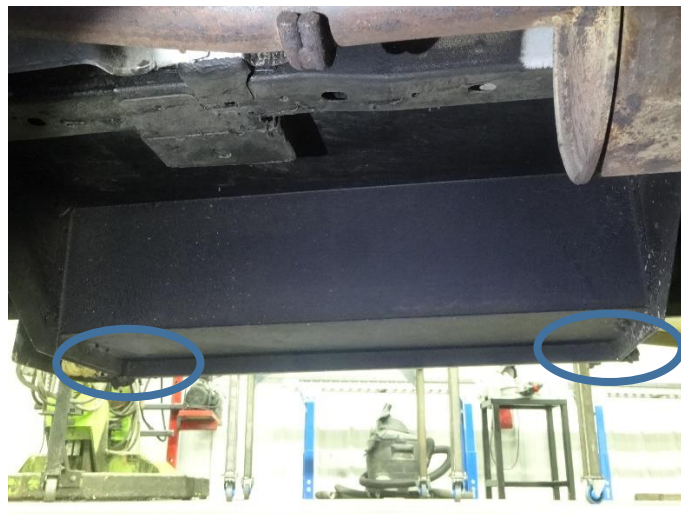
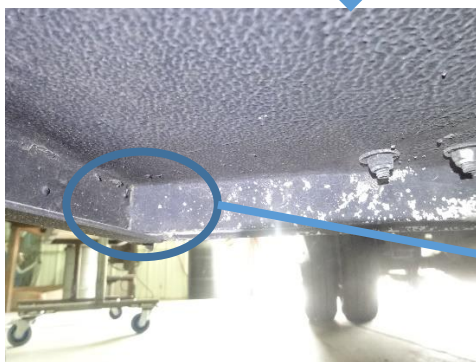
1. Inspect entry door on the underside at the front of lower step for weld as identified in Illustration #1 and Illustration #2 on each side of the entry step.
 - If a weld is present, no further action is required.
 - If a weld is not present, then complete the repair as identified beginning with Step #2.
2. Remove undercoat on entry step in location identified in Illustration #1 on both sides of entry on the back side of flange.

3. Grind area to remove paint/E-coat and prep area for welding.
4. Weld on front side of break/flange as shown in Detail D, Illustration #2. Ensure fillet weld captures both vertical edges and fuses into the corner of the multilayered steel assembly.
