Service Bulletin

Bulletin No.: 19-NA-070

Subject: Squeaking/Creaking Noise from Rear Suspension When Driving on Rough Roads or Over Bumps

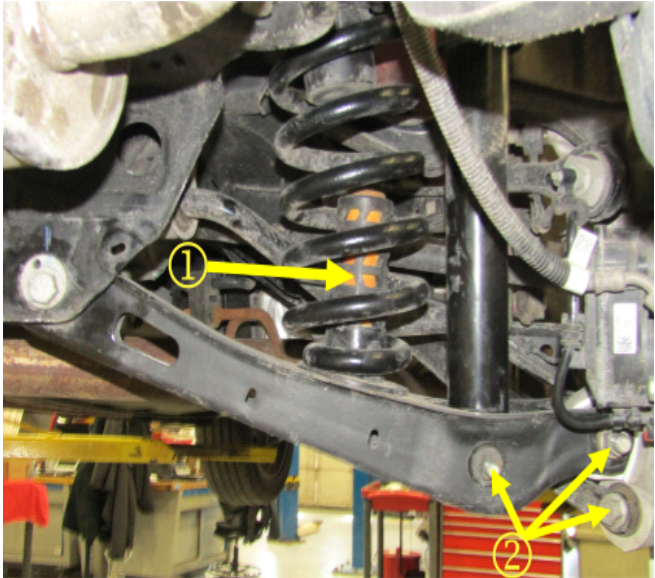
Involved Region or Country	North America, N.A. Export Regions
Additional Options (RPOs)	Equipped with WHEEL-21 X 8.5, J, ALUMINUM, DESIGN 1 (RQM) or WHEEL-21 X 8.5, J, ALUMINUM, DESIGN 2 (ROY)
Condition	Customer may comment on hearing a squeak or creak type noise coming from the rear suspension, when driving on rough roads or over bumps. The condition can occur on the driver, passenger, or in some cases, both sides.
Cause	The cause of the condition may be a poor interface between the lower control arm and the rear suspension jounce bumper.
Correction

<p style="text-align: right;">5310094</p> <p>Note: When removing the spring(s) to access the rear suspension jounce bumpers (1), it will also be necessary to replace 3 single - use fasteners (2), per side.</p> <p>Verify which side, or both, are affected and replace the rear suspension jounce bumpers (1), on those sides. Refer to <i>Rear Coil Spring Replacement</i>, in SI.</p>
