# Service Bulletin

Bulletin No.: 19-NA-073

**Subject:** Difficult to Shift into Gear, Intermittent Gear Pop Out and/or Mushy Shifts (No Grind)

Brand:	Model:	Model Year:		VIN:		Engine:	Transmission:
		from	to	from	to		
Chevrolet	Corvette	2014	2019			All	Equipped with 7 Speed Manual Transmission (RPO MEL, MEP, MEK)

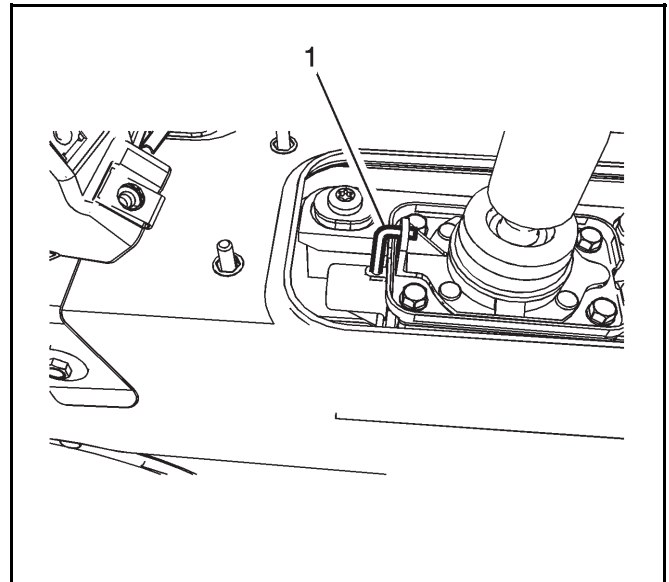
3346997

**Note:** There may be some variation on how and where the rubber band is placed. The above picture shows one possible location.

5. Before performing the shifter adjustment, make sure that the rubber band used to retain the shifter link during assembly is removed.
