Service Bulletin

Bulletin No.: 19-NA-082

Subject: Water Leak From Rear Window Area

Brand:	Model:	Model Year:		Date Breakpoint:		Engine:	Transmission:
		from	to	from	to		
Chevrolet	Colorado VIN S, VIN T	2019	2019	SOP	Prior to December 14, 2018	All	All
GMC	Canyon

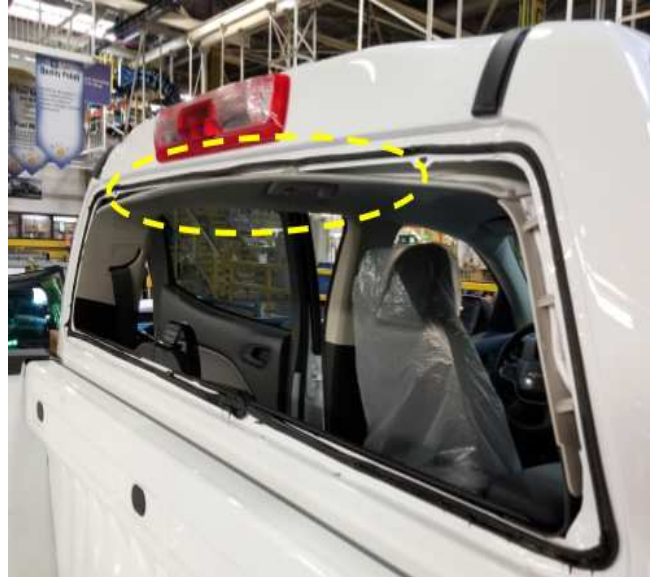
5319670

Involved Region or Country	North America, N.A. Export Regions
Additional Options (RPOs)	
Condition	Customer may comment on seeing a water leak around the rear window area.

Important: Though sometimes mistakenly attributed to the Center High Mount Stop Lamp (CHMSL), **this leak is not caused by the CHMSL.**

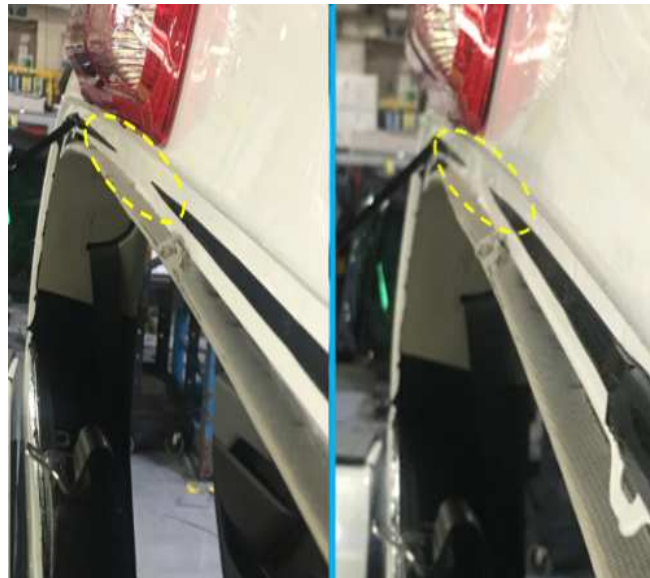
5319673

The cause of the condition may be that the headliner was positioned too far rearward upon installation. The rear flange portion of the headliner may have been extended too far into the rear window opening and may have interfered with the adhesion of the rear window, at the top.

Note: The graphic below shows several examples of the condition, where a void in the urethane sealing of the window is evident.

First verify the condition; then remove the rear window, reposition the rear of the headliner as necessary, and reseal the window, following the steps in the Service Procedure below.
