# Service Bulletin

Bulletin No.: 19-NA-083

**Subject:** Creaking Type Noise Around Front Strut Mounts When Steering Wheel is Turned Right or Left in Colder Weather

Brand:	Model:	Model Year:		Breakpoint:		Engine:	Transmission:
		from	to	from	to		
Chevrolet	Impala	2014	2019

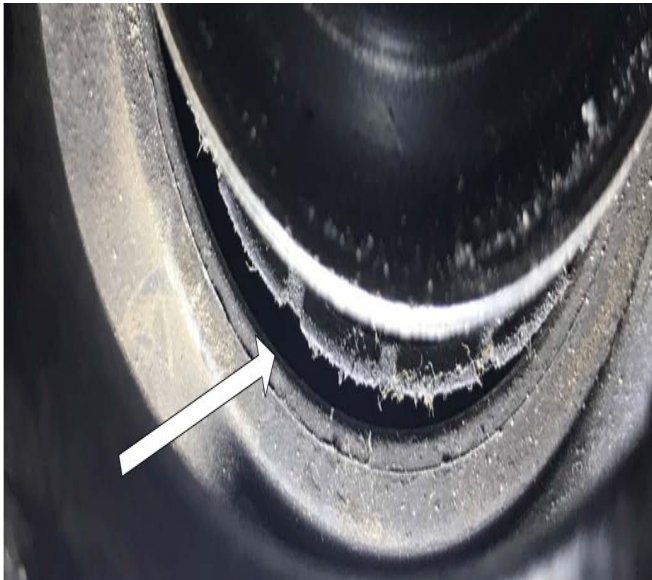
<b>Involved Region or Country</b>	North America and N.A. Export Regions
<b>Condition</b>	Some customers may comment on a creaking type noise heard from the front strut mounts when the steering wheel is turned right or left in colder weather.
<b>Cause</b>

<p style="text-align: right;">5315933</p> <p>This condition may be caused by a gap between the bearing lower housing and top mount body.</p>
<b>Correction</b>	Replace both front strut mounts. Refer to <i>Strut, Strut Component, or Spring Replacement</i> in SI.

Causal Part	Description	Part Number	Qty
X	MOUNT, FRT SUSP STRUT	84583352	2
