# Service Bulletin

Bulletin No.: 19-NA-084

**Subject:** Ground Effects Fit Issue at Rear Fascia Accessory Valance (Rear Diffuser)

Brand:	Model:	Model Year:		VIN:		Engine:	Transmission:
		from	to	from	to		
Chevrolet	Camaro	2019	2019			All	All

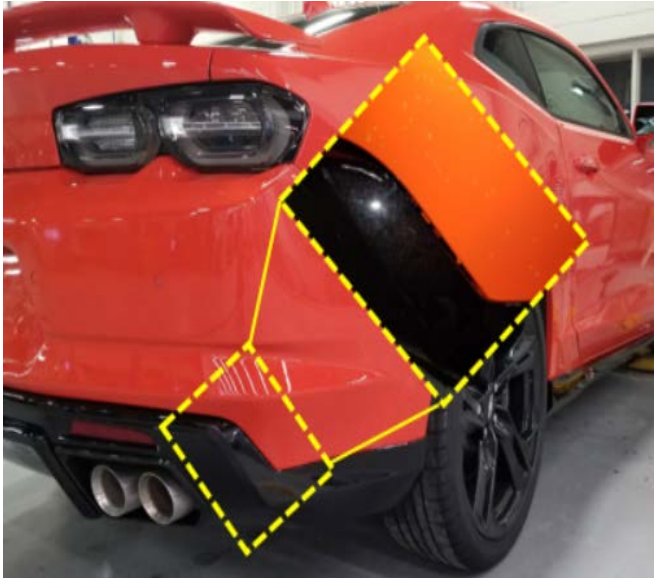
<p style="text-align: right; font-size: small;">5317583</p> <p>For vehicles with ground effects installed, customers may comment on seeing a fit issue on the rear fascia accessory valance (rear diffuser). They most specifically point out gaps at the areas on each side of the vehicle, where the diffuser and fascia interface, as shown above.</p>
<b>Cause</b>	The cause of the condition may be slight build variation between the rear diffuser and rear fascia.
<b>Correction</b>	This can be corrected by adjusting the fit of the rear diffuser to bumper fascia. Follow the Service Procedure below.
