Bulletin No.: 19-NA-088

Subject: Performance Cold Air Intake Interference at Air Extractor and Hood Blanket

Brand:	Model:	Model Year:		VIN:		Engine:	Transmission:
		from	to	from	to		
Chevrolet	Corvette	2014	2019

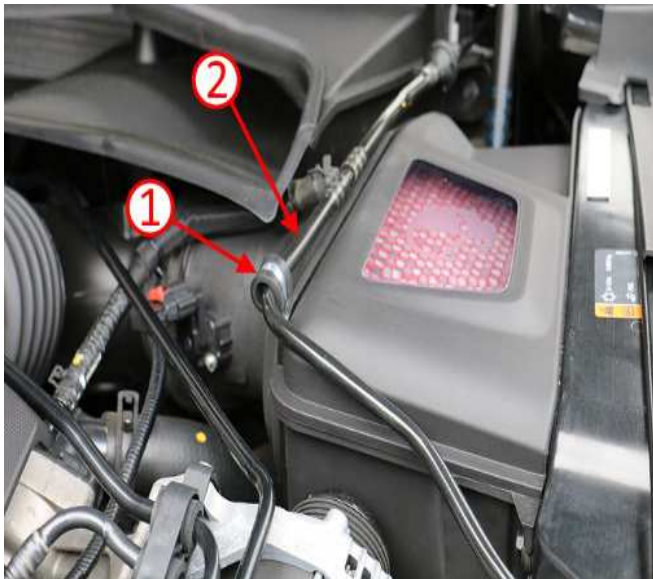
5318292

Involved Region or Country	North America
Additional Options (RPOs)	Performance Cold Air Intake (RVK)
Condition	Some customers may comment on interference at the hood air extractor and/or hood blanket after the installation of the Performance Cold Air Intake.
Cause	This condition may be caused by slight build variation of the surge tank coolant hose and modified routing due to the larger performance air intake.
Correction	This can be corrected by modifying the retaining clip and clocking of the coolant hose clamp.

1. Remove and discard the retaining clip (1) that secures the coolant surge hose (2) to the air box.
2. Ensure the coolant hose is retained at original fender clip location (1).
⇒ if this clip is not present, it must be ordered and installed.
3. Rotate the coolant hose clamp (2) approximately 90° forward and check clearance to the hood air extractor and MAF tube. Adjust as necessary.
