## **Service Bulletin**

Bulletin No.: 19-NA-090

Subject: Information on Possible Oil Consumption and/or Leaks, Malfunction Indicator Lamp (MIL) Illuminated - DTC P0300 Set

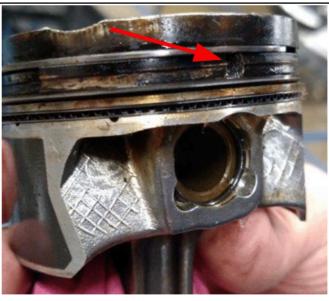
4576900

This condition may be caused by a broken piston ring land.
