N302NAS1

TECHNICAL BULLETIN

11 APR 2019

Service Action: Rear Right Wheel Arch Inner Panel Crack

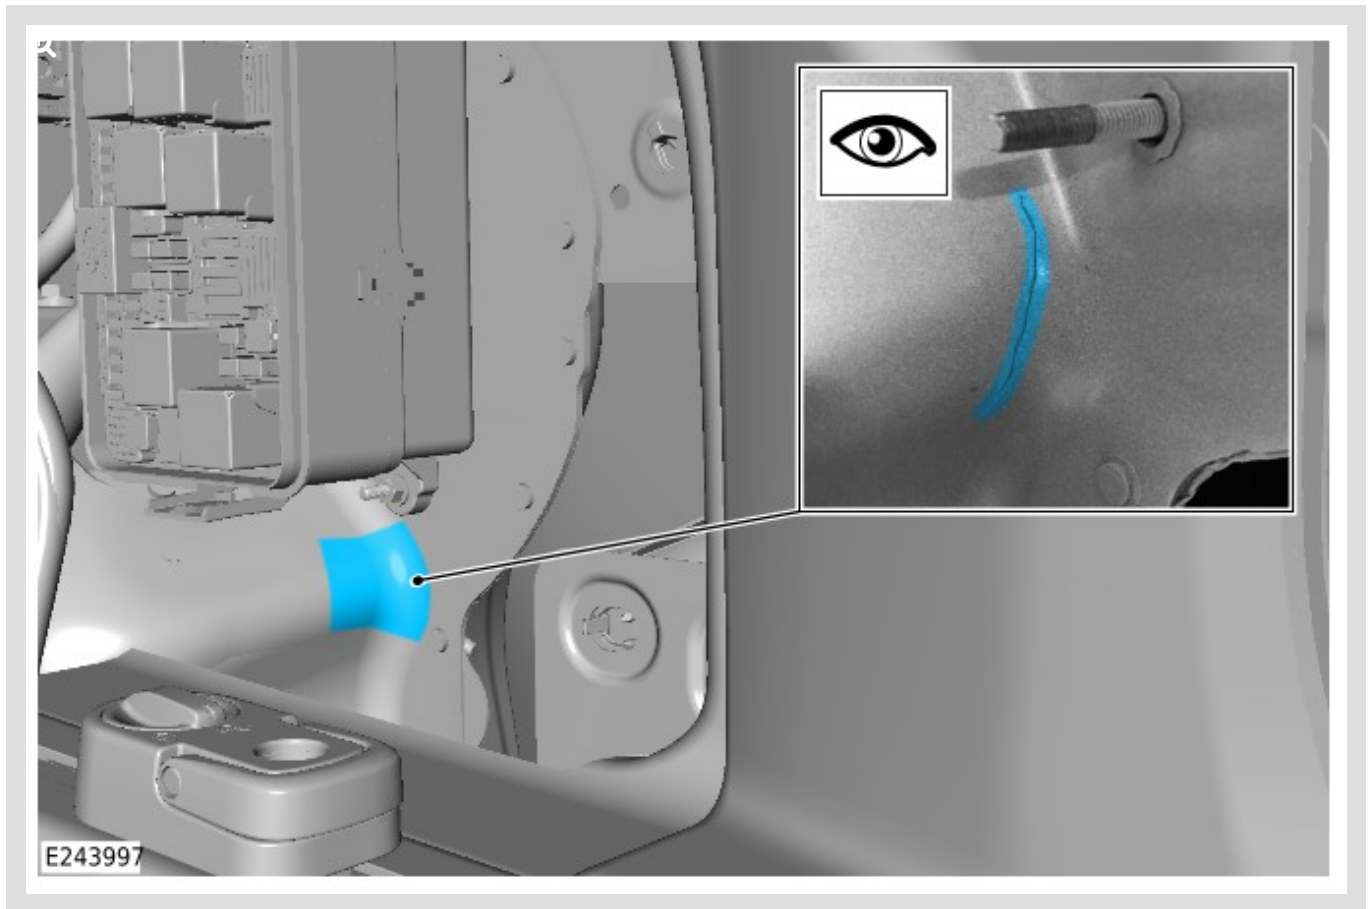
Inspect the area shown.

- If the body panel is cracked, go to the Workshop Procedure below.
- If the body panel is not cracked, go to Step 6.

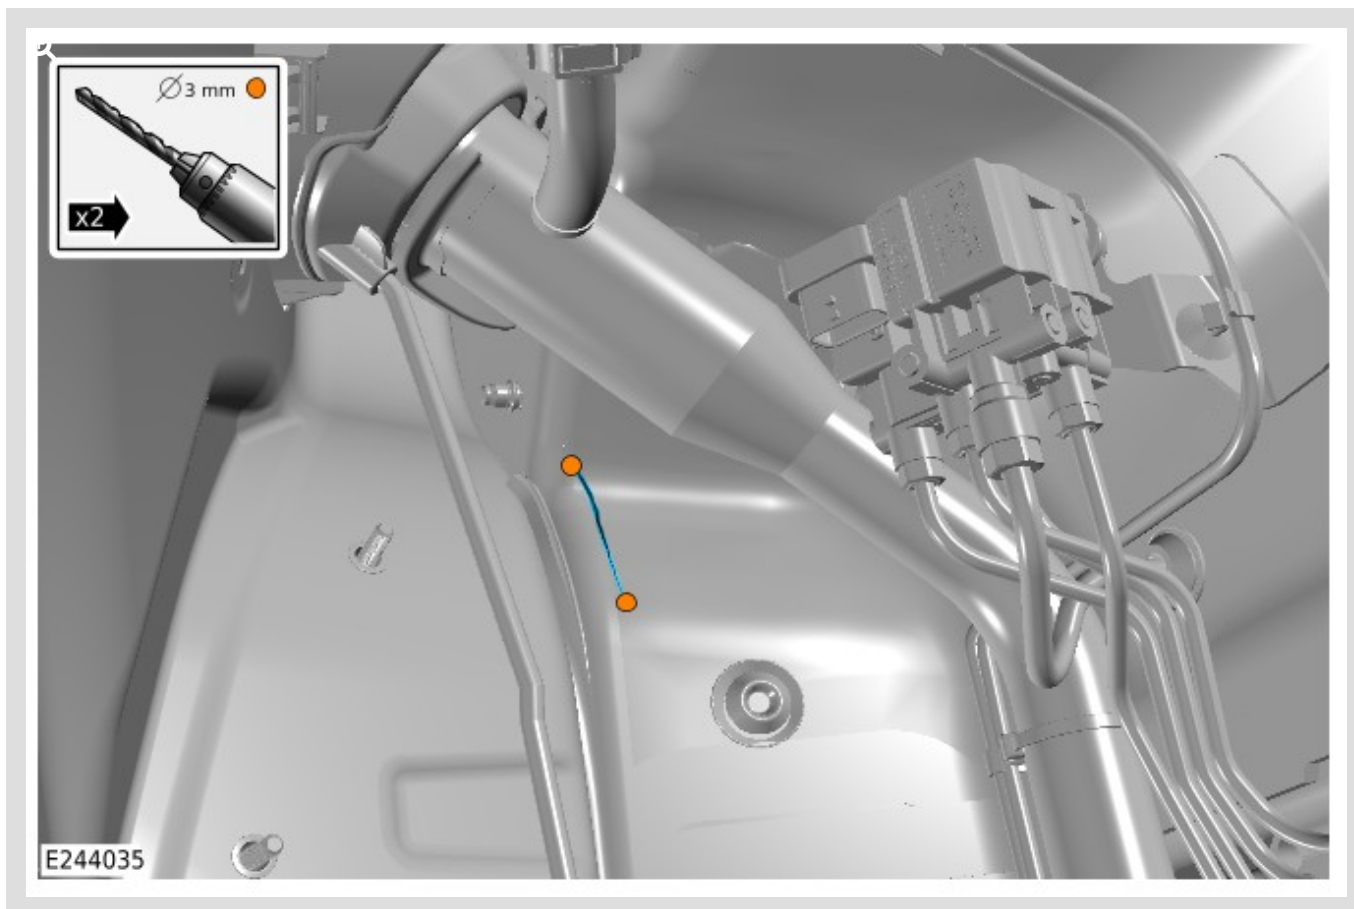
The ends of the body panel crack may be in different positions from either side of the body panel.

If required: drill a 3 mm hole at each end of the body panel crack.
