N089NAS2

# TECHNICAL BULLETIN

310-01A

Service Action: Misfueling Protection Device Potentially Damaged

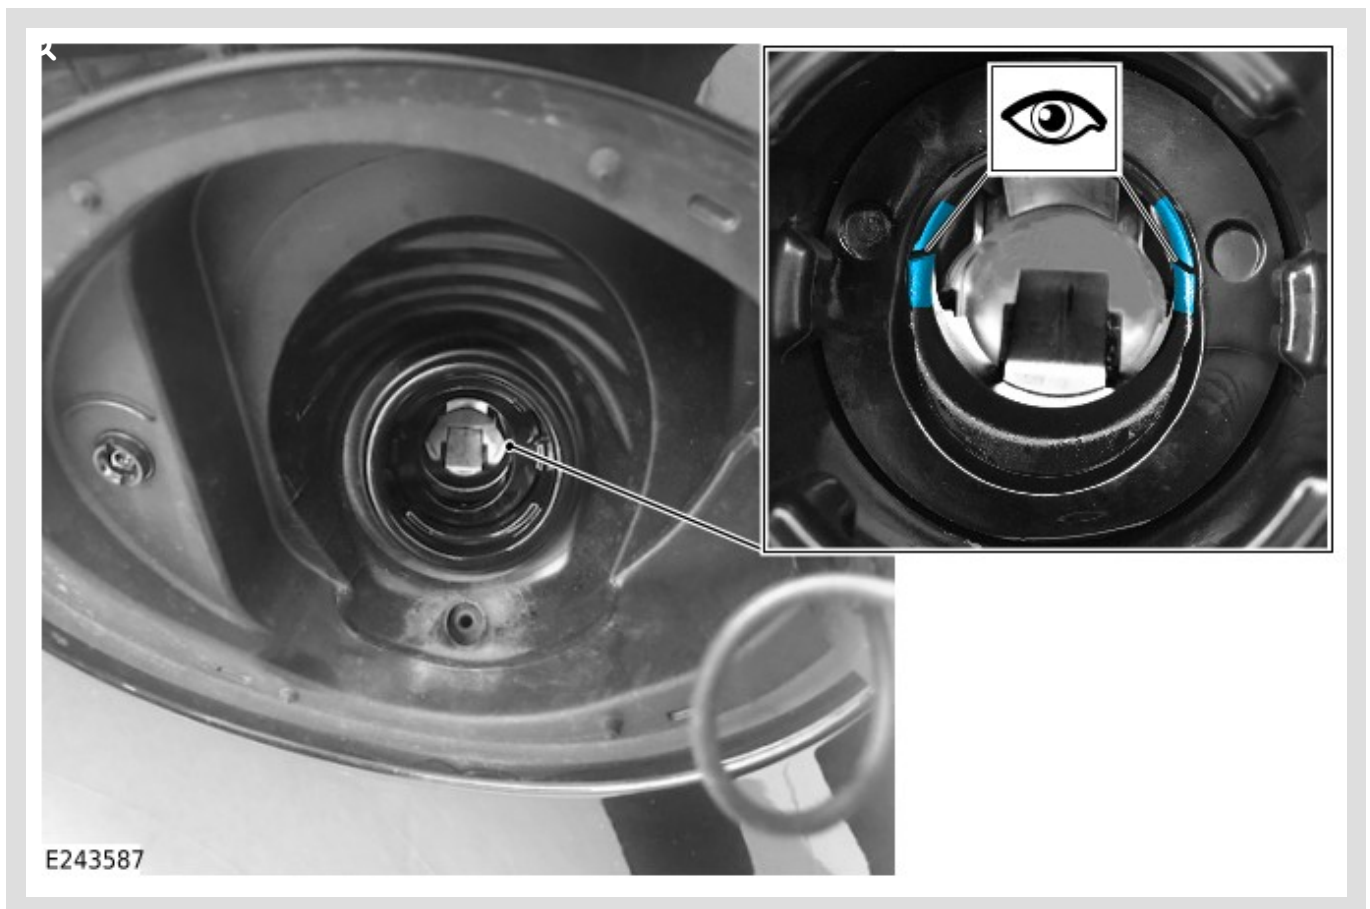
3

Inspect the fuel filler neck for signs of cracking as shown.

- If there are not signs of cracking, go to Step 3.
- If there are signs of cracking, go to Step 4.

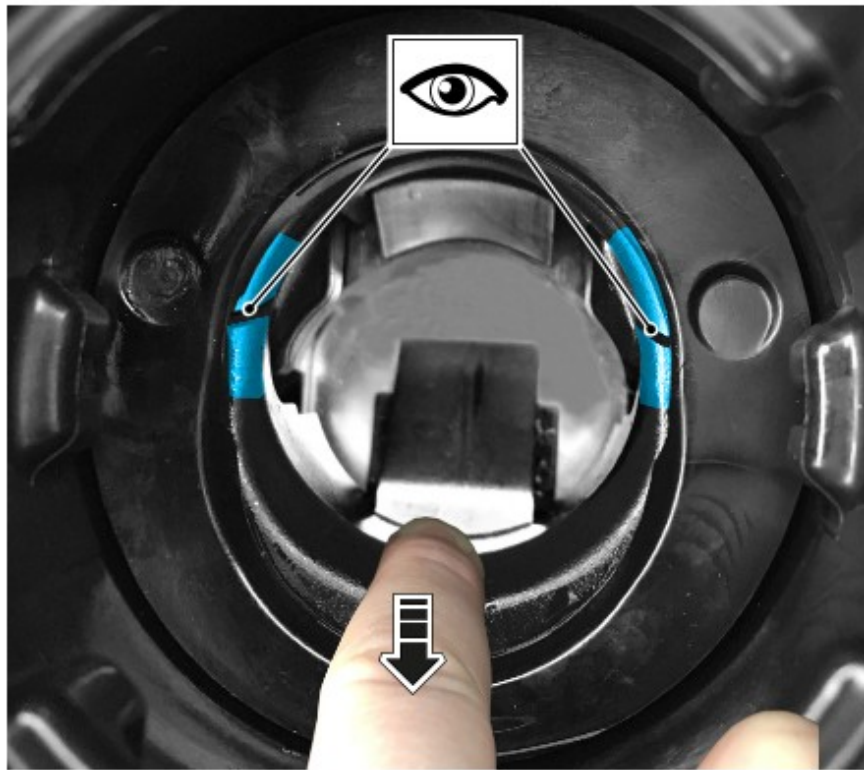
E245012

Use your finger to apply gentle downward pressure to the fuel filler neck to widen any potential small cracks.

- If there are not signs of cracking, install the fuel filler cap and close the fuel flap. No further action required.
- If there are signs of cracking, go to Step 5.

Renew the fuel filler neck (see TOPIx Workshop Manual section 310-01: Removal and Installation - Fuel Tank Filler Pipe).
