LTB01292NAS1

# TECHNICAL BULLETIN

Front Fender Lower Cladding Misaligned

MODEL:	MODEL YEAR:	VIN:	ASSEMBLY PLANT:
New Range Rover Evoque (LZ)	2020	000269-006456	Halewood

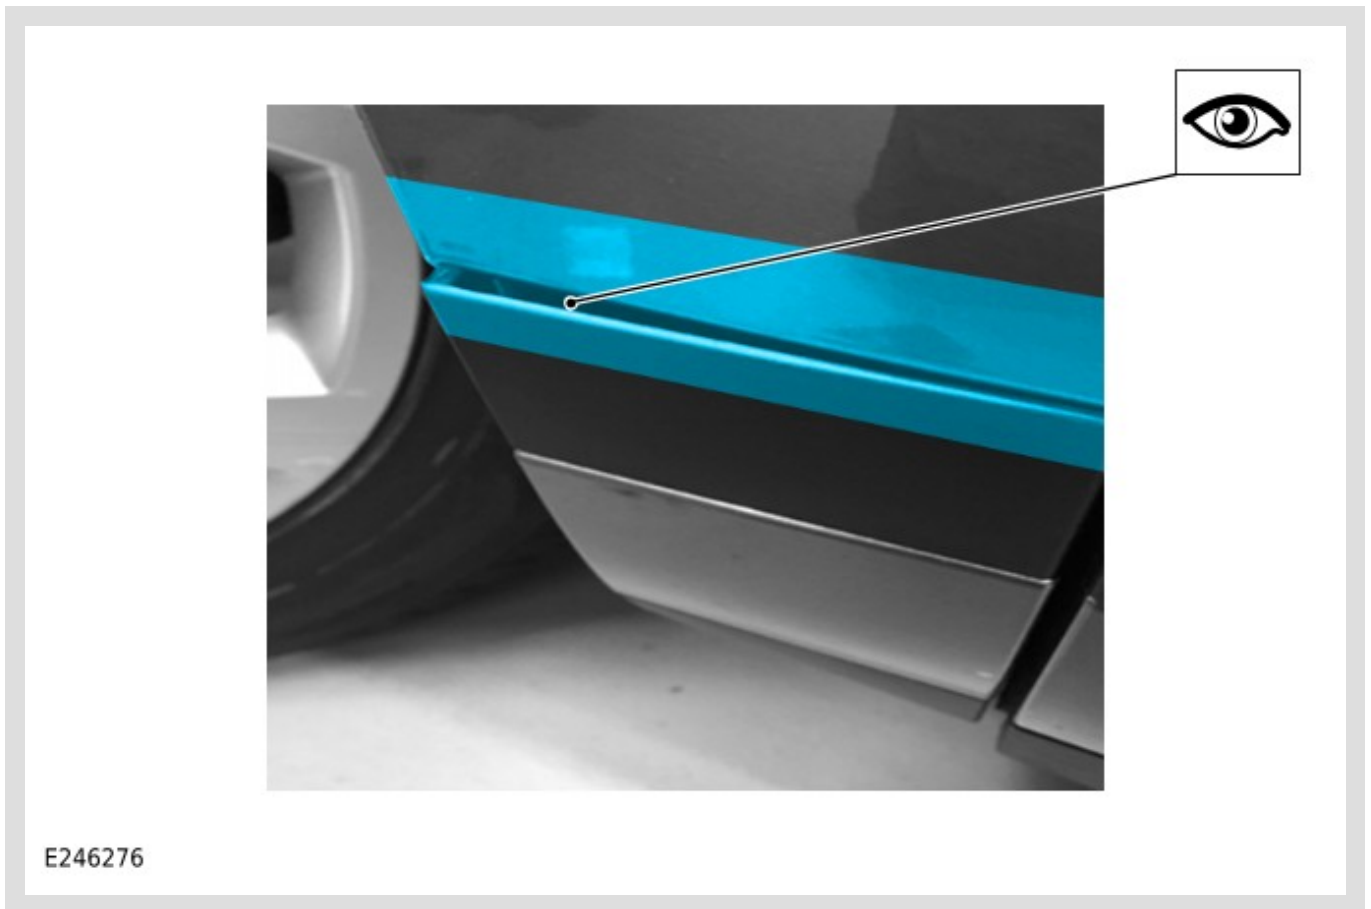
The front fender lower cladding may not be flush with the front door lower cladding. There may also be a tapered gap between the top of the front fender, lower cladding, and the bottom of the front fender.

This may be caused by insufficient clip retention.

Inspect the alignment between the front fender lower cladding and the bottom of the fender.

- If a tapered gap is visible on either side of the vehicle, continue to step 1 of the Tapered Gap Repair Procedure.
- If a tapered gap is not visible on both sides of the vehicle, continue to step 2 of the Inspection Procedures.

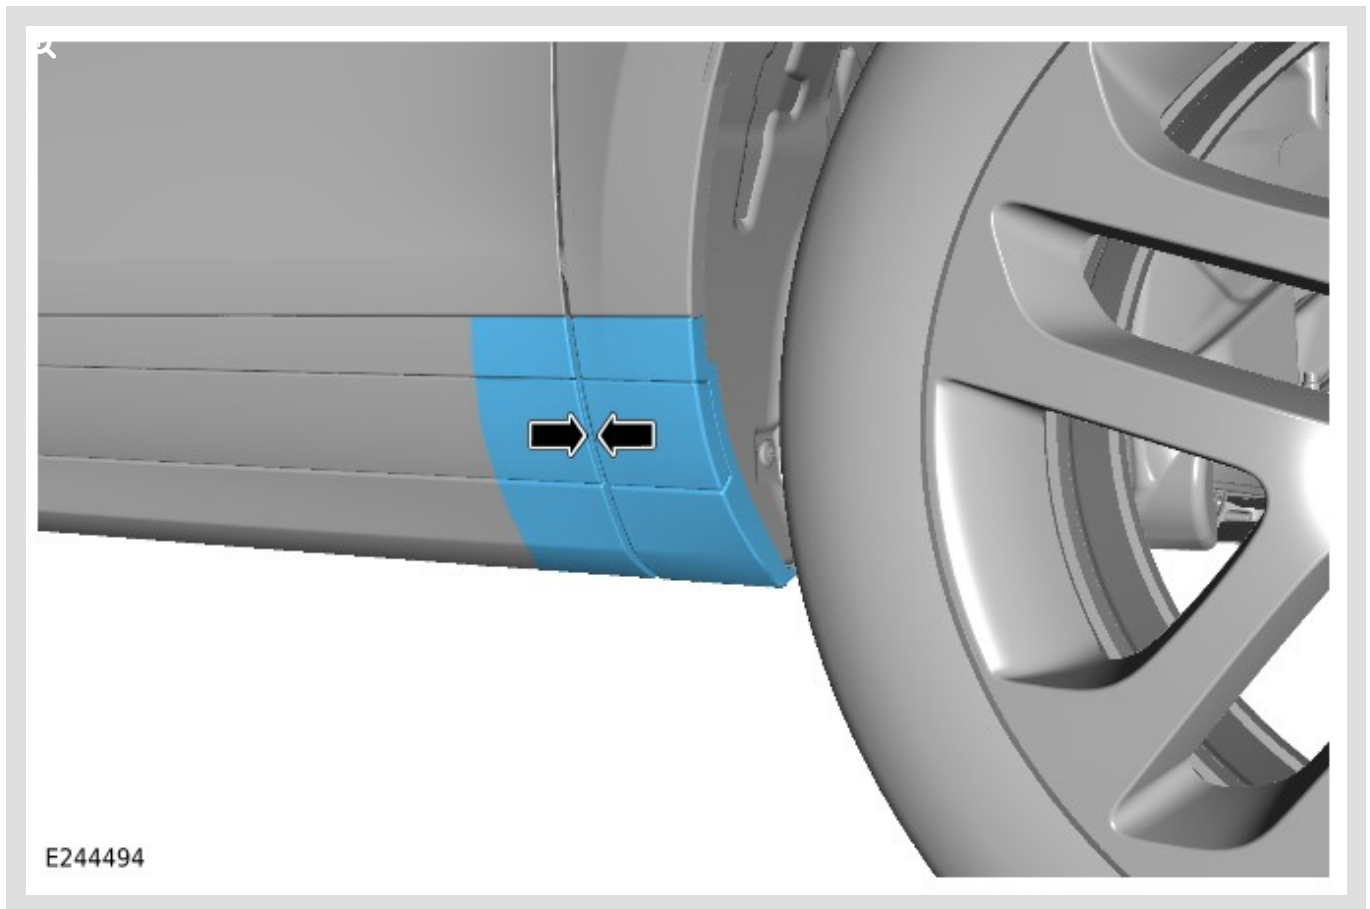
Inspect the flush condition across the entire length of the front fender lower cladding and the front door lower cladding.

Inspect the flush condition (**0 mm +/- 1.6 mm**) between the front fender lower cladding and the front door lower cladding on both sides of the vehicle.

- If the measurements are correct on both sides of the vehicle, do not continue with this bulletin.
- If the measurements are not correct on either side of the vehicle, continue to step 1 of the Flush Condition Repair Procedure.

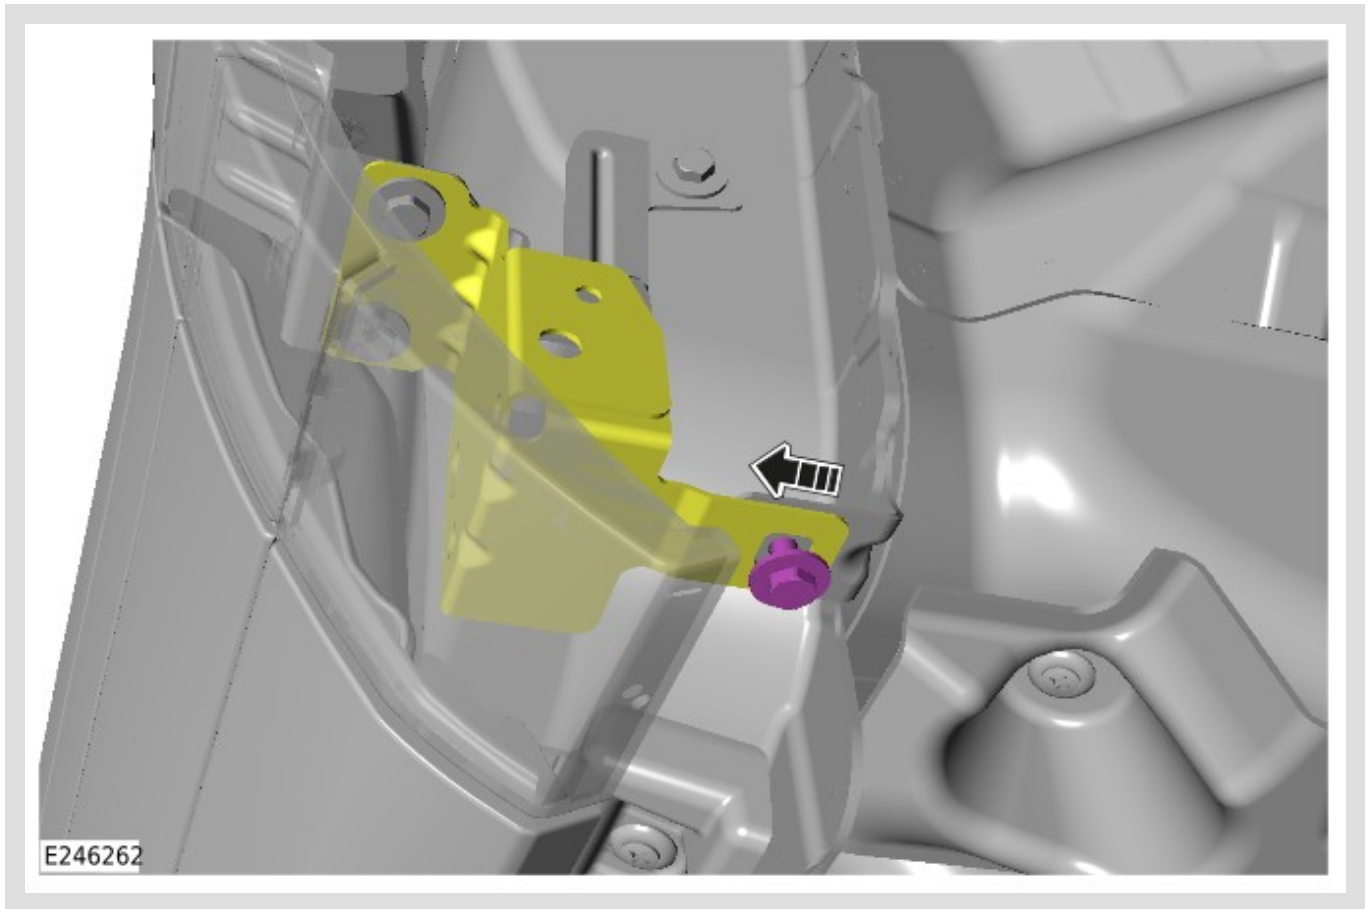
The lower fender bracket may remain in place due to paint adhesion, if so, break the paint adhesion using a suitable tool to allow the lower fender bracket to move.

Adjust the position of the lower fender bracket to achieve the correct measurements as shown in step 2 of the Inspection Procedures.

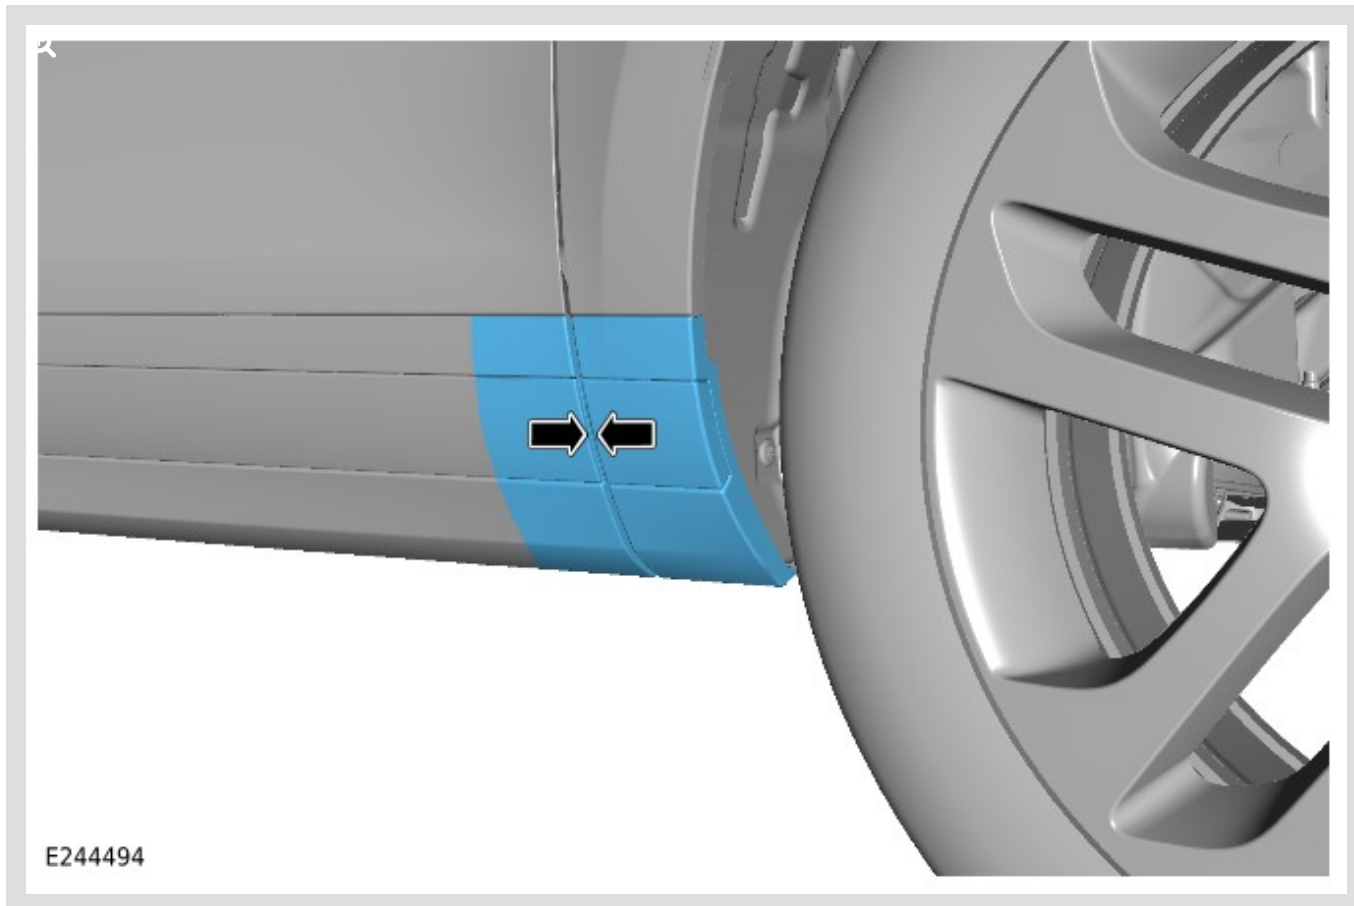
Inspect the flush condition (**0.5 mm +/- 1.6 mm**) between the front fender lower cladding and the front door lower cladding.

- If the measurements are not correct, repeat steps 1 - 5.
- If the measurements are correct, continue to step 7.
