## LATEST VEHICLE CONCERN FIXES

| Wind Noise From Sunroof | Discovery 18MY |

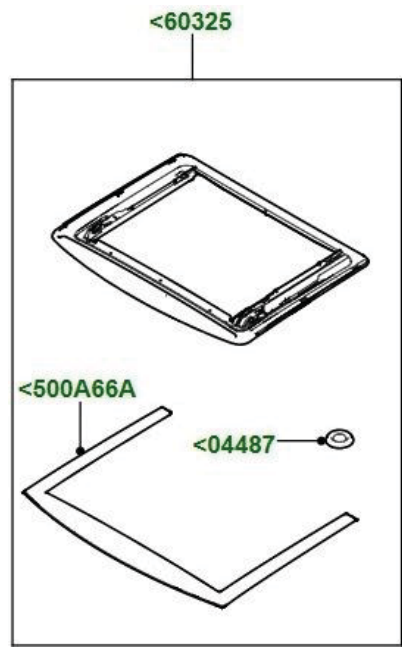
| Wind Noise From Sunroof | Discovery 18MY |
|---|---|
| <p><b>Customer Voice:</b></p> <ul style="list-style-type: none"><li>– A customer may complain of a wind type noise emanating from the sunroof area while driving.</li></ul> <p><b>Technical Description:</b></p> <ul style="list-style-type: none"><li>– This may be caused by a sunroof trim seal that has become displaced or a roof opening panel that is not adjusted properly.</li></ul> <p><b>Status:</b></p> <ul style="list-style-type: none"><li>– Should a customer express a concern, please inspect the sunroof trim panel seal fitment to ensure it has not dropped down, also inspect the roof opening panel for proper alignment with the roof trim panel.</li><li>– Should the sunroof trim seal appear to be dropped down, please submit an EPQR for the concern with pictures showing the area of the seal that has dropped down, then push the seal back into position using a suitable tool.</li></ul> | <p>The diagram illustrates the sunroof assembly. At the top, a rectangular sunroof panel is labeled with the part number &lt;60325. Below it, a cross-section view shows the sunroof trim seal, labeled &lt;500A66A, which is designed to fit into a channel on the roof trim panel. A screw, labeled &lt;04487, is shown being used to secure the trim panel, ensuring the seal is properly seated.</p> |
