# Technical Service Bulletin

## 91 Voice recognition is not available or not enabled

91 19 46 2038136/3 March 12, 2019. Supersedes Technical Service Bulletin Group 91 number 17-07 dated February 10, 2017 for reasons listed below.

Model(s)	Year	VIN Range	Vehicle-Specific Equipment
A3 Cabriolet	2015 - 2018	All	MIB MMI
A5 Cabriolet	2010 - 2017	All	MMI3G or 3G+

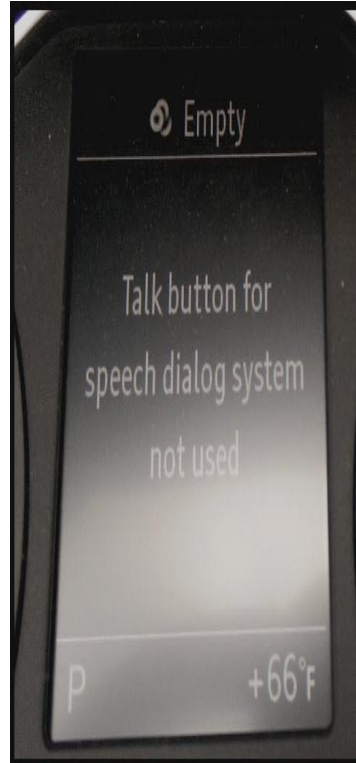
- The message “Talk button for speech dialog system not used” appears in the DIS (driver information system) for A3 Cabriolet vehicles (Figure 1).
- The message “Not available” appears in the DIS for A5 Cabriolet vehicles (Figure 2).

*Figure 1. Message for A3 Cabriolet.*

By design, the voice recognition (VR) system (also known as the speech dialog system (SDS)) is not enabled by the factory for A3 Cabriolet and A5 Cabriolet vehicles due to potential performance issues. R8 Spyder and 3<sup>rd</sup> Generation TT Roadster are not affected because these vehicles use seatbelt microphones to improve VR/SDS performance.

If the customer requests to have the VR feature enabled, it can be done through a change to the coding of the information control module 1, J794 (address word 005F). The labor to perform this change is not covered by warranty.

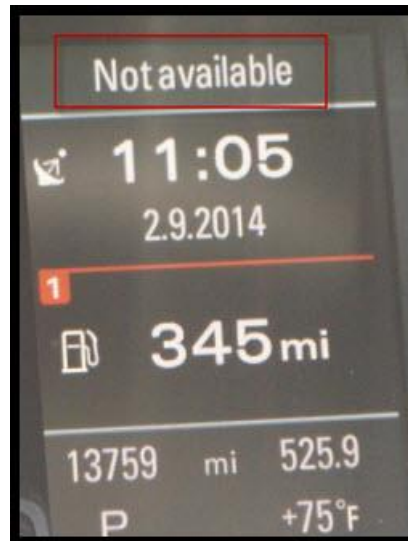
*Figure 2. Message for A5 Cabriolet.*

**Coding change for A5 Cabriolet vehicles with MMI3G/MMI3G+:** Byte 16 of the information control module 1, J794 (address word 005F) long coding controls the activation of the VR/SDS system. Note that this is byte 16 when counting in decimal, i.e., 1, 2, 3,...9, 10, 11, 12, 13, 14, 15, 16. Some aftermarket diagnostic tools number the coding bytes using HEX, i.e., 1, 2, 3,...9, A, B, C, D, E, F, 10, 11.

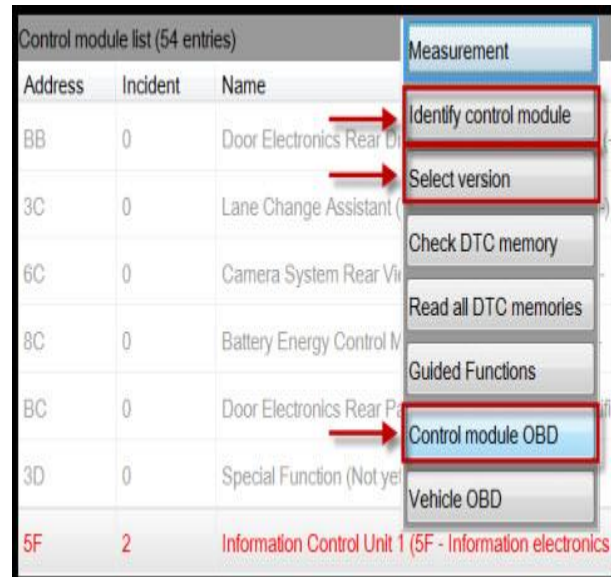
Figure 3. ODIS Options for 5F.

2. Right-click 5F\*. Choose "Identify Control Module". Next, right-click 5F again and choose "Select version". Then, right-click 5F again and choose "Control module OBD", then select "Code" (Figure 3).

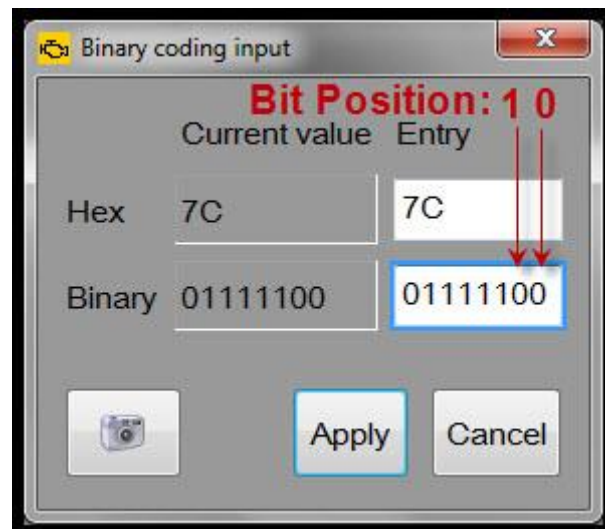
Figure 4. ODIS binary input for coding with indicated bit positions.

3. **For MMI3G/MMI3G+:** Scroll down to byte 16 and select it.  
**For MIB High:** Scroll down to byte 24 (which should be the last option) and select it.
4. At the bottom of the screen, choose "Binary Coding". The Binary coding input window will appear (Figure 4).

5. **For MMI3G/MMI3G+:** Change bit 0 from "1" to "0". Bit position 0 is indicated in Figure 4.  
**For MIB High:** Change bit 1 from "0" to "1". Bit position 1 is indicated in Figure 4.

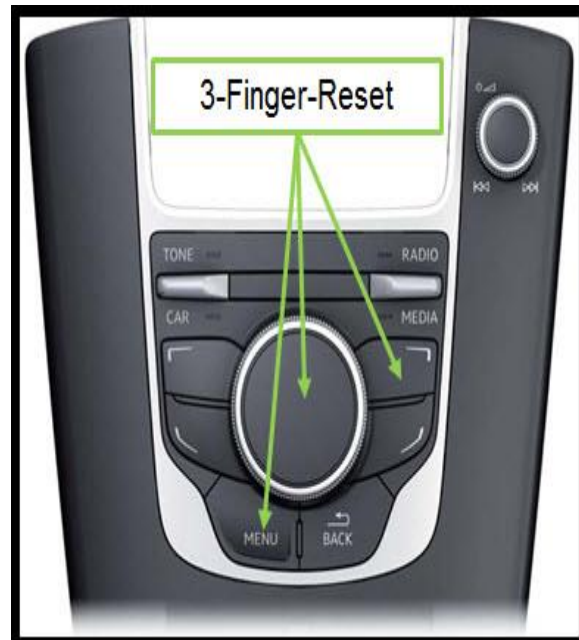
**Figure 6.** Three-finger reset for MIB1.

- Hit “Apply” in the pop-up window, then hit “Apply” at the bottom of the main window.
- Perform a three-finger reset of the main unit using the MMI control panel (Figure 6-9).

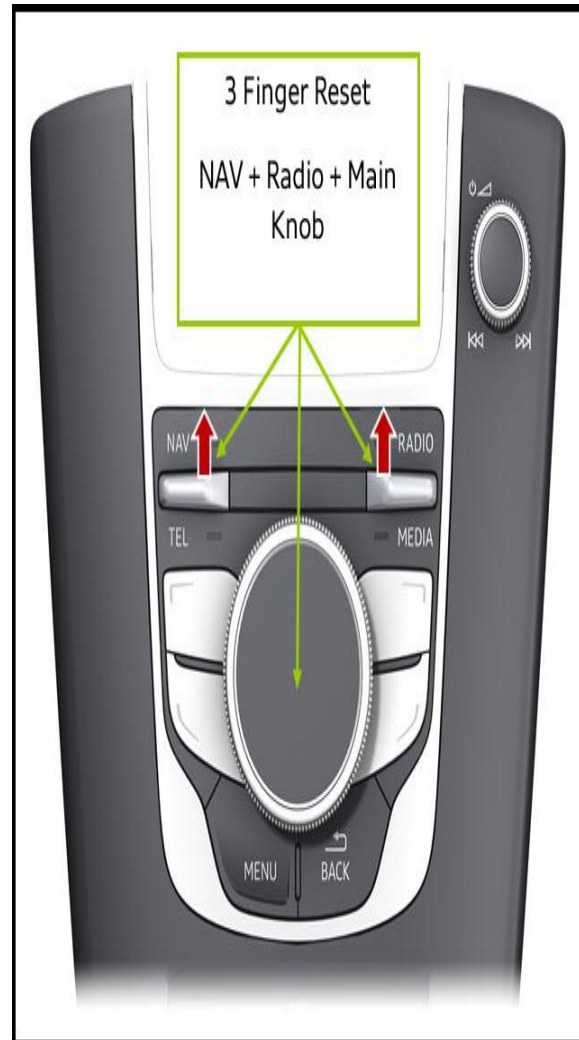
*Figure 7. Three-finger reset for MIB2.*

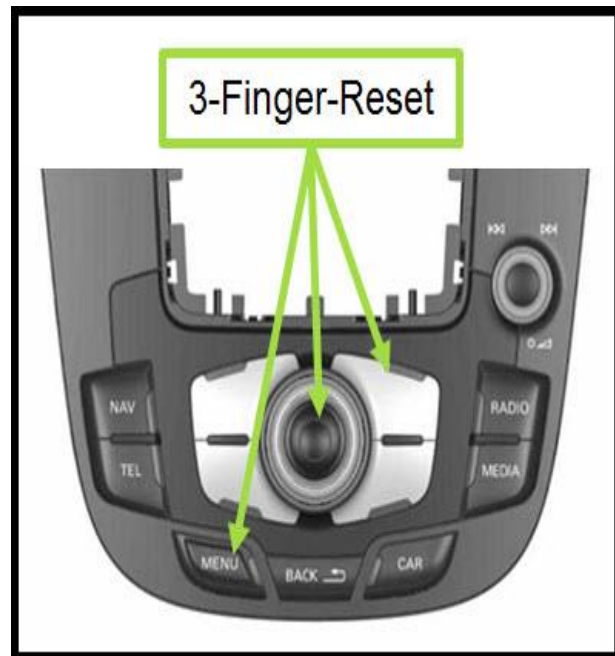
**Figure 8.** Three-finger reset for MMI3G+.

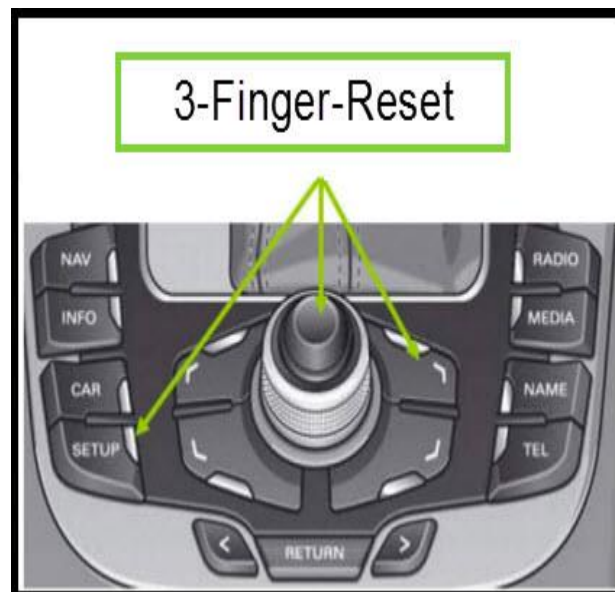
**Figure 9.** Three-finger reset for MMI3G.

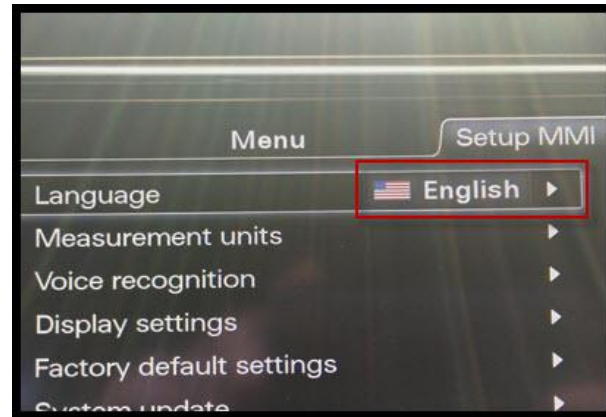
**Figure 8.** System language setting.

8. Test the system to verify all functionality. If the VR/SDS system does not fully function, or if it is in a different language, go to *Menu >> Setup MMI >> Language* (Figure 8) and change the language to any language other than English (either Spanish or French). Perform a three-finger reset, then set the language back to English and test the system again.
