**PRODUCT CAMPAIGN BULLETIN**

**APPLICABILITY:** 2019MY Forester and Crosstrek Vehicles      **NUMBER:** **WUC-88R**  
**SUBJECT:** Power Steering Gear Box Inspect/Replacement      **DATE:** 02/12/19  
**REVISED:** 03/22/19  
**NHTSA ID:** 19V-065

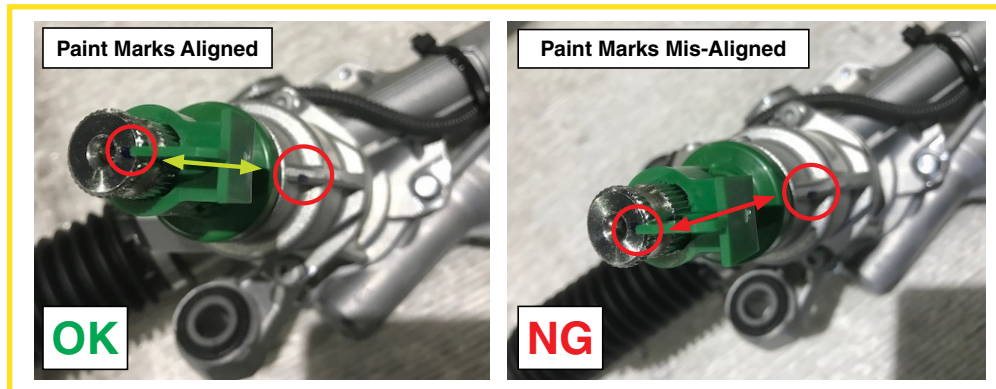
There is a VERY SMALL possibility the EPS gear box assembly was not properly centered before the plastic retainer was installed during manufacturing. If this occurs:

- it may be difficult to match up the marks when re-connecting the EPS gear box assembly to the steering shaft
- the number of turns between full steering lock left and right will be different
- one tie-rod boot will be collapsed (or extended) more than the other.

- If a **NG** condition is identified, see **APPENDIX A** on page 9 of this bulletin for the **EPS Gear Box Centering Procedure**.
  - Although the plastic retainer cap is white in the photos, it will likely be either green or blue depending on application.
5. When the Lot Number inspection procedure determines the EPS gear box assembly requires replacement, follow the procedure in the applicable Service Manual along with the Helpful Hints provided below. Pay close attention to the items listed as one-time-use. They are all supplied in the Hardware Kit and **MUST** be replaced during reassembly.

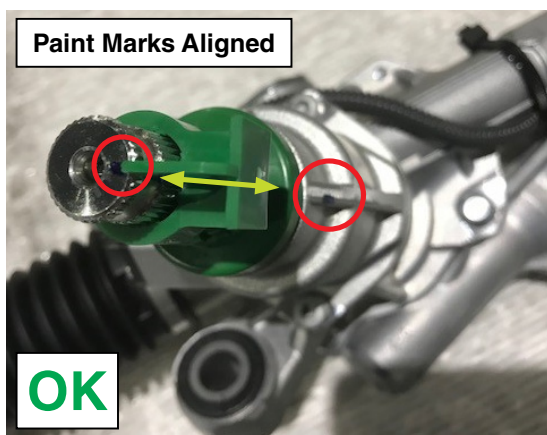
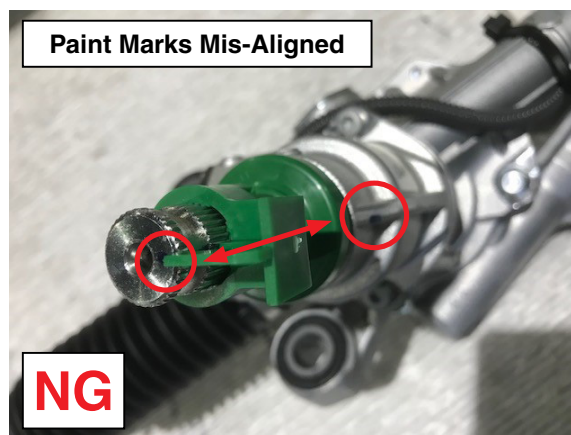
There is small possibility the steering gear box center position may be incorrect on the new replacement EPS gear box. This condition could cause the following two issues:

- Difficult to match the paint markings when connecting the gear box and the steering shaft.
  - The steering angle (number of turns) to full steer left and right may be different.
1. Before installing the new EPS gear box, confirm the input shaft paint mark and the housing paint mark are aligned as shown in the OK photo below.
  2. Confirm the tie rods and boots are the same length, left and right.
