SERVICE INFORMATION BULLETIN

APPLICABILITY: 2019MY Forester

NUMBER: 12-259-19

SUBJECT: Cowl Panel Gap- Design Change

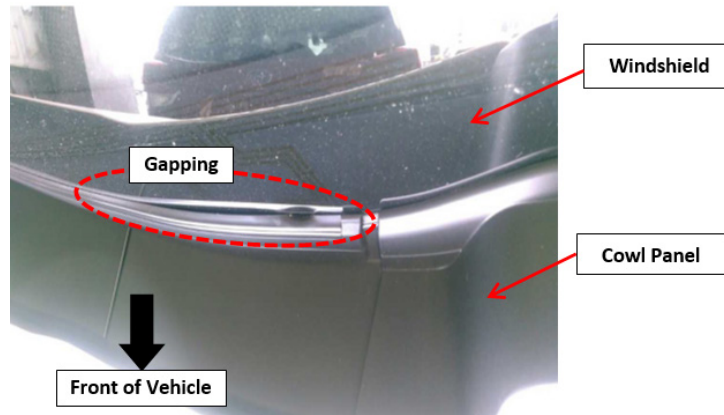
This Service Information bulletin announces a design change to the cowl panel. The change was made to the shape of the part which will eliminate a gap between the cowl panel and the windshield in the lower corner area as shown in the photo below. The gap may develop during expansion and contraction of the plastic cowl panel material as a result of temperature changes.

Description	Part Number
COWL PANEL ASSEMBLY	91419SJ011
	91419SJ031
