Technical Service Bulletin

Mazda North American Operations
Irvine, CA 92618-2922

**CREAKING NOISE FROM FRONT SHOCK ABSORBER WHEN GOING
OVER BUMPS**

Bulletin No.: 02-005/19

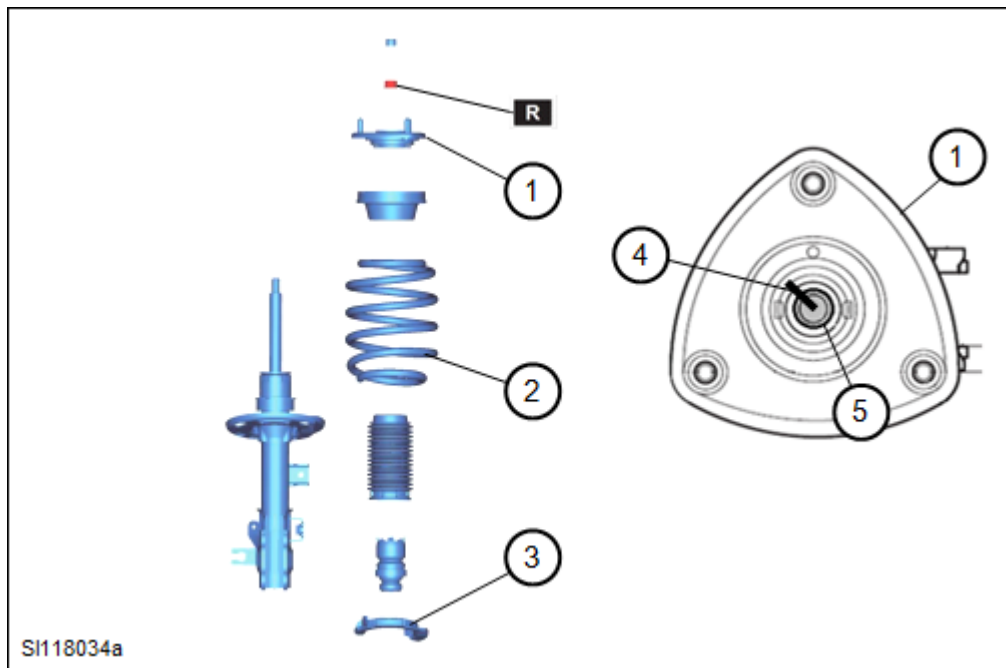
Mounting Rubber Removal Note

Some vehicles may experience a creaking noise from the front shock absorber when going over bumps. Upon inspection, the coil spring is found to be broken at the lower part without any trace of an accident. It may be found during maintenance or service opportunity without customer complaints. Mud and sand caught between the coil spring and the lower spring seat causes paint damage on the coil spring, resulting in rust holes and uneven force application. To correct this issue, the shape of the lower spring seat has been modified.

1. Verify customer concern.
2. Replace the broken coil spring (2) with a new one and the affected side spring seat (3) with a modified one according to the instruction on MGSS (FRONT SHOCK ABSORBER AND COIL SPRING DISASSEMBLY/ASSEMBLY).

Put a position mark (4) on the mounting rubber (1) and piston rod (5) before removing the mounting rubber from the shock absorber assembly so the mounting rubber can be installed back in the original position. If this has been done, it is not necessary to adjust the front wheel alignment because the front shock absorber and the mounting rubber are not replaced.
