<b>Subject:</b> <b>IGNITION DOES NOT TURN OFF WHEN PRESSING START / STOP BUTTON (WITH GATE-TYPE AT SHIFTER)</b>	<b>Bulletin No.:</b> 05-003/19
	<b>Last Issued:</b> 05/06/2019

2013-2014 CX-5 vehicles with VINs lower than JM3KE\*\*\*\*\*430747 (produced before Dec. 27, 2013)  
 2014 Mazda6 vehicles with VINs lower than JM1GJ\*\*\*\*\*162747 (produced before Nov. 29, 2013)

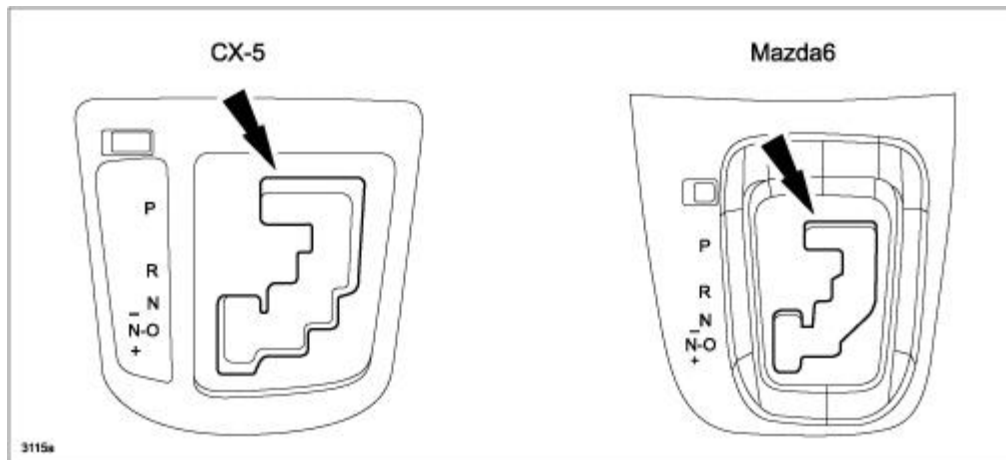
When pressing the START/STOP button, the ignition may not turn off on some vehicles equipped with a gate-type AT shifter. Although the shift lever is in "P" position and the engine shuts off normally, the ignition may stay on (in accessory mode). Some customers may describe this concern as "the radio stays on" or "the radio is staying on".

This concern may be caused by a worn switch unit. To eliminate this concern, the switch unit material has been changed to improve wear resistance. Modified switch units have been established as new service parts.

Customers having this concern should have their vehicle repaired using the following repair procedure.
