Service Alert

MAZDA CONNECT REBOOT OR BLANK SCREEN

Service Alert No.: SA-006/19

Last Issued: 05/01/2019

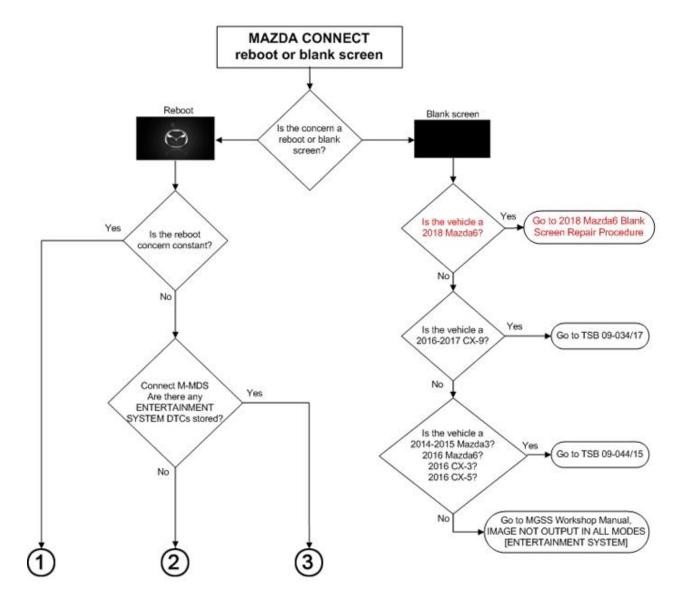
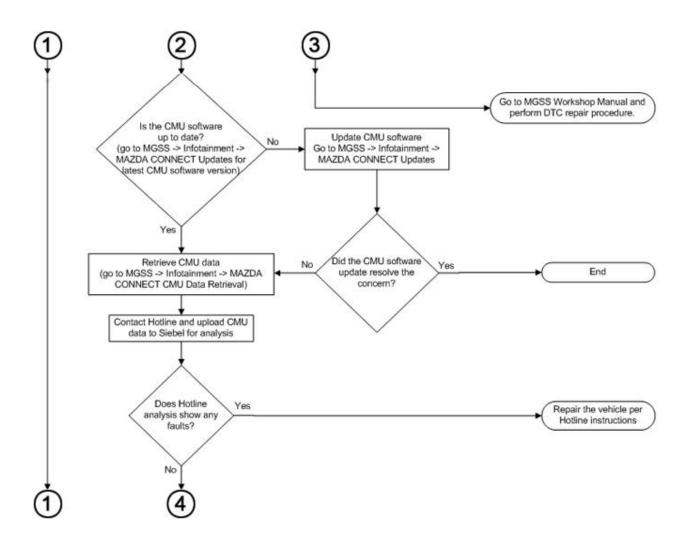
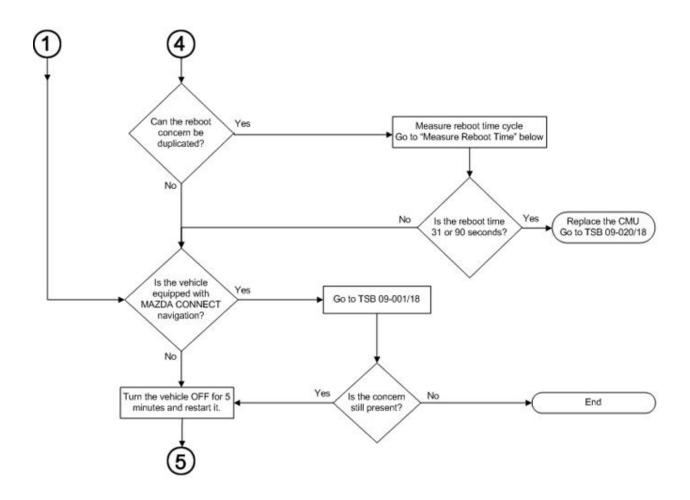
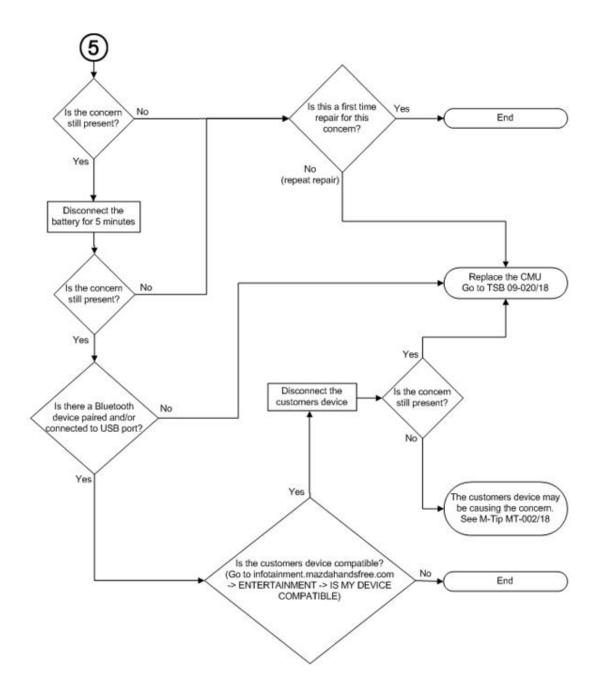
Flowchart

Some customers may complain about a MAZDA CONNECT system reboot or blank screen. Use the flowchart below to repair the vehicle.

REPAIR PROCEDURE
