Service Alert

Subject: CLOCK CANNOT BE RESET AFTER BATTERY DISCONNECT	Service Alert No.: SA-021/19
	Last Issued: 05/23/2019

2007-2012 CX-7
2007-2015 CX-9

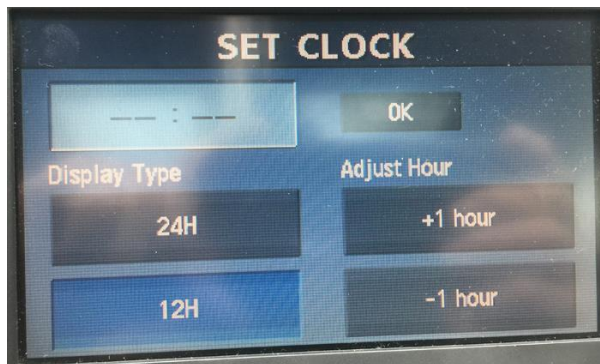
Some vehicles may experience a clock failure after a battery disconnect. The clock shows dotted lines and cannot be reset.

Mazda is aware of this issue and is working on a solution. Do not perform any vehicle repairs at this time. This service alert will be revised when a countermeasure repair is available.
