## INSTRUCTION TO SERVICE

**ITS: 58663**

| <b>SUBJECT:</b> | Kneeling Buzzer Replacement |

# ITS58663

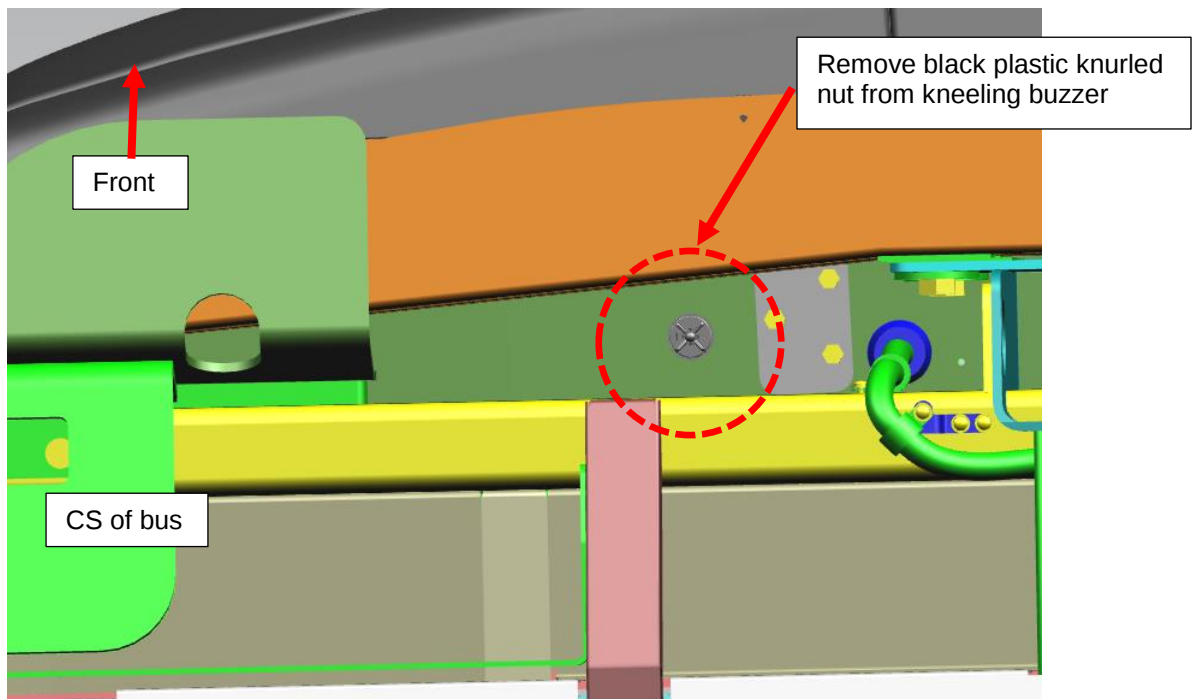
**Figure 1 – View below the CS section of the front mask – Remove kneeling buzzer nut**

1. Turn the battery disconnect switch to the "OFF" position.
2. If required, lift bus in accordance with the applicable section of the New Flyer Service Manual.
3. Move below the bus and locate the Kneeling Buzzer below the CS section of the front mask. Remove the black plastic knurled nut. Refer to Figure 1.

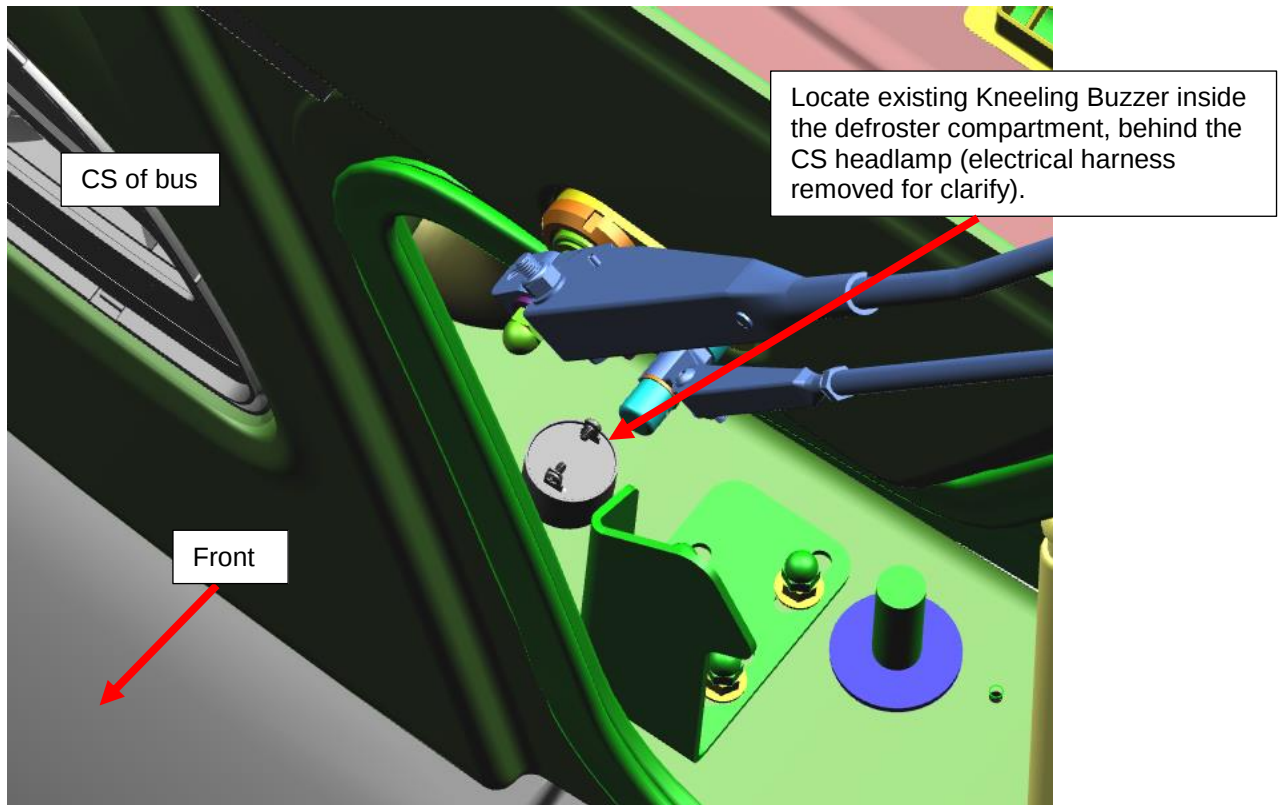
**Figure 2 – Gain access to defroster compartment and remove existing kneeling buzzer**

4. Proceed to the front exterior of the bus and open the Defroster Door. Locate the Kneeling Buzzer inside the defroster compartment, near the CS headlamp. Refer to Figure 2.

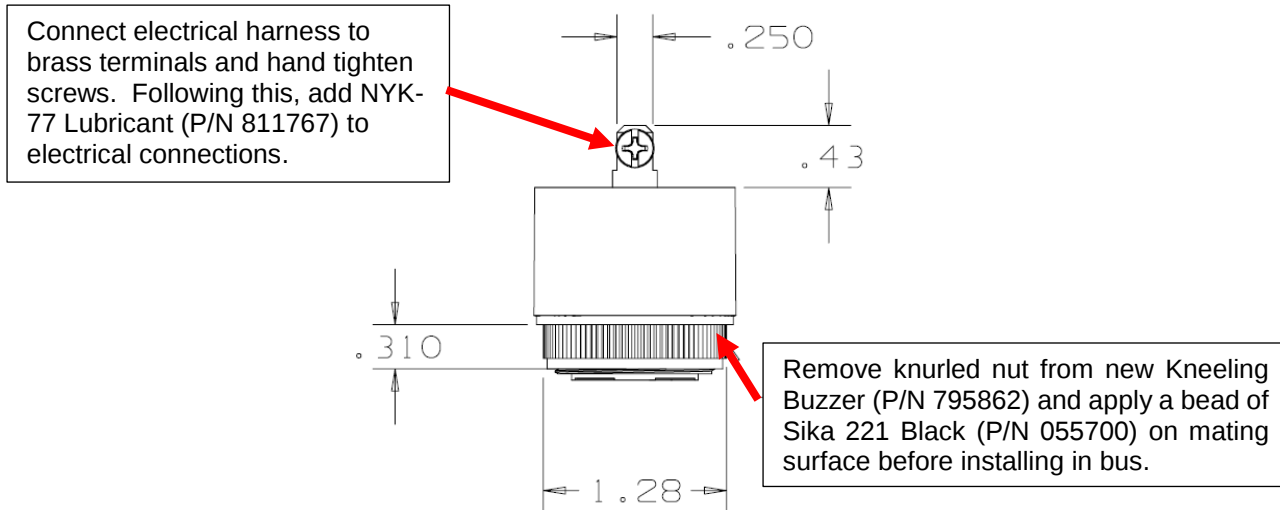
**Figure 3 – New Kneeling Buzzer (P/N 795862)**

5. Remove both screws and disconnect the electrical harness from the Kneeling Buzzer terminals.
6. Gently pull Kneeling Buzzer upwards out of the front mask and remove from the bus.
7. Gently clean remaining Sika from hole in the front mask.
8. Remove knurled nut from new Kneeling Buzzer (P/N 795862) and install threaded front in existing hole in the front mask. Refer to Figure 3.

**Note:** Apply a light bead of Sika 221 Black (P/N 055700) on the mating face of buzzer before installing.

9. Reconnect the electrical harness to the brass terminals on new Kneeling Buzzer (P/N 795862) by hand tightening screws. Following this, add NYK-77 Lubricant (P/N 811767) to the electrical connections. Refer to Figure 3.
