GROUP Electrical	MODEL 2019MY Sportage (QL)
	NUMBER PS603	DATE May 2019

SUBJECT: 19MY QL BLUETOOTH INTERMITTENT NO SOUND

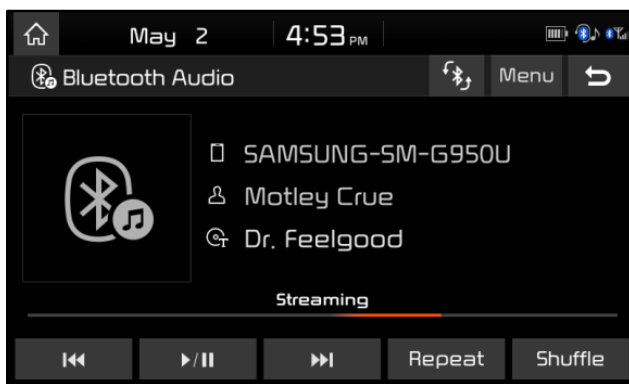
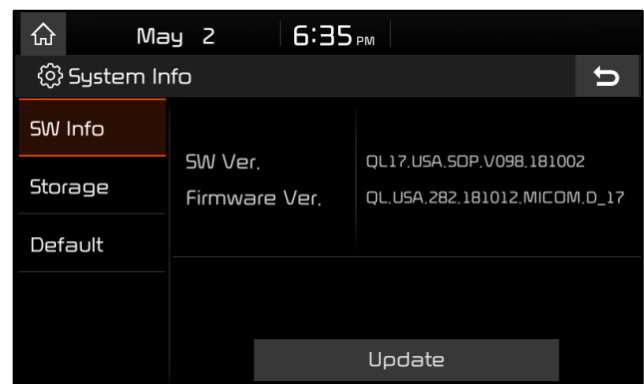
This Pitstop provides information regarding Bluetooth playback and connectivity concerns on some 19MY Sportage (QL) vehicles equipped with UVO 3.0 audio head units with the following software:

Head Unit Software Version
QL17.USA.SOP.V098.180612

- “When phone is connected to the Bluetooth, music playback cuts in and out”.
- “Bluetooth randomly loses connection to head unit”.

If customer complaints are present and the head unit has this software version, then replace the head unit with a re-manufactured head unit through Direct Exchange. If the software version is already up to date and concern is present, then open tech line case.

After replacing the head unit, ensure that the software version is:

QL17.USA.SOP.V098.181002 or newer.
