GROUP <b>BOD</b>	MODEL <b>2020MY Soul (SK3)</b>
	NUMBER <b>190</b>	DATE <b>May 2019</b>
<b>TECHNICAL SERVICE BULLETIN</b>		
SUBJECT: <b>SERVICE ACTION: INOPERATIVE HORN REPLACEMENT (SA384)</b>

This issue number is **SA384**.

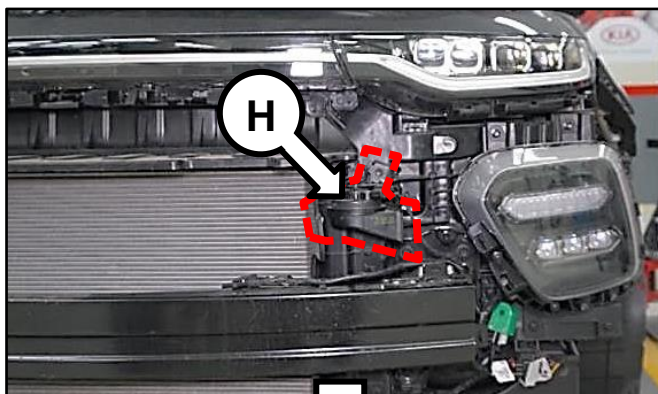
This bulletin provides the procedure to replace the horn assembly on some 2020MY Soul (SK3) vehicles produced from December 10, 2018 through January 11, 2019 which may exhibit a weak intermittent or non-operational “sound” due to moisture inflow into the horn. Kia is requesting the completion of this Service Action on all affected vehicles including dealer stock, prior to delivery. Before conducting the procedure, verify that the vehicle is included in the list of affected VINs.

5. Disconnect the horn connector (F) and remove the retaining bolt (G) to remove the horn (H).

6. Replace the horn and test for proper operation.
