GROUP ELE	MODEL 2019MY K900 (RJ)
	NUMBER 167 (Rev 1, 05/02/2019)	DATE April 2019
TECHNICAL SERVICE BULLETIN		
SUBJECT: SERVICE ACTION: AVN FACTORY RESET (SA376)

SERVICE ACTION: AVN FACTORY RESET (SA376)

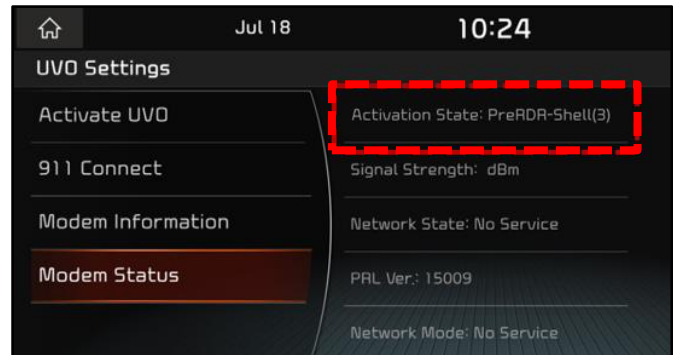
If the modem status is “PreRDR-Shell (3)”, then this procedure was performed correctly and the UVO system is working properly.

17. Verify that the UVO Activation Status is “PreRDR-Shell(3)”:

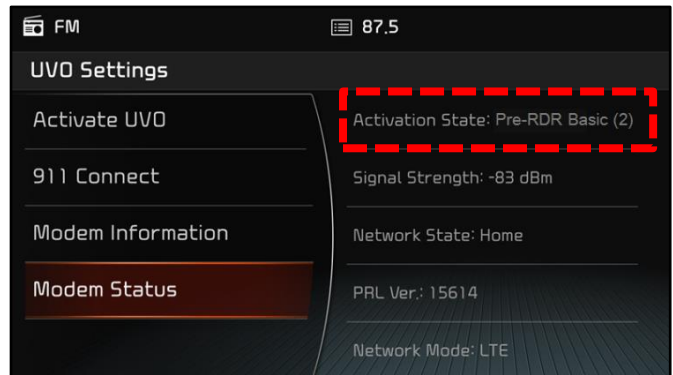
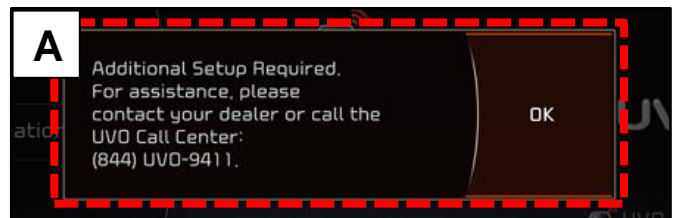
18. If the modem status is “PreRDR-Basic (2)” and the message (A) shown below is displayed, open a Techline case online.
