Stress Cracks in the Left and/or Right Headlamp Lenses

Topic number	LI82.10-N-069621
Version	1
Function group	82.10 Exterior lights
Date	04-04-2019
Validity	Model 447 up to 04/2018 production
Reason for change	
Reason for block

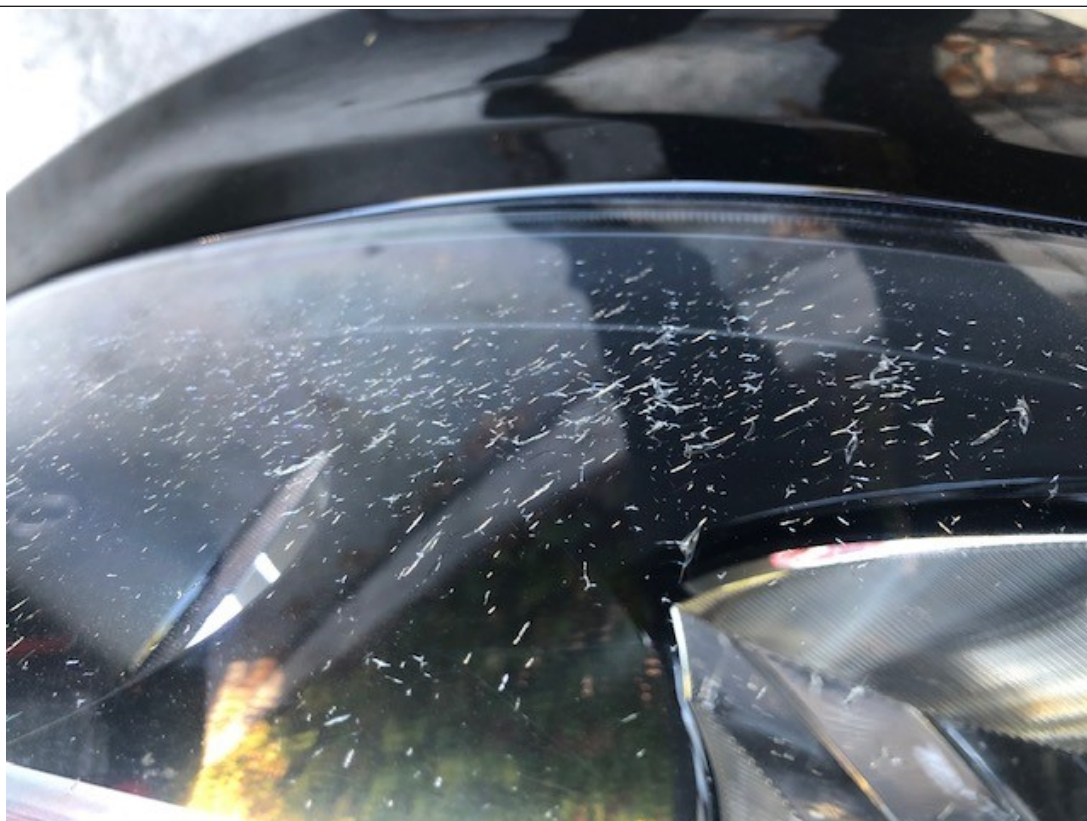
Stress Crack Example 1.
jpg:

Cracks in the left and/or right headlamp lenses

Inadequate elastomer/UV protection of the headlamp lenses during manufacturing

Replace the left and/or right headlamp units
