Carriage of load compartment sliding door runs out of lower guide rail

Topic number	LI72.16-N-069628
Version	1
Function group	72.16 Sliding doors
Date	04-04-2019
Validity	Model 907.###
Reason for change	Measure 3 adapted and validity limited.
Reason for block

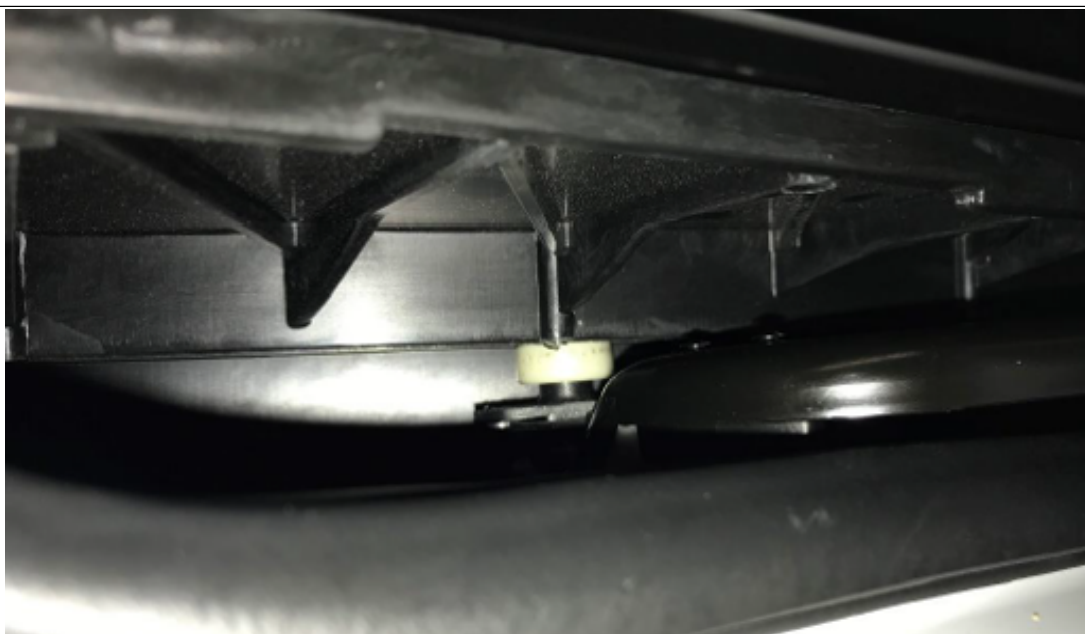
01.jpg:

The guide roller of the lower carriage of the load compartment sliding door can run out of the guide rail in the front area (see picture 01).

Attachments	
File	Description
01.jpg	The guide roller of the lower carriage of the load compartment sliding door can run out of the guide rail in the front area. (Note: shown on left sliding door)

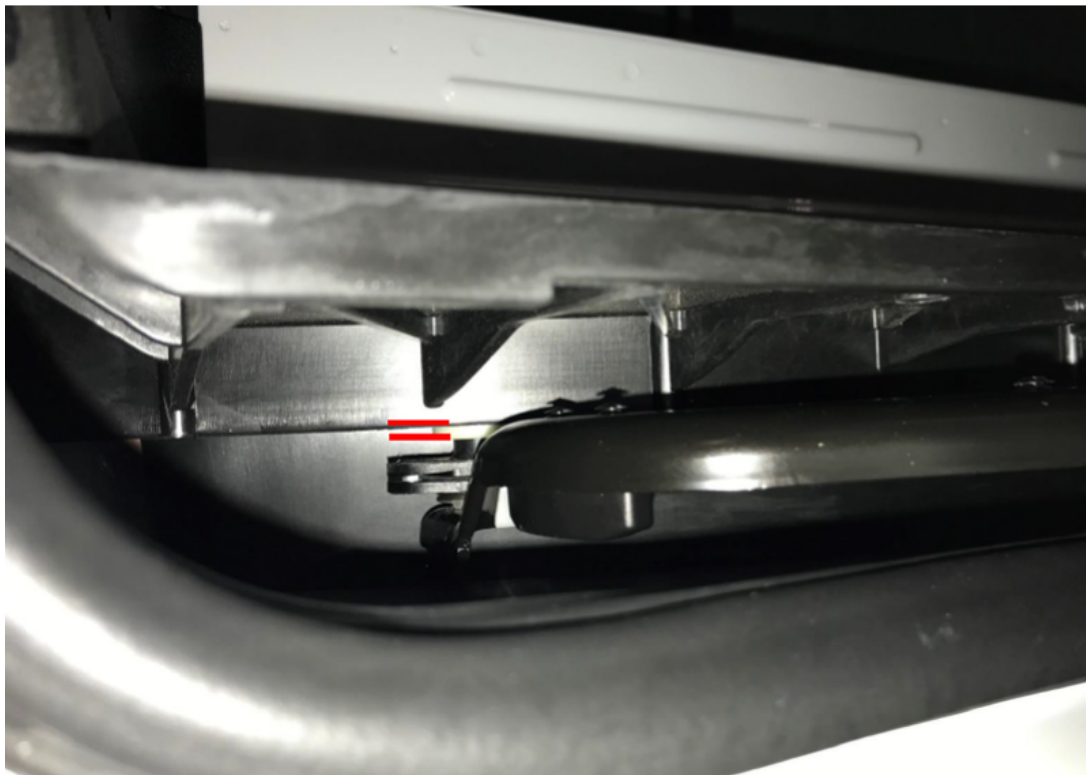
02.jpg:

If the guide roller of the carriage at the load compartment sliding door protrudes downwards out of the guide rail by more than max. 2 mm in the entire range of travel (see picture 02), then the following measures are necessary.
