Preliminary Information

PIT5564B SIR MIL With DTC's B0012 B0013 B0014 B0015 B0019 B0020 B0021 and/or B0022 (Aftermarket USB/Phone Charger)

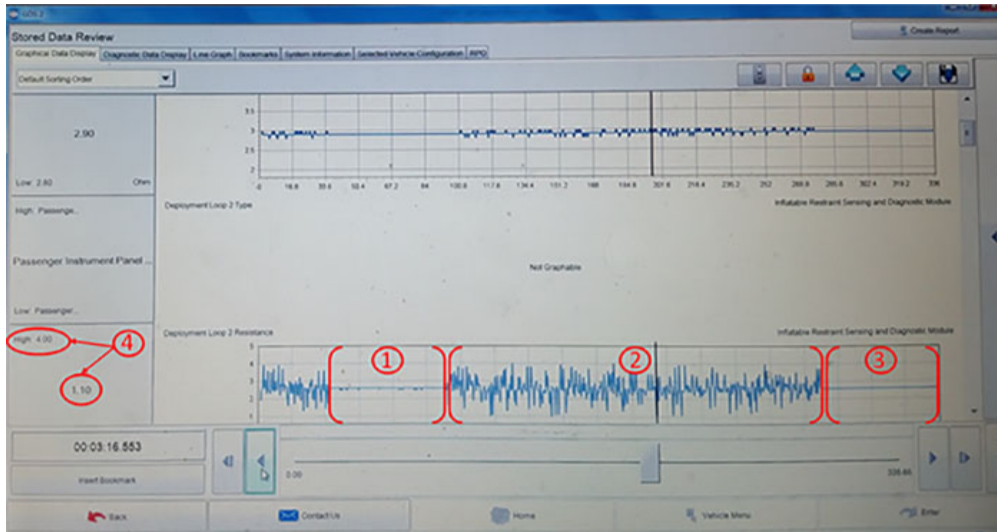
| Condition | Some owners may comment of an intermittent SIR MIL. When checking for DTC's, any of the following may be set: B0012, B0013, B0014, B0015, B0019, B0020, B0021, and/or B0022. In most cases, it will have symptom codes for both high and low loop resistance (0D - Loop Resistance Above Threshold and 0E - Loop Resistance Below Threshold). |
| Cause | <p>This concern could be caused by interference from an aftermarket USB and/or phone charger plugged into the 12 volt power outlet. Below is a screen print of the scan tool displaying the resistance of an air bag deployment loop.</p> <ul style="list-style-type: none"> - 1 is with only a USB charger plugged into the center console 12 volt power outlet and slight resistance changes can be seen. - 2 is when a phone was plugged into the USB charger and the deployment loop resistance is fluctuating up and down greatly. This fluctuation up and down is why many cases will have both symptoms codes for the loop resistance being above and below threshold (0D and 0E). - 3 is with everything unplugged from the 12 volt power outlet and the resistance is very steady, as it should be. |

If, after following normal diagnostics and the root cause is not found, inspect the vehicle and/or question the customer if they are using any type of USB/phone charger/etc.

As in the example above, the scan tool was used to monitor the suspect air bag loop resistance while using/operating the aftermarket item plugged into the 12 volt power outlet.

If the concern is intermittent and/or can not be duplicated, ask the owner to refrain from using anything that is being plugged into the 12 volt power outlets and see if the issue goes away.

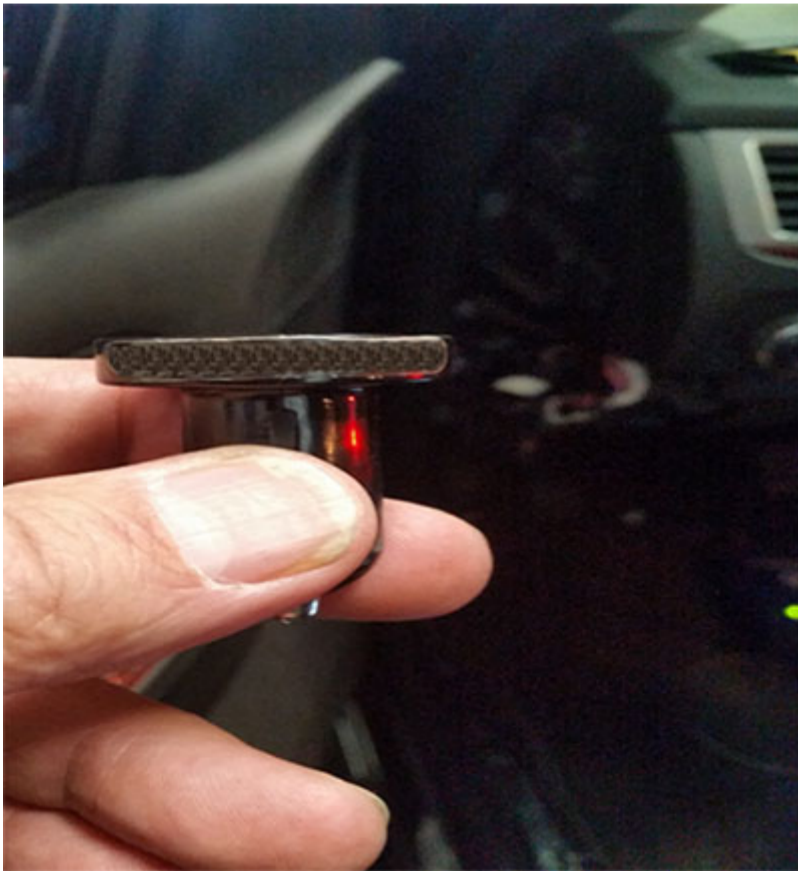
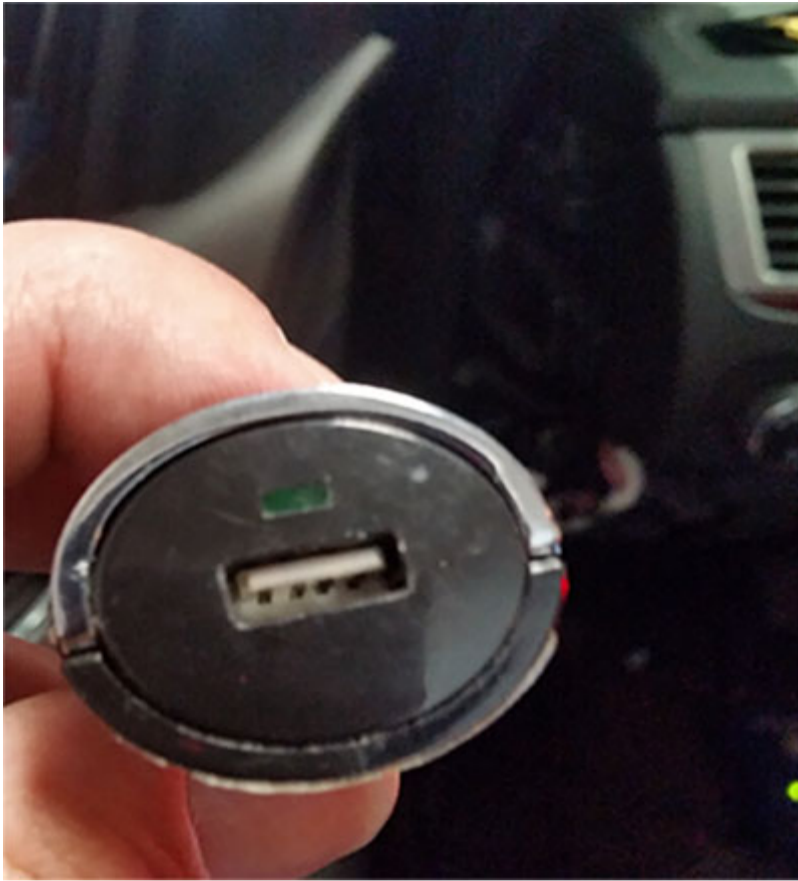
Shown below is one example of a USB charger that has caused this type of concern.
