Preliminary Information

PIP5122G Pop Noise From Fuel Tank After a Cold Start or EVAP Purge Event

| Brand: | Model: | Model Years: | VIN: | | Engine: | Transmissions: |
|---|---|---|---|---|---|---|
| Chevrolet | Equinox | 2010 - 2017 | All | All | All | All |
| GMC | Terrain | 2010 - 2017 | All | All | All | All |

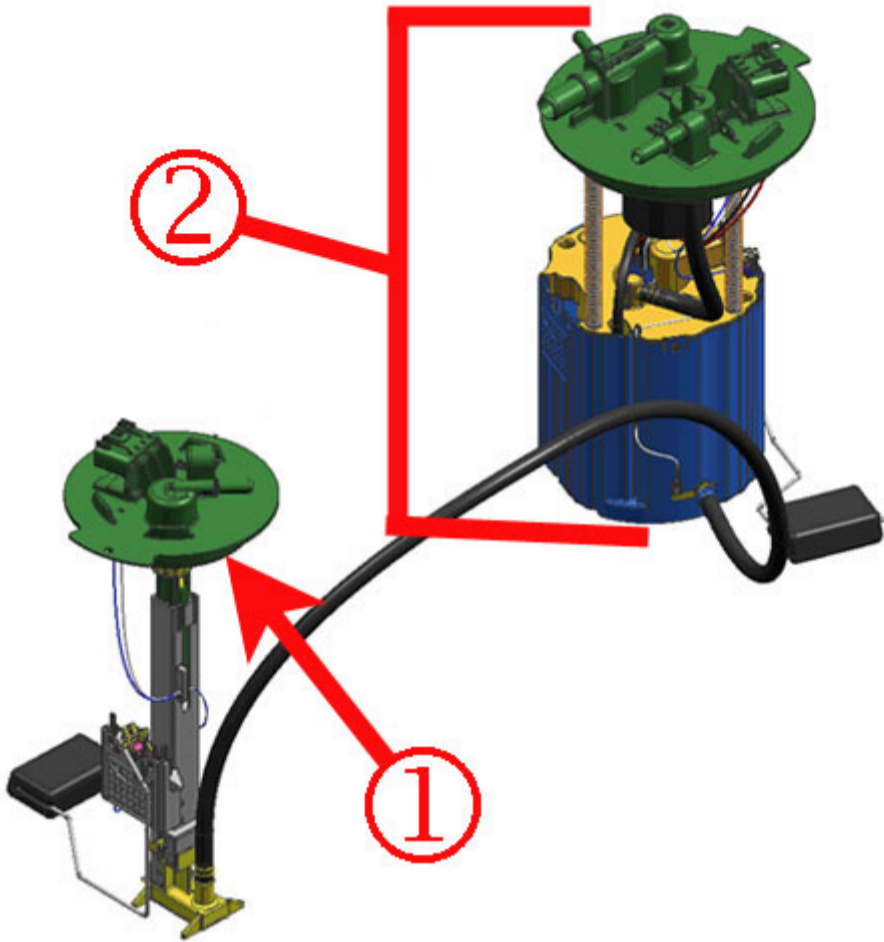
As the vacuum reaches 3 to 5 inches, the pop/popping noise should be duplicated. The cause for this concern is the auxiliary fuel pump in the left side of the fuel tank changing height (spring loaded leg).

Important: The condition described in this PI applies only to the auxiliary fuel pump module assembly. The Parts Catalog calls this auxiliary pump component (1) the "Fuel Pump Auxiliary" which is the correct part for this repair. Replacing the primary fuel pump module (2) assembly would NOT correct this noise condition. The parts catalog calls this primary pump component the "Fuel Pump" which is the incorrect part for this repair.

| Part Number | Usage | Description | Qty |
|---|---|---|---|
| 13506193 | 2010-2011 Equinox/Terrain LAF & NT7 or NU5 2012-2017 Equinox/Terrain LEA FHO & NT7 or NU5 | Fuel Pump Auxiliary | 1 |
| 13506192 | 2011-2012 Equinox/Terrain LFW NU5 2010 Equinox/ Terrain LF1 & NT7 or NU5 2012-2017 Equinox/Terrain LEA FHS NT7 2013-2017 Equinox/Terrain LFX FHS | Fuel Pump Auxiliary | 1 |
