Preliminary Information

PIP5202B (EREV) Diagnostic Tips for Intermittent MIL With DTC P0AB9

Brand:	Model:	Model Years:	VIN:		Engine:	Transmissions:
			from	to		
Chevrolet	Volt	2011 - 2015All	All	All	All	
Cadillac	ELR	2014 - 2016	All	All	All	All

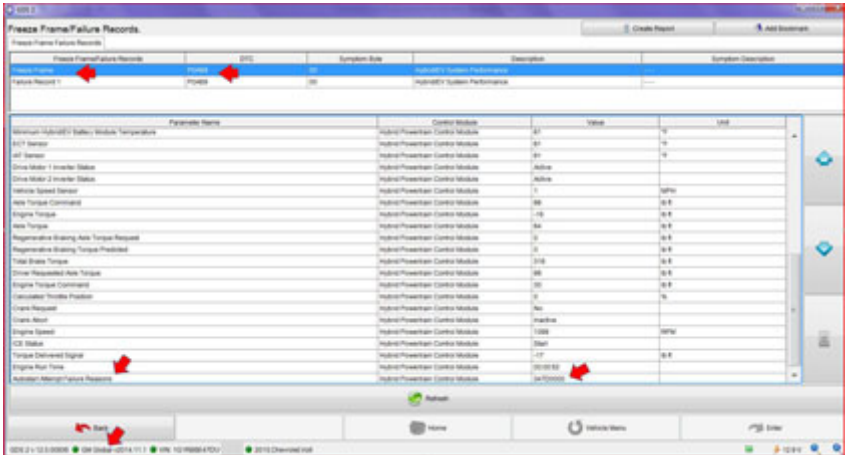
- 1) Review all modules for DTCs using GDS2 and select "Vehicle Wide DTC Check With Module Info" under the Vehicle Diagnostics Menu. DO NOT clear any DTC's. Review the HPCM and ECM Freeze Frame Data, then create a report. You can save the report or email it after doing so.
- 2) The HPCM Freeze Frame and Failure Records will include "Autostart Attempt Failure Reasons". In order to view them in the Freeze Frame Record, GDS2 must be updated to v12.0.0.00835 - Global v2014.11.1 or later.
