Preliminary Information

PIT5404E Squeak Chirp Whistle Rattle Type Noise from Rear of Vehicle (Passive Exhaust Valve) or Buffeting Vibration Drone Exhaust Tone Change Body Pressure Booming (AFM Exhaust)

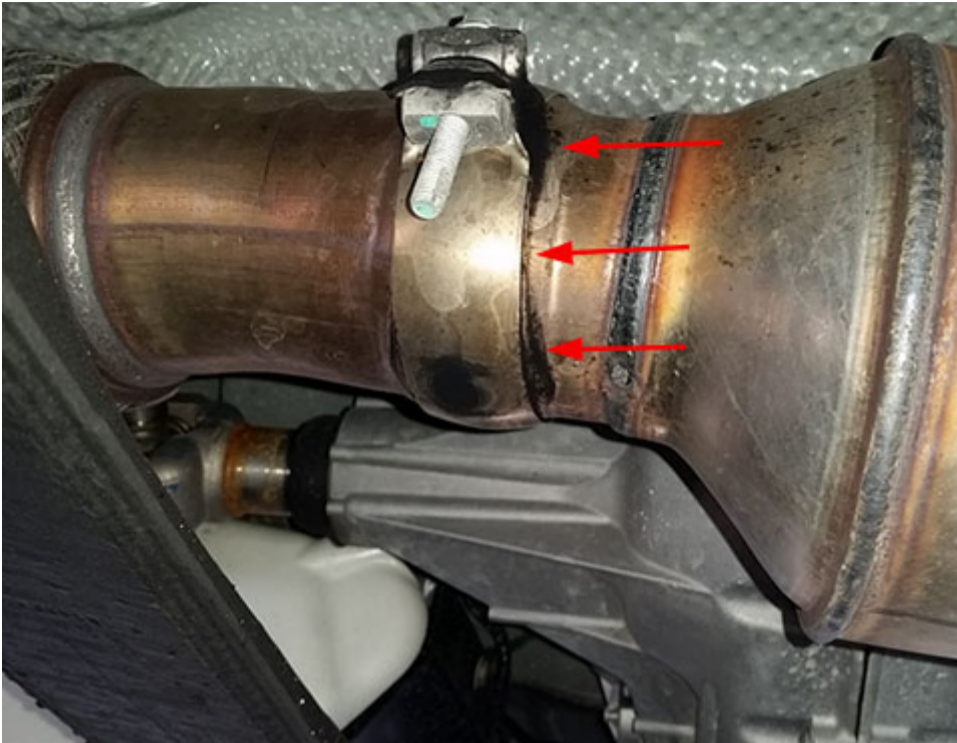
1. Ensure there are no leaks at the exhaust band (Norma) clamp joint. It has been found in some cases that a leak at the clamp joint could allow some level of exhaust

tone change or exhaust vibration/drone type noise and/or buffeting vibration or body pressure booming to occur. Refer to latest version of [PIP5442](#).
