Preliminary Information

PIP5643 MIL Illuminated DTC P0299

Brand:	Model:	Model Years:	VIN:		Engine:	Transmissions:
			from	to		
Cadillac	XT4	2019	All	All	2.0L LSY	All

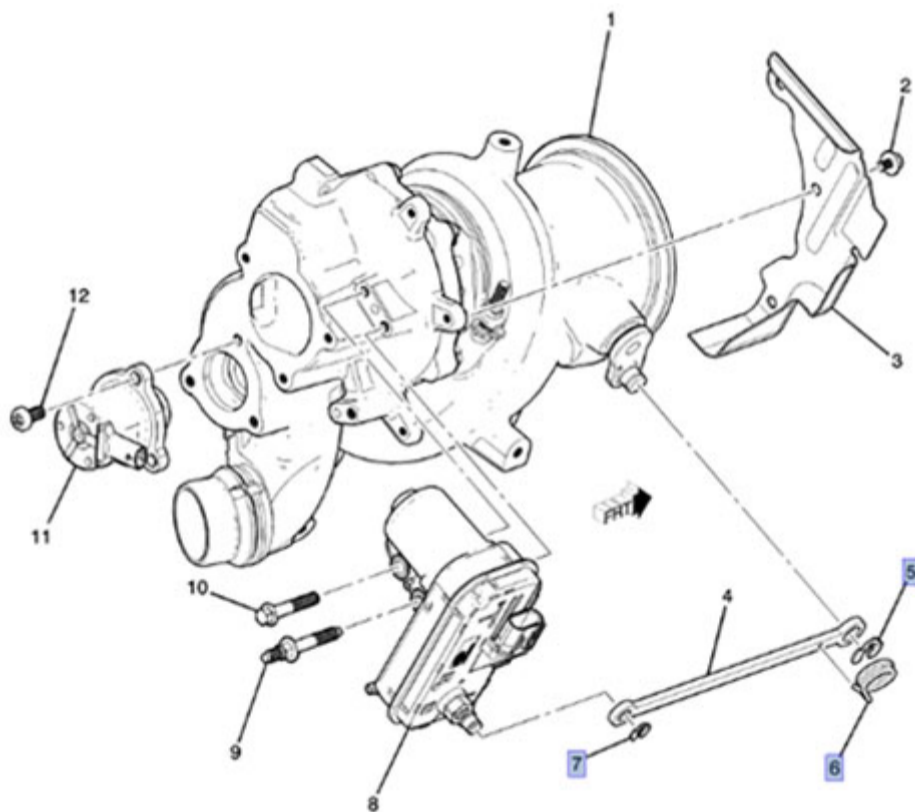
Involved Region or Country:	North America and...
Condition:	MIL Illuminated DTC P0299
Cause:	Possible missing turbocharger wastegate lever retaining clip

If you encounter a vehicle with DTC p0299 inspect the wastegate lever for a possible missing retaining clip at the wastegate actuator or at the wastegate valve causing the lever to become disconnected. The wastegate lever side also has an anti-rattle spring that could be missing. (Call outs 5, 6 and 7 in the illustration below reference the anti-rattle spring and retaining clips.)

If you find a missing wastegate lever retaining clip either at the actuator or wastegate valve. These retaining clips and anti-rattle spring may be available through CCA Parts, if so, then install the missing retaining clip and anti-rattle spring if needed and evaluate.

Note: if the retaining clips or anti-rattle spring are not available turbocharger replacement would be required. Do not attempt to swap the retaining clips from the new turbo to the OE turbo. Install the new turbocharger assembly as the old parts will be requested back for further analysis to determine root cause for missing retaining clip.

Important: Do not attempt to remove the existing retaining clip on the wastegate lever of the original turbo. Please refer to PI0653E for additional warranty part return information.
