# Preliminary Information

## PIT5675A Diagnostic Tip: Loss of Power Steering Assist May Have Chassis Bus Communication Codes or C0800 in The PSCM

### Models

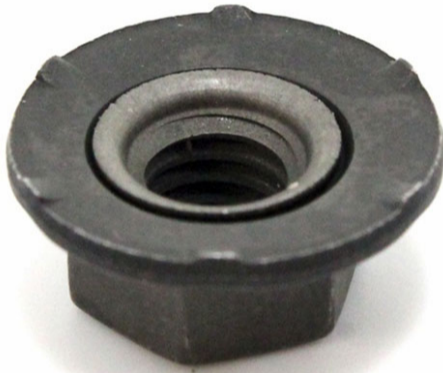
<b>Involved Region or Country:</b>	<b>North America</b>
<b>Condition:</b>	<b>Loss Of Power Steering Assist May Have Chassis Bus Communication Codes Or C0800 In The PSCM.</b>
<b>Cause:</b>	<b>Inspect G112 for a standard nut versus a shouldered nut similar to the one shown below. If the standard nut is installed it will not provide proper clamp load on the ground lug.</b>
