GROUP ELE	MODEL 2020MY Telluride (ON)
NUMBER 168	DATE May 2019

TECHNICAL SERVICE BULLETIN

**SUBJECT: SERVICE ACTION: ELECTRONIC PARKING BRAKE
CONNECTOR INSPECTION AND/OR ADJUSTMENT (SA381)**

This issue number is **SA381**.

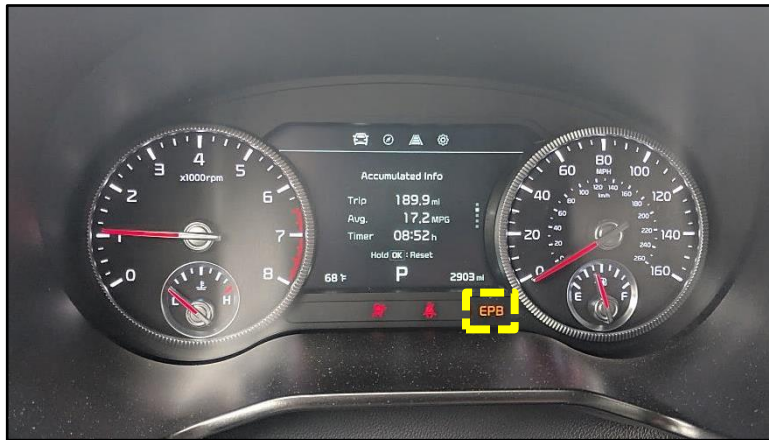
This bulletin provides information on some 2020MY Telluride (ON) vehicles produced from January 17, 2019 through April 9, 2019, which may exhibit an Electronic Parking Brake (EPB) warning light illuminated. Follow the procedure to ensure the EPB connector is firmly locked in place by performing a pull test. If the connector can be removed without depressing the locking tab, additional steps are required to seat the terminal lock retainer. Kia is requesting the completion of this Service Action on all affected vehicles including dealer stock, prior to delivery. Before conducting the procedure, verify the vehicle is included in the list of affected VINs.

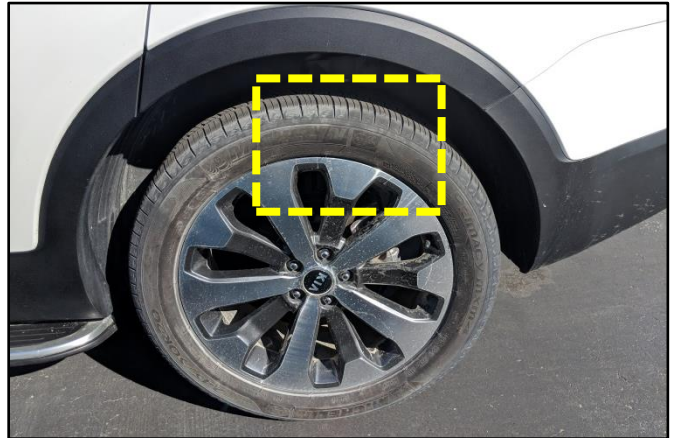
1. Locate the EPB connector in the left rear axle area, behind the rear wheel area as shown.

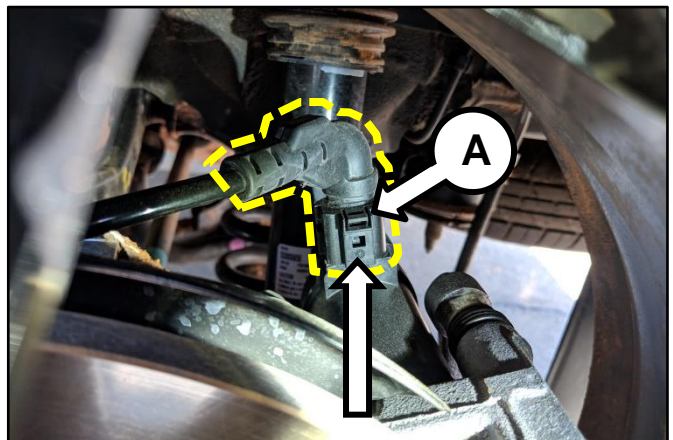
2. Attempt to pull EBP connector (A) upward.

If EBP connector does not release, there is no concern. This action is complete.

If EBP connector does release, proceed to Step 3.

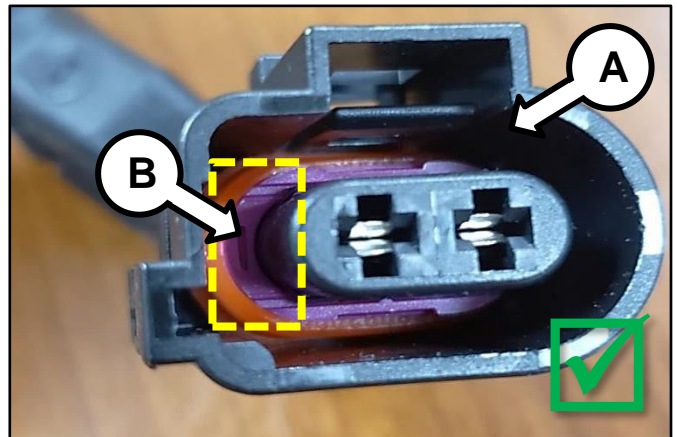
3. Check the terminal retainer (B) located inside of the connector (A).

Terminal retainer is fully seated – **Good.**

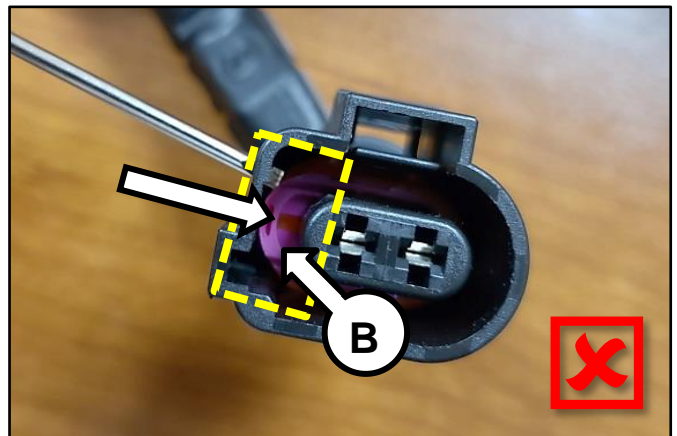
Terminal retainer is NOT seated – **NG.**

4. If retainer (B) is unlocked as shown, then slide the lock retainer towards the center of the connector as shown using small flathead screwdriver.
