MODEL
2011-2013MY
Sorento (XMa)

NUMBER
179 (Rev 1, 05/13/2019)

TECHNICAL SERVICE BULLETIN

SUBJECT: HALOGEN LOW BEAM BULB
CONNECTOR REPLACEMENT

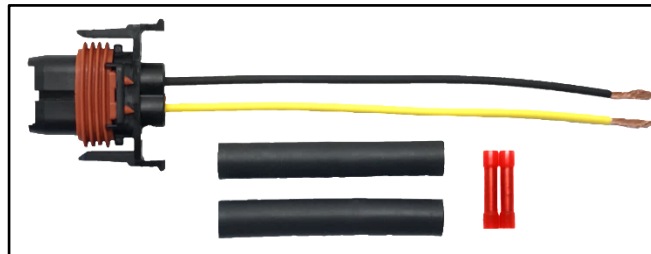
This bulletin provides the procedure to replace the halogen low beam bulb connector on some 2011 - 2013MY Sorento (XMa) vehicles, produced from October 24, 2009 through January 31, 2013, which may experience an inoperable low beam bulb due to poor terminal contact at the low beam bulb connector. This condition on the affected headlamp does not affect the other low beam. In addition, the high beams continue to function at all times. Follow the procedure outlined in this bulletin to replace the low beam bulb connector.

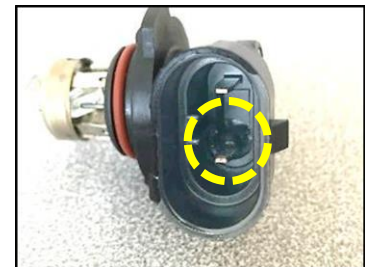
- Remove the affected halogen low beam bulb from the headlamp and take one (1) KVID photo of the damaged bulb terminal(s) (Attachment Type: 'XX'). Ensure the affected area of the terminal is clearly visible in the photo.

This TSB is part of Warranty Extension WTY012. Only the affected headlamp low beam connector should be replaced. If the low beam bulb is inoperative due to damage by the electrical connector from poor terminal contact, replace the low beam bulb after fulfilling the KVID requirement:
