North America LLC **Customer Advisory Letter**

Subject; Brake Clevis Pin

This documentation applies to FCCC, MT45/MT55 and 2015 to 2017 Year vehicles.

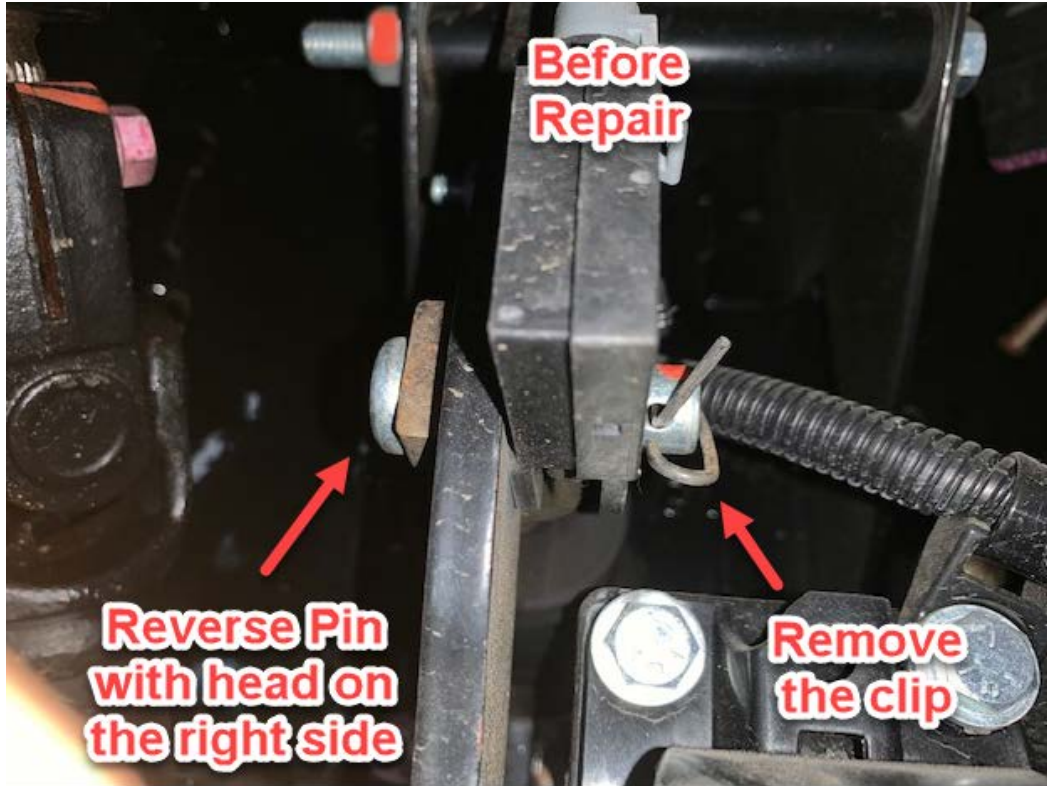
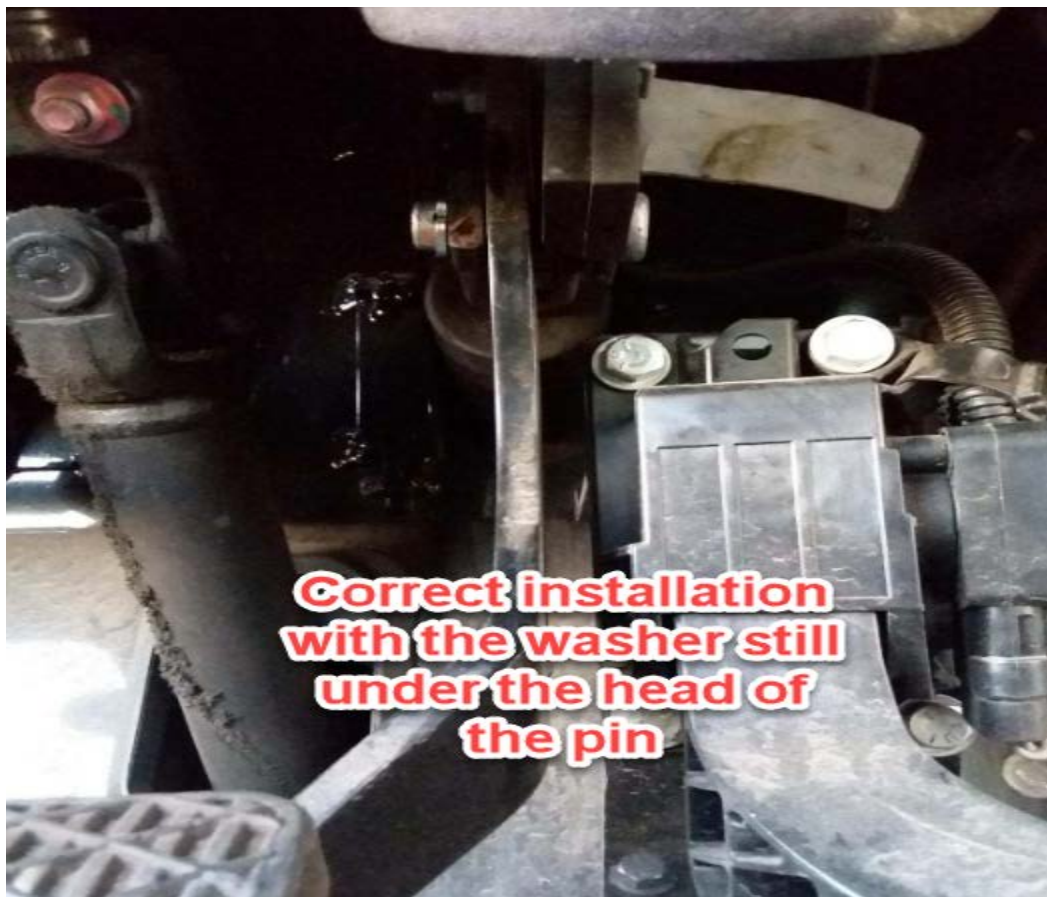
The clip holding the clevis pin can be rotated where it is close to the TPS (throttle position sensor) and mounting that could cause the clip to bend and/or break.

Remove the clip holding the clevis pin, note if the clip was bent, missing or damaged. Record this on your repair order. Remove the clip or retainer from the clevis pin, remove the clevis pin keeping the washer at the head of the pin, reverse the clevis pin by reinstalling the pin opposite from how it was removed. This will move the retaining hole of the clevis pin away from the TPS. Use a 1/8 inch cotter pin bending the cotter pin tightly around both sides of the clevis pin.

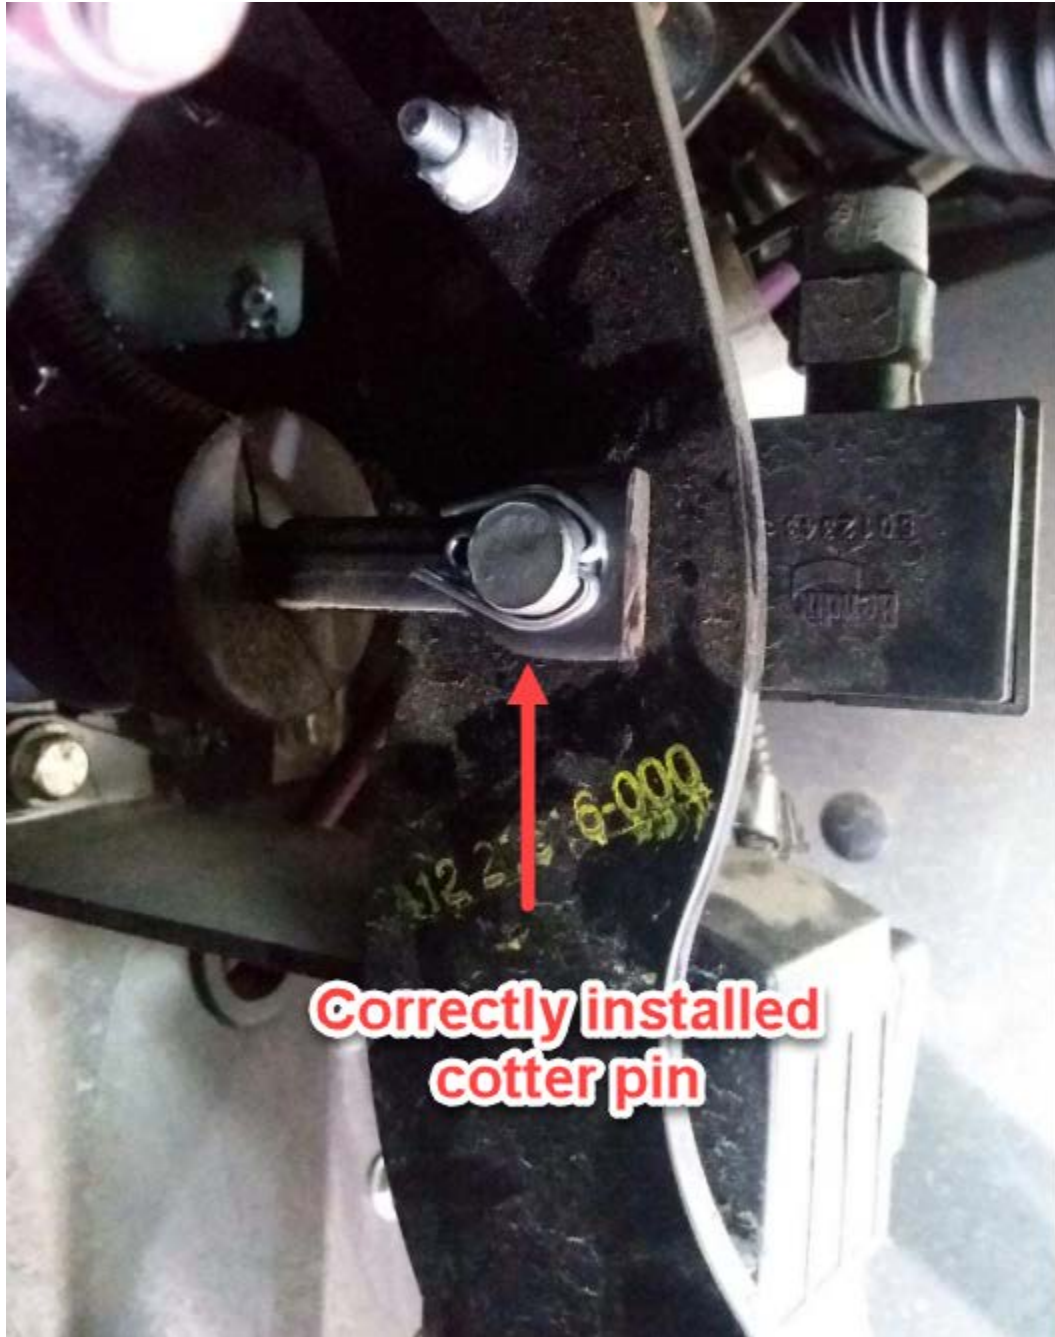
**Correctly installed
cotter pin**
