North America LLC Customer Advisory Letter

Subject : Rear PTO Pump Support

Subject; Rear Transmission Support Bracket

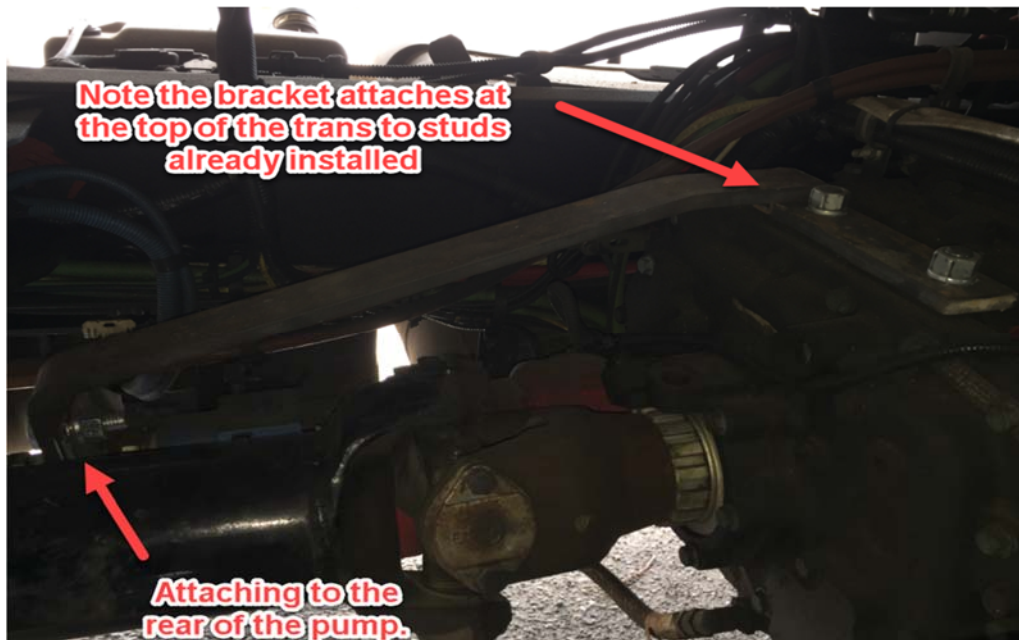
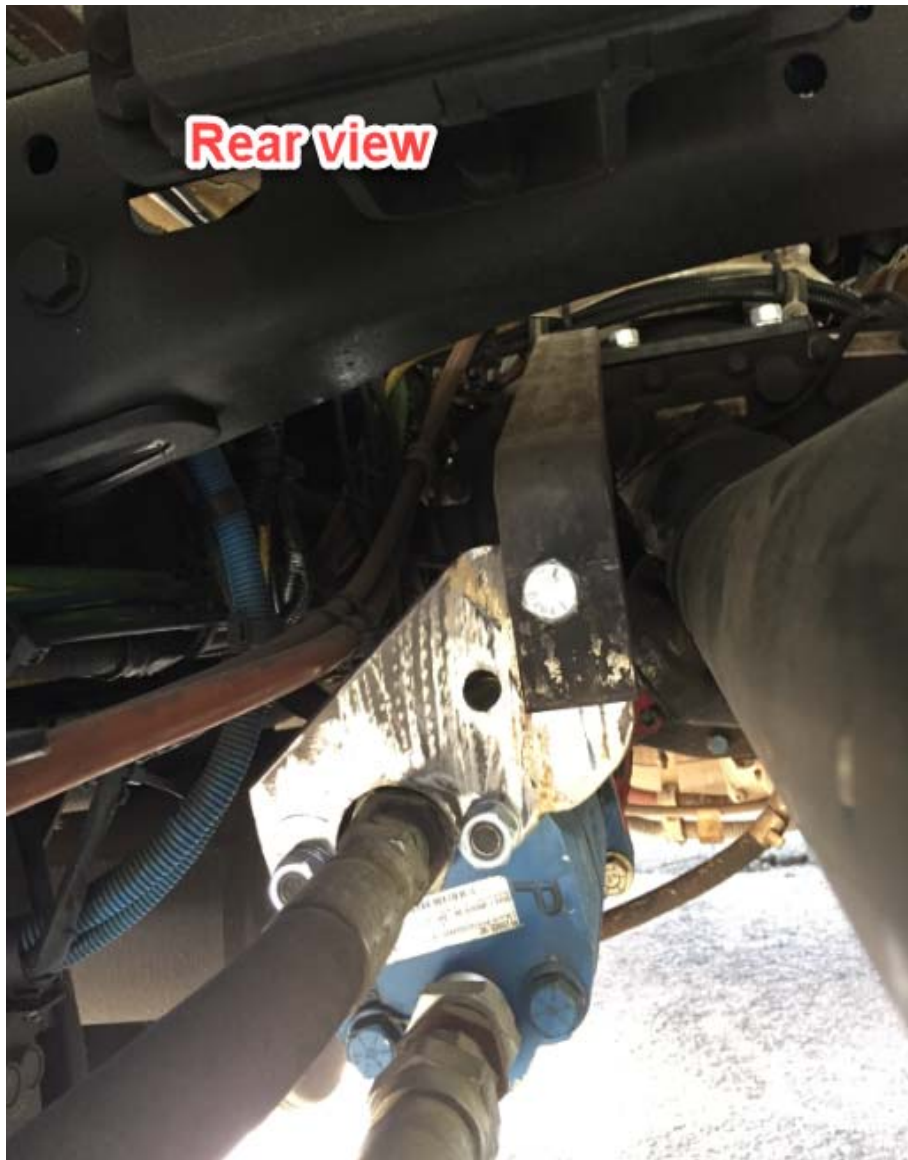
Those Fuller transmissions with the PTO rear mounted with a HYD Pump mounted to the PTO. There were some mounted with a support strap attaching to a single 3/8 bolt at the top of the transmission to one of the pump studs. We now have a support bracket that can be ordered from the location below that will bolt to the 2 - 5/8" studs from the top of the transmission and to the rear of the pump. The pump should have 2 studs, if they are now installed on the top of the pump, remount where the bracket will attach.

The pump support brackets costs 200.00 per truck, you will need to set up billing.

Blalock Machine Works Inc
2201 N Monroe St
Albany, GA 31701
