Technical Service Bulletin

94 Headlight cracked/water ingress into headlight lens

94 19 08 2034735/3 May 31, 2019. Supersedes Technical Service Bulletin Group 94 number 14-42 dated May 29, 2014 for reasons listed below.

Model(s)	Year	VIN Range	Vehicle-Specific Equipment
A6	2012-2013	All	Xenon or LED Headlights
A6	2014	000001-041047	Xenon or LED Headlights

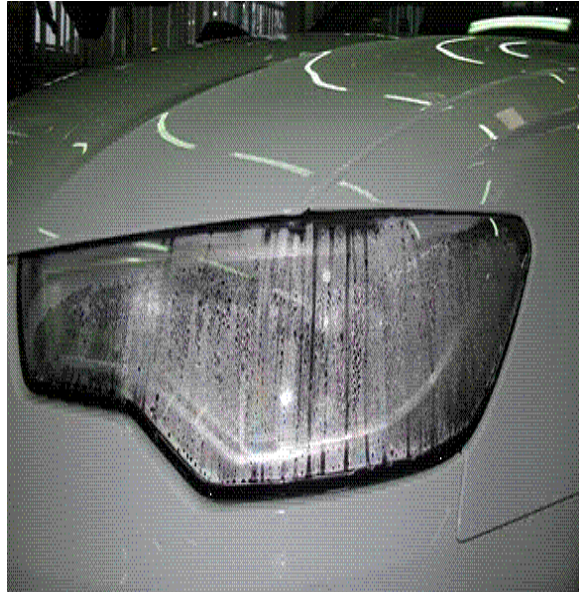
- Heavy condensation is present in the headlight (Figure 1).

Figure 1. Headlight with heavy condensation.

The moisture is an optical condition that does not affect the function or performance of the headlights, and it will not lead to corrosion or damage of the internal headlight parts.

Replace the affected headlight with the updated part number found in the ETKA parts catalog.

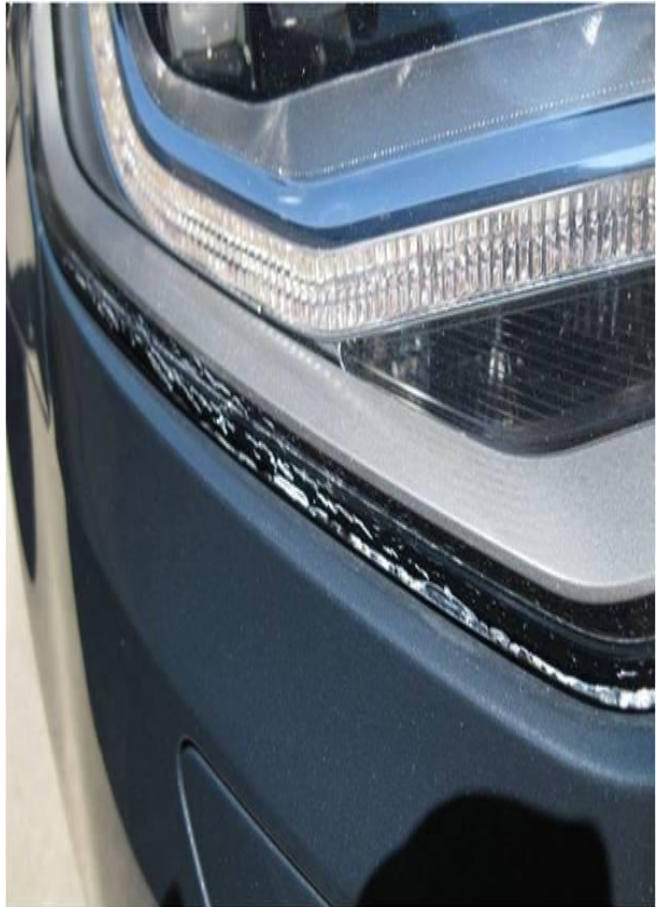
- Lower headlight lens is cracking (Figure 2 and Figure 3).

Figure 2. Lower headlight lens is cracking.

The production process causes stress on the headlights from the bumper, as well as the torsional force from installation.

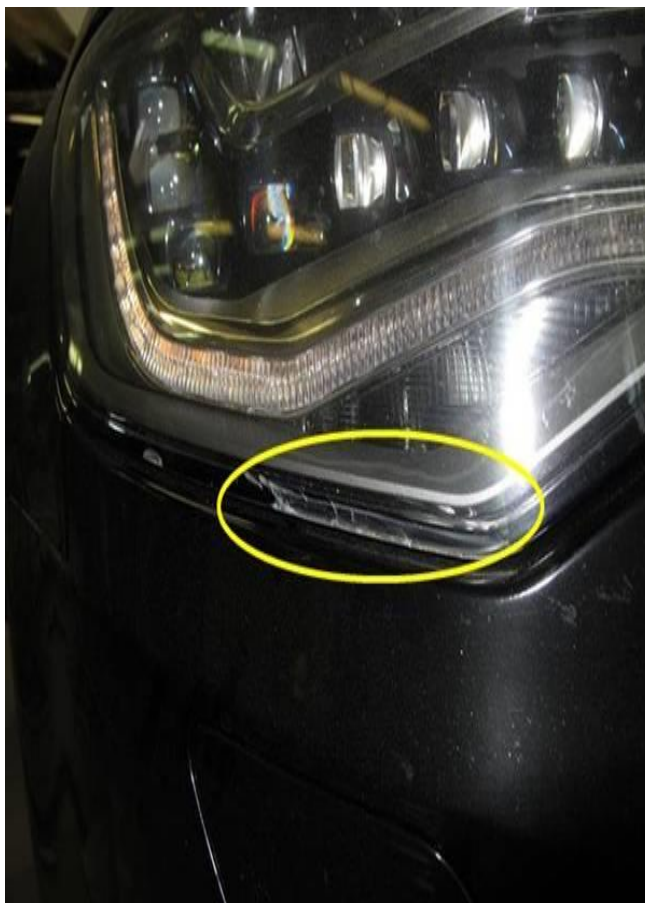
Figure 3. Lower headlight lens is cracking.

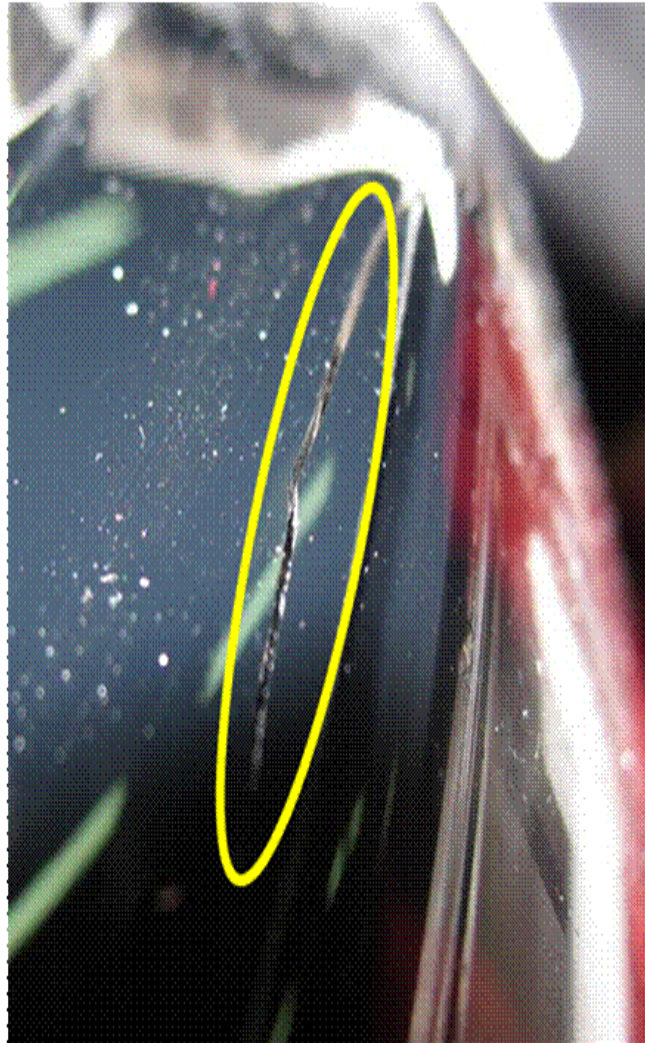
- Upper headlight housing is cracking (at the transition from the lens to black surround) (Figure 4 and Figure 5).

Figure 4. Upper headlight housing is cracking.

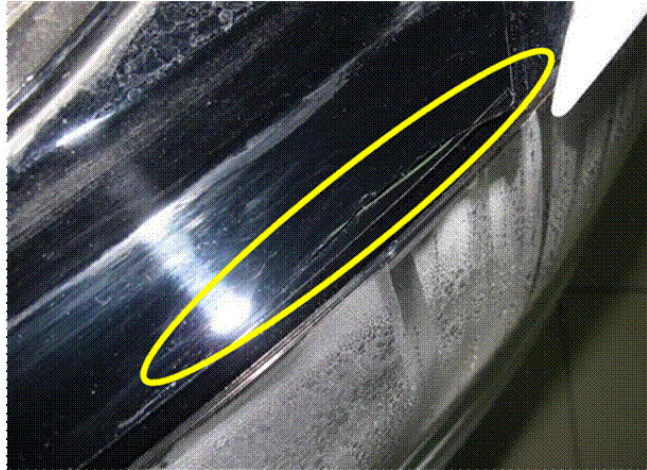
Figure 5. Upper headlight housing is cracking.
