| DOC # | PROCESS NAME | PAGE | REVISION | STATION | BY | DATE |
|---|---|---|---|---|---|---|
| <b>AR864</b> | <b>ARBOC SPIRIT OF EQUUS CAC HARNESS<br/>MODIFICATION</b> | <b>1 OF 3</b> | - | SER-E | J. SPRY | 6/5/2019 |

**Complaint:** Efan system on Diesel bus found to have improper 12V power to Radiator and CAC fans, causing unnecessary running at low temperatures that drain batteries.

**Cause:** Improper supply of 12v analog signal to fans in Grayson Fan Harness

**Correction:** Field fix is to cut and insulate analog signal wire.

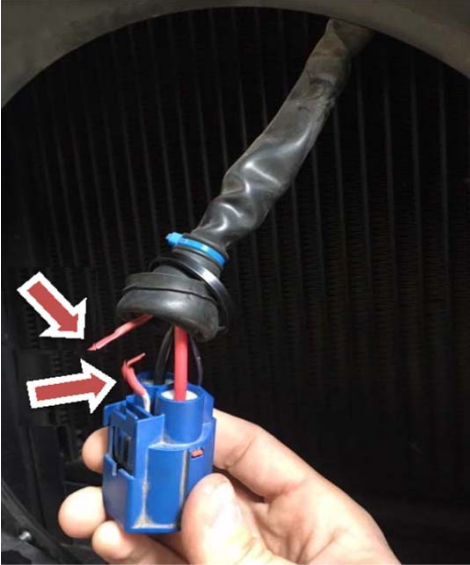
Step 4: Locate the Analog wire leading to pin 3 of the Yazaki connector. This wire will provide a constant 12V when ignition is switched on. In Grayson systems this wire has been seen to be either grey or white, depending upon the model. The wire is the one immediately adjacent to the latch tab on the harness connector.

Step 5: Cut the CAC harness wire about 1" back from the connector. Use heat shrink to seal both ends from moisture and pinch the end of the heat shrink while hot to seal.
