**Document ID:** IK1600226

**Major System:** CAB / SLEEPER / HOOD

**Title:** LT Grille - Chrome Plating Delamination

**Applies To:** LT

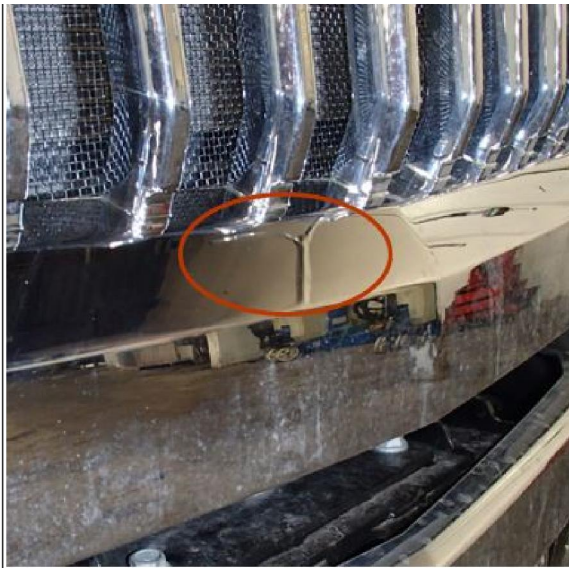
**Figure #1: Chrome Grille Defect**

Customer states that the grille has chrome peeling, flaking off, de-laminating, blistering, or worming and/or wrinkling. The grille has no external damage to the plating.

| Step | Action | Decision |
|---|---|---|
| 1 | Does the grille have bad chrome appearance similar to the photo in figure 1 below? | Yes. Go to Step 2 |

| Step | Action | Decision |
|---|---|---|
| 2 | <p>Is the grille date code between 01/02/2017 - 02/18/2017?</p> <p>See Figure 2 for how to identify date code of grille.</p> <p>Note: The build date (Date Code) can only be seen with the grille removed. Do not remove or replace grille unless customer complaint is evident. The grill date code will be relatively close to the truck build date.</p> | Yes. Contact your Navistar CSE to open an FSR for grille replacement. |
